2013

Annual ADNR Surveillance and Monitoring Report

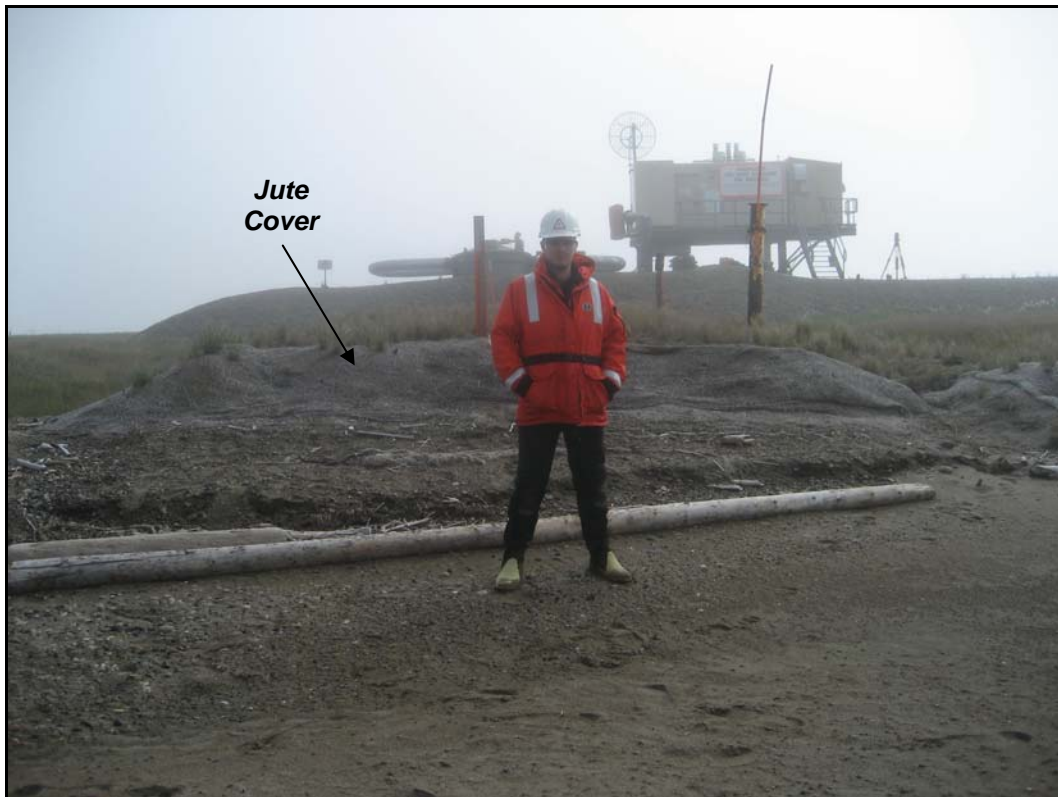
Photo 1. Jute Fabric Cover and Driftwood Debris at Shore Crossing

The seaward face of the sediment backfill mound that covers the pipelines from the bluff edge to the pipeline service pad has eroded to a greater degree than the adjacent tundra located to the east or west, as shown in Photo 4. This greater susceptibility to wave-induced erosion is expected, given both the lack of natural vegetative cover of the backfill and the thermal effects of the buried pipelines that tend to thaw the backfill. Attempts to vegetate the surface of the sediment backfill have been undertaken and appear to be succeeding. However, given the combination of westerly storms which elevate the coastal water level coupled with the effects of thermal erosion of the bluff during the warm summer months, further erosion of the bluff and the backfill mound will occur. The jute fabric cover that was placed over the face of the shore crossing in 2004 was damaged and removed in 2008 by the wave impacts of a major westerly storm. The jute cover was replaced during the summer of 2009 and was in good condition at the time of the August 2013 inspection (Photos 1 and 4).

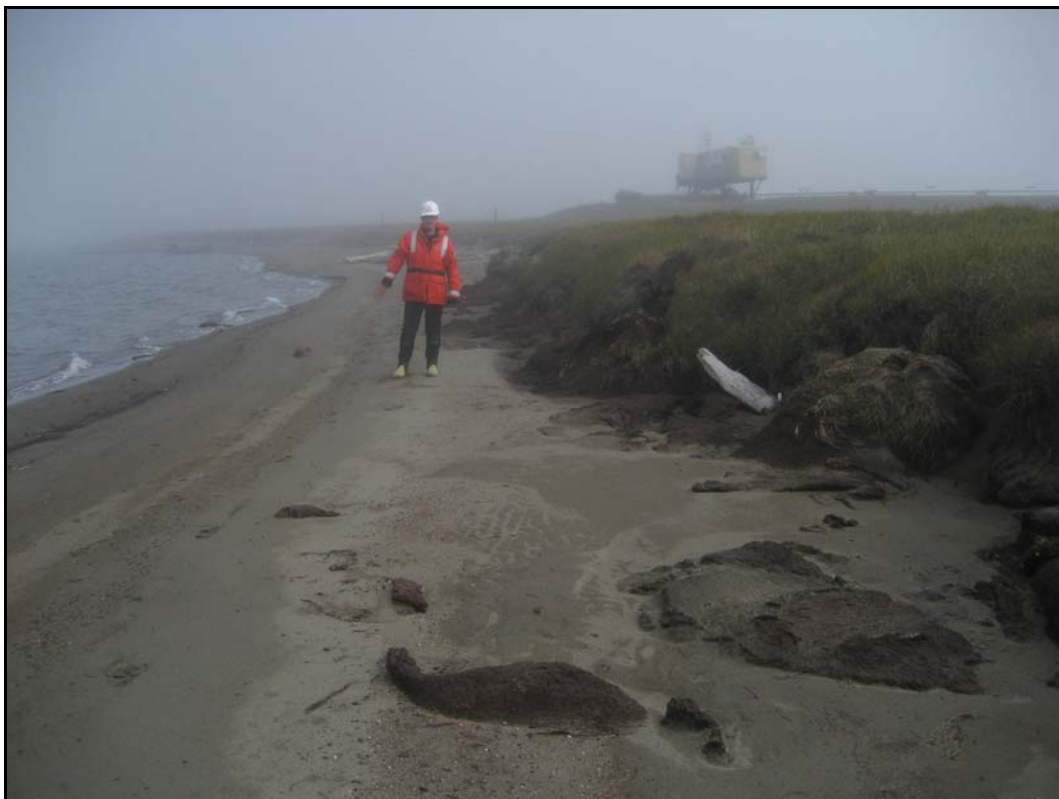
Photo 2. Bluff Condition to the West of Shore Crossing

Photos 2 and 3 show general conditions along the coast. Photo 2 is viewed from the west and shows a large piece of tundra that has detached from the bluff edge and covers the exposed bluff face. This condition will provide additional protection and limit direct wave impacts to the bluff face in the event of strong westerly wind and the associated increased water levels. Photo 3 provides a view of the undulating beach looking west towards the shore crossing. As previously noted, driftwood shown in the photo has accumulated near the back beach, suggesting relatively recent water levels reaching to the base of the bluff.

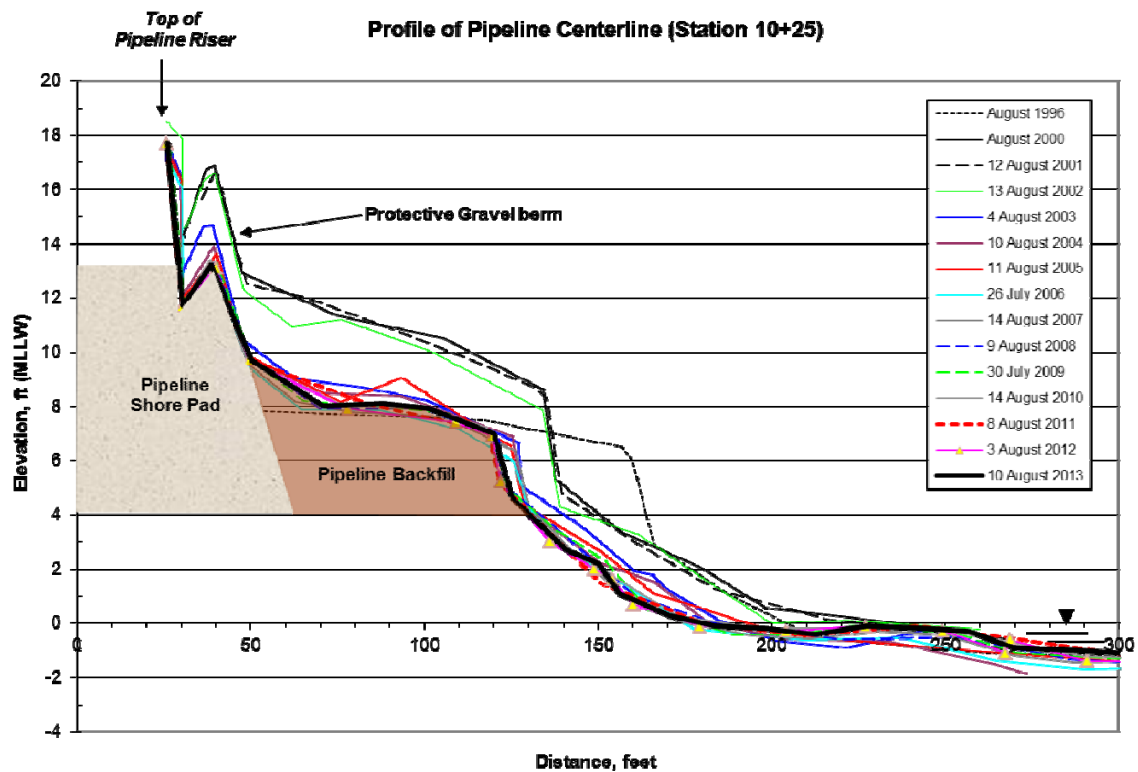
The average annual bluff erosion rate at the pipeline shore crossing (Station 10+25) for the 2000-2013 period is 1.4 ft/year, or 25% of the average rate of 5.7 ft/year for the 1996-2000 ("Pre-Project") period.

Figure 9. Subsidence and Recession History at Pipeline Shore Crossing (Sta 10+25)

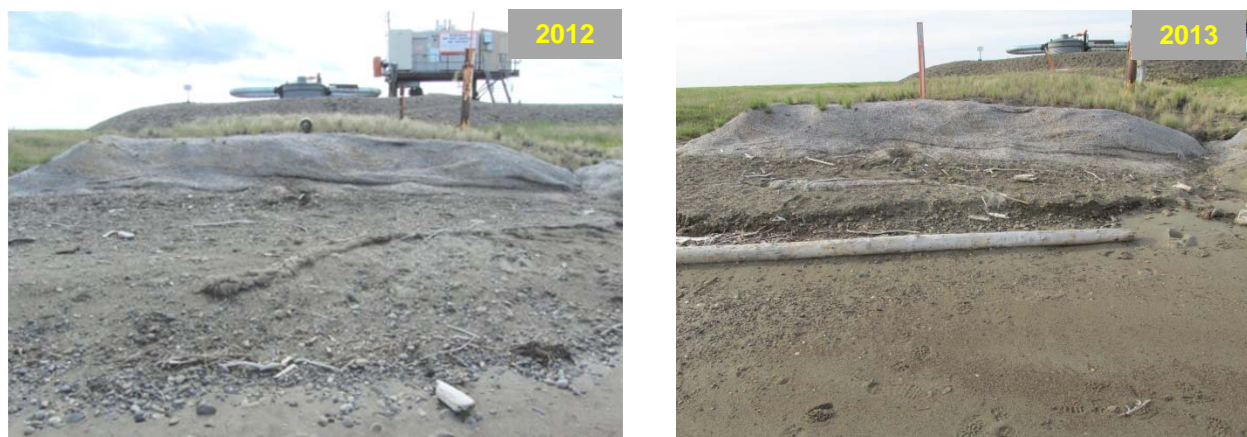
Figure 4. Views (east) of side slope treated with erosion control matting, Northstar Pipeline Landfall Shore Crossing, 28 July 2012 and 3 August 2013.

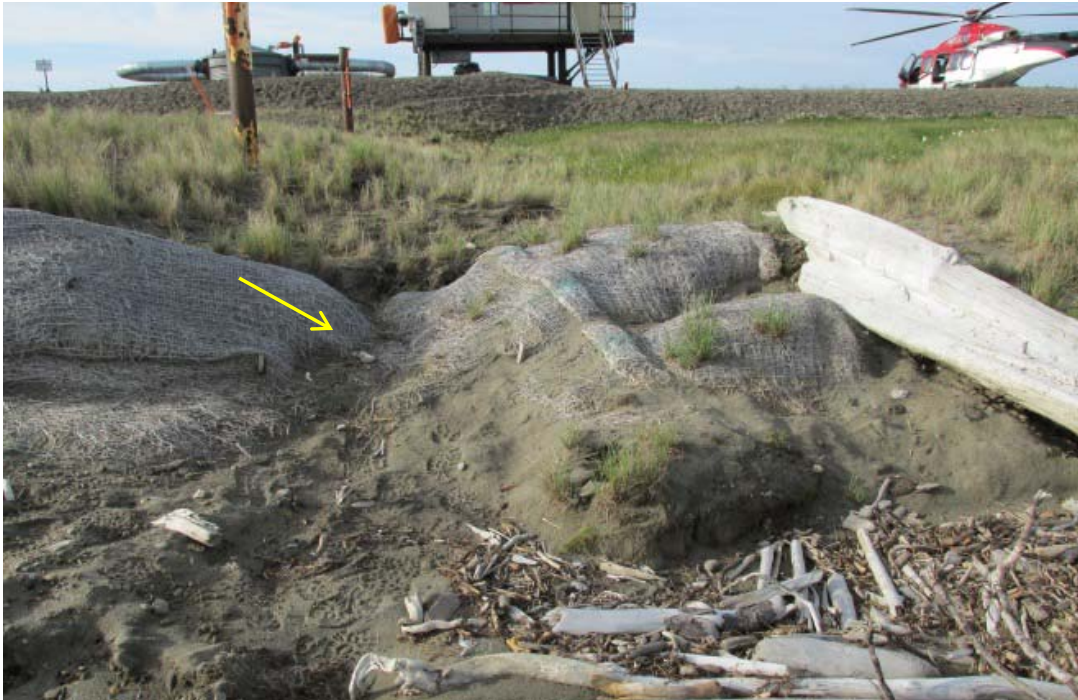
Erosion of the trench side slope has been minimal since 2009, due primarily to the protection provided by the erosion control fabric. The rooting system of plants can also protect against erosion, but vegetation on the side slope is too sparse to provide this function. If the site is

Figure 5. Close-up of area at west end of erosion control fabric where a slight gully has formed (yellow arrow), Northstar Pipeline Landfall Shore Crossing, 3 August 2013.
