5.0 CONCLUSIONS AND RECOMMENDATIONS

5.1 Geologic Hazards Recommendations

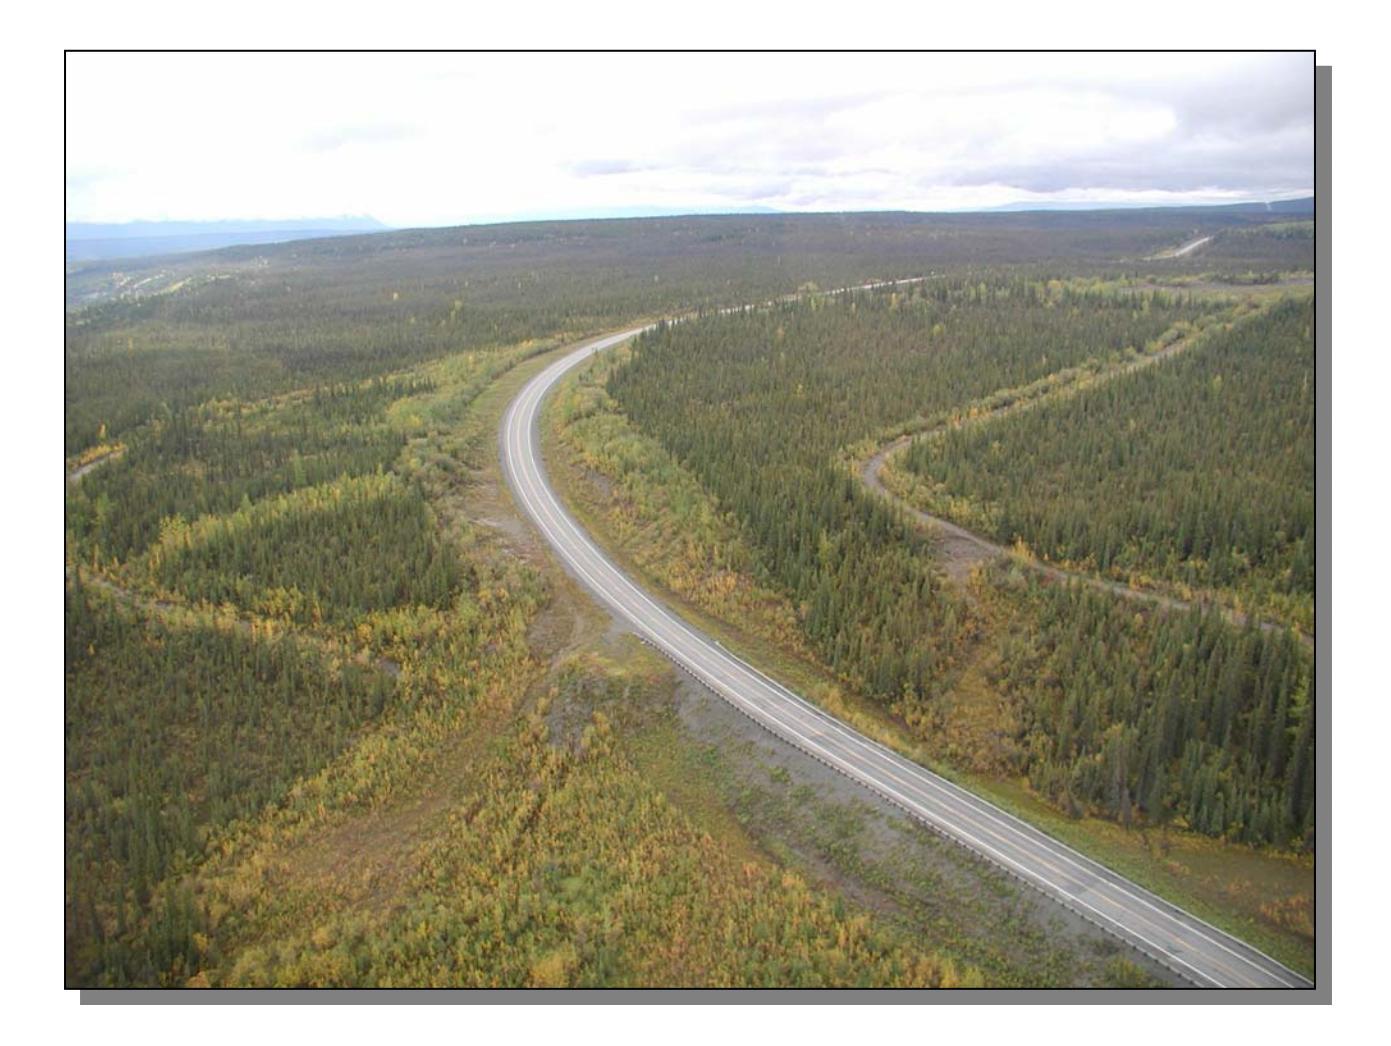
FIGURE 13

- Milepost 16.0 to 16.8: West side of Tolsona Creek valley (Figure 13). The Glenn Highway at this location has suffered significant thermal erosion and resultant slumping where it climbs up the west valley slope. Old landslides were noted north and south of the highway alignment. *Consideration should be given to possible realignment of the spur line to the old gravel pit access road lying north of the highway. Drainage should be directed*

West side of Tolsona Creek valley (approx. MP 51). Alignment is presently following the right side of the highway. Access road to gravel pit is shown on the right side of photo. September 2, 2005.

Note the small erosion feature apparently caused by concentrated drainage downhill of the bend in the access road.

to minimize the concentration of water flow along this road. Detailed subsurface exploration should be performed to determine site-specific conditions.

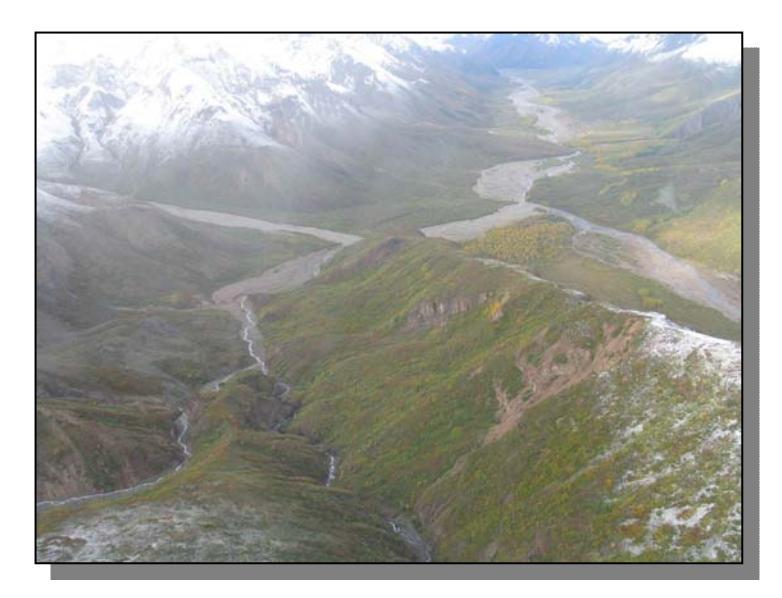
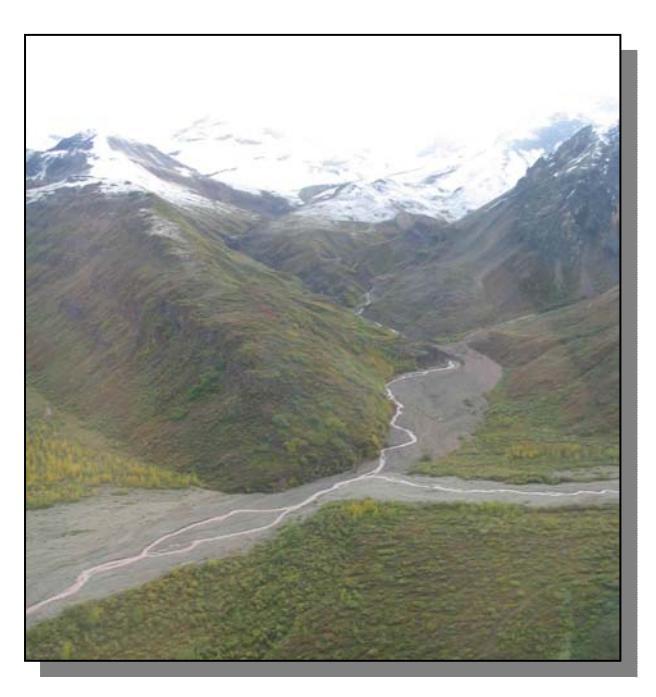
FIGURE 14

- Milepost 91.2 to 91.9: Two large landslides were observed on either side of a small creek flowing from Chitna Pass to Boulder Creek. The landslide on the east side of the creek was observed to be active during our field reconnaissance, as evidenced by numerous surface cracks and very loose surficial material. What appeared to be older, less active slides were observed on the west side of the creek. *We recommend that the alignment be moved out of this area. See Section 5.2.1.*

During our aerial route reconnaissance conducted on September 2, 2005, landslides were observed on the west side of Chitna Pass, at the point where the pipeline alignment descends out of the pass to Boulder Creek, as shown on Figure 14. The current pipeline alignment traverses the steep bedrock ridge on the west side of the creek. In this area, apparent landslides were observed on both sides of the creek. It should also be noted that the helicopter pilot did not consider the pass labeled as "Chitna Pass" on the U.S. Geological Survey map as Chitna Pass. He referred to the pass about two miles to the north as Chitna Pass.

On the west side of Chitna Pass, a large, very active landslide was encountered. Large cracks were observed on the surface with up to four feet of vertical displacement. The

Looking south, down Boulder Creek Valley (MP 92) from the west end of Chitna Pass (?). The pipeline alignment is located on the east side of the narrow ridge on the west (right) side of the creek. A large active slide is seen on the east (left) side of the creek. What appeared to be older slides were observed along the west (right) side of the creek. September 2, 2005.

Looking north into the west side of Chitna Pass (?) from Boulder Creek (MP 92). September 2, 2005. surficial material was very loose and difficult to traverse on foot. A small depression in the surface of the landslide indicated that there may be ice buried in the rubble. This landslide appeared to be advancing toward the creek and the toe was actively being removed by the creek. What appeared to be older slides were observed on the east side of the creek. These slides are more heavily overgrown and may be somewhat more stable. However, the creek appeared to also be cutting the toes out from under these slides. These slides may also still be active.

Due to time constraints and weather (snow and low ceiling), our reconnaissance effort in this pass was limited. *However, based on existing geotechnical information and what was observed during the aerial reconnaissance, we recommend that the proposed northern realignment, as shown in Figure 15 be given further consideration.*

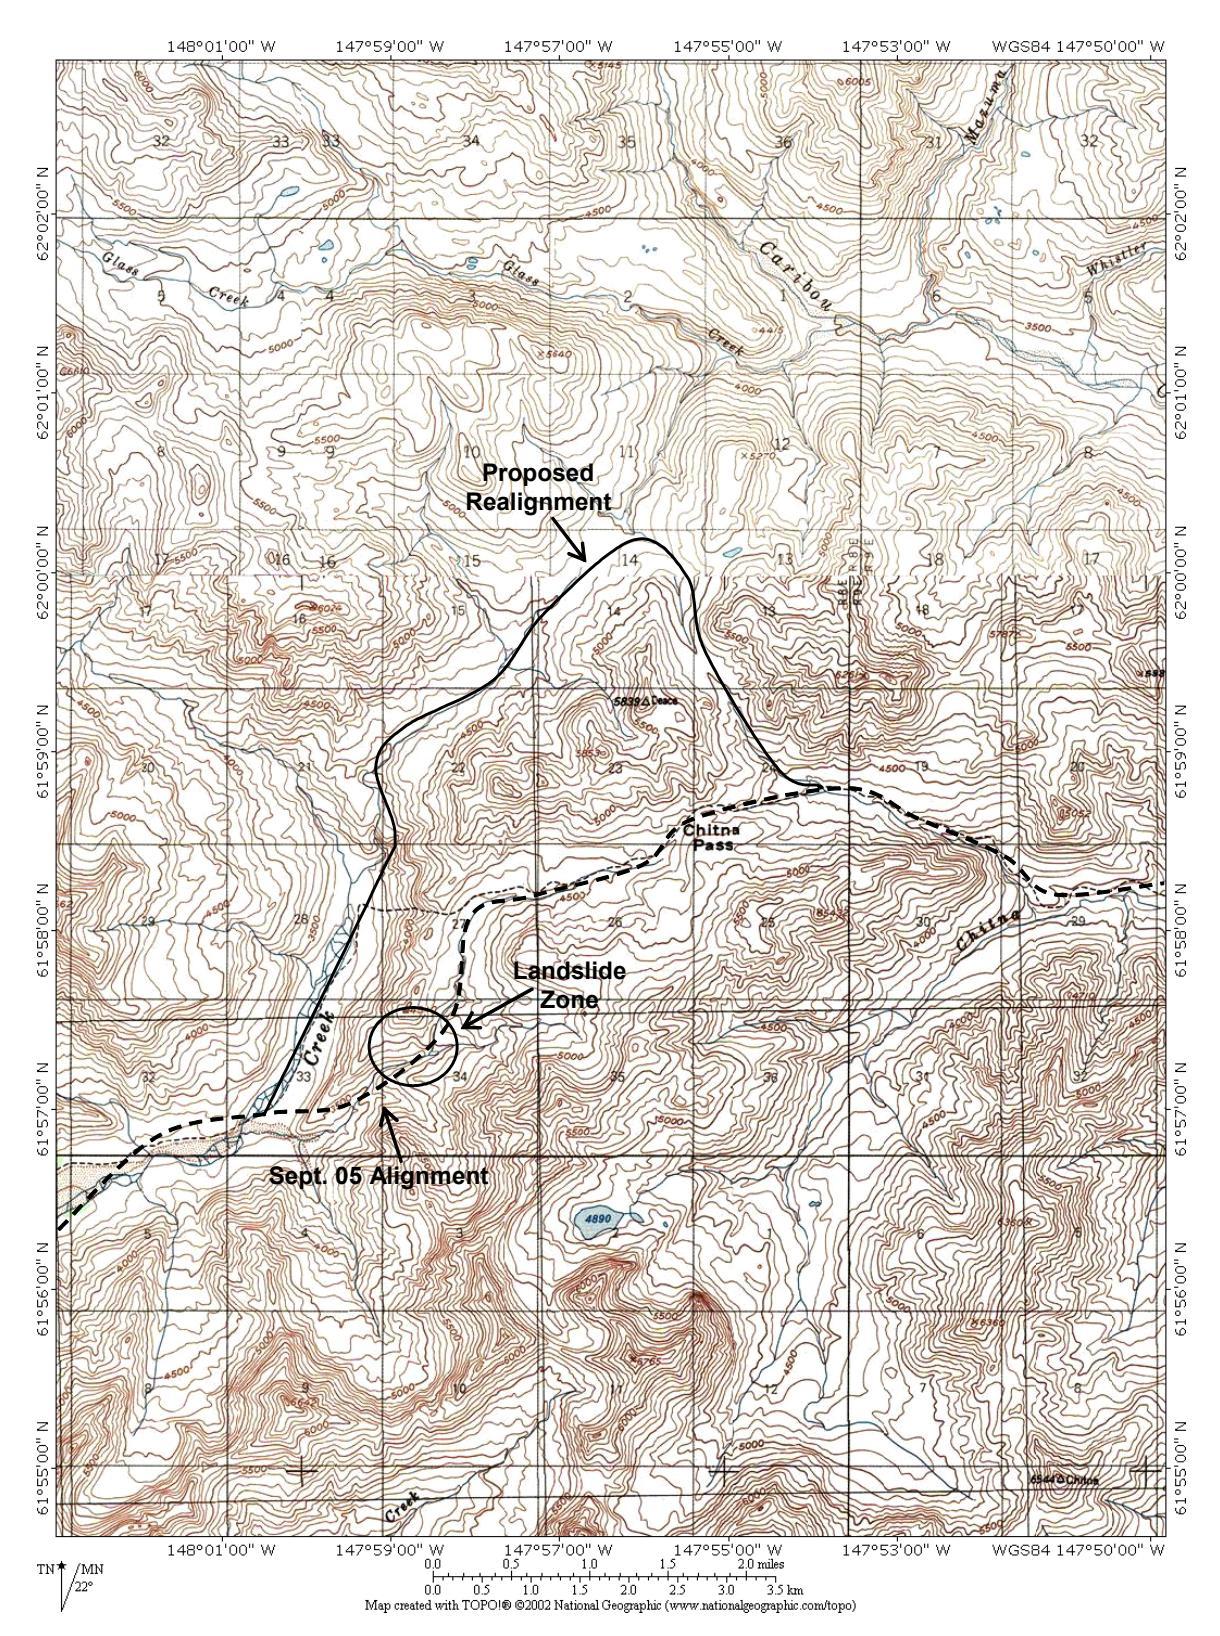
PROPOSED CHITNA PASS REALIGNMENT

After observing the potential problems with this pass, we flew north and reconnoitered the pass that the pilot called Chitna Pass. Based on our over-flight, the western approaches to this pass from Boulder Creek appeared to present less difficulty than that in the southern pass (current alignment). However, the eastern approaches to the northern pass from Caribou Creek appeared to be very difficult. There is a narrow valley connecting the two passes that appeared more suitable for spur line construction. The summit elevation of the southern pass is at approximately 4,800 feet and the northern pass at 4,600 feet. The summit elevation in the small pass that connects the two routes is about 5,100 feet.

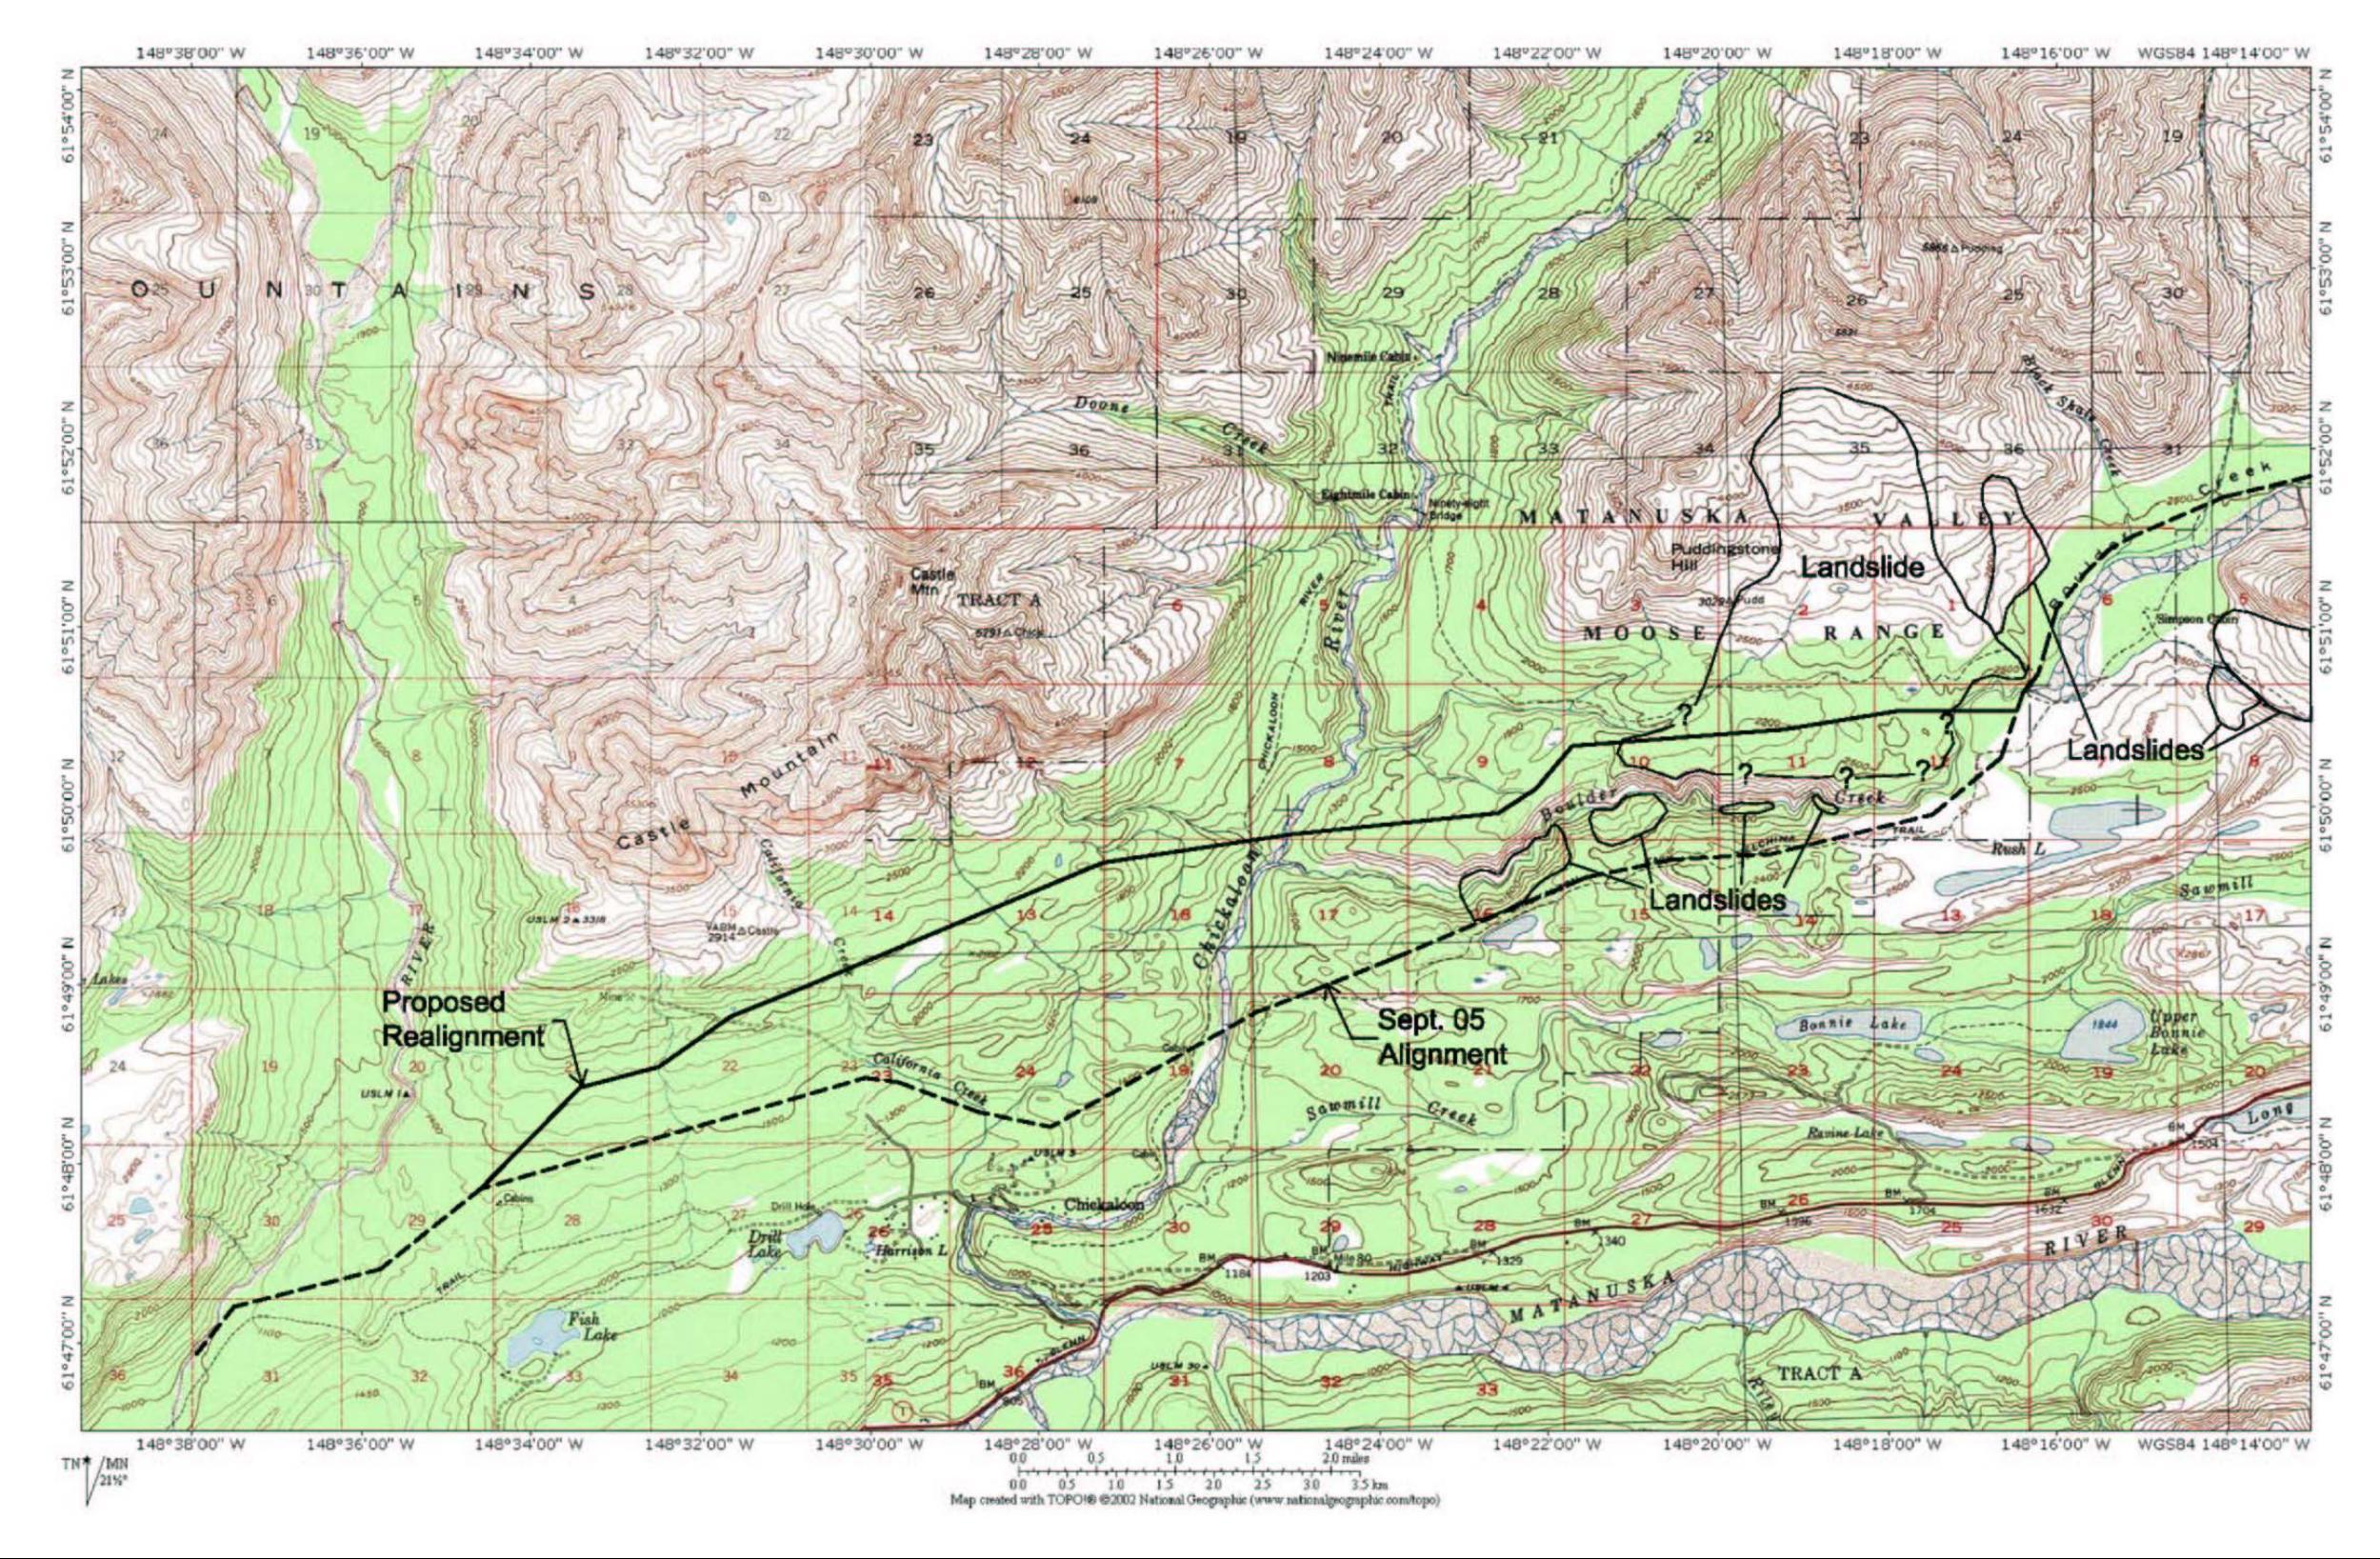
FIGURE 16

The east bank of the present Chickaloon River Crossing is a steep 140-foot high bedrock cut bank that drops directly into the river. This river is anadromous fish habitat and it would be extremely difficult to construct a crossing at this location. *Thus we recommend shifting the alignment either up or downriver to a more advantageous crossing location.*

The realignment shown in Figure 16, Proposed Chickaloon Crossing Realignment, indicates a northern route that crosses slightly over a mile upriver of the present crossing. The route shown would lie along the north side of Boulder Creek and cross just upstream from its confluence with the Chickaloon River. This route would avoid the step cut bank at the present alignment and several private land issues north of the village of Chickaloon. However, it would cross at or near the bottom of a large landslide on the

south side of Puddingstone Hill. If this is not possible, then the alignment should stay south of Boulder Creek and cross the Chickaloon River on the south side of Boulder Creek.

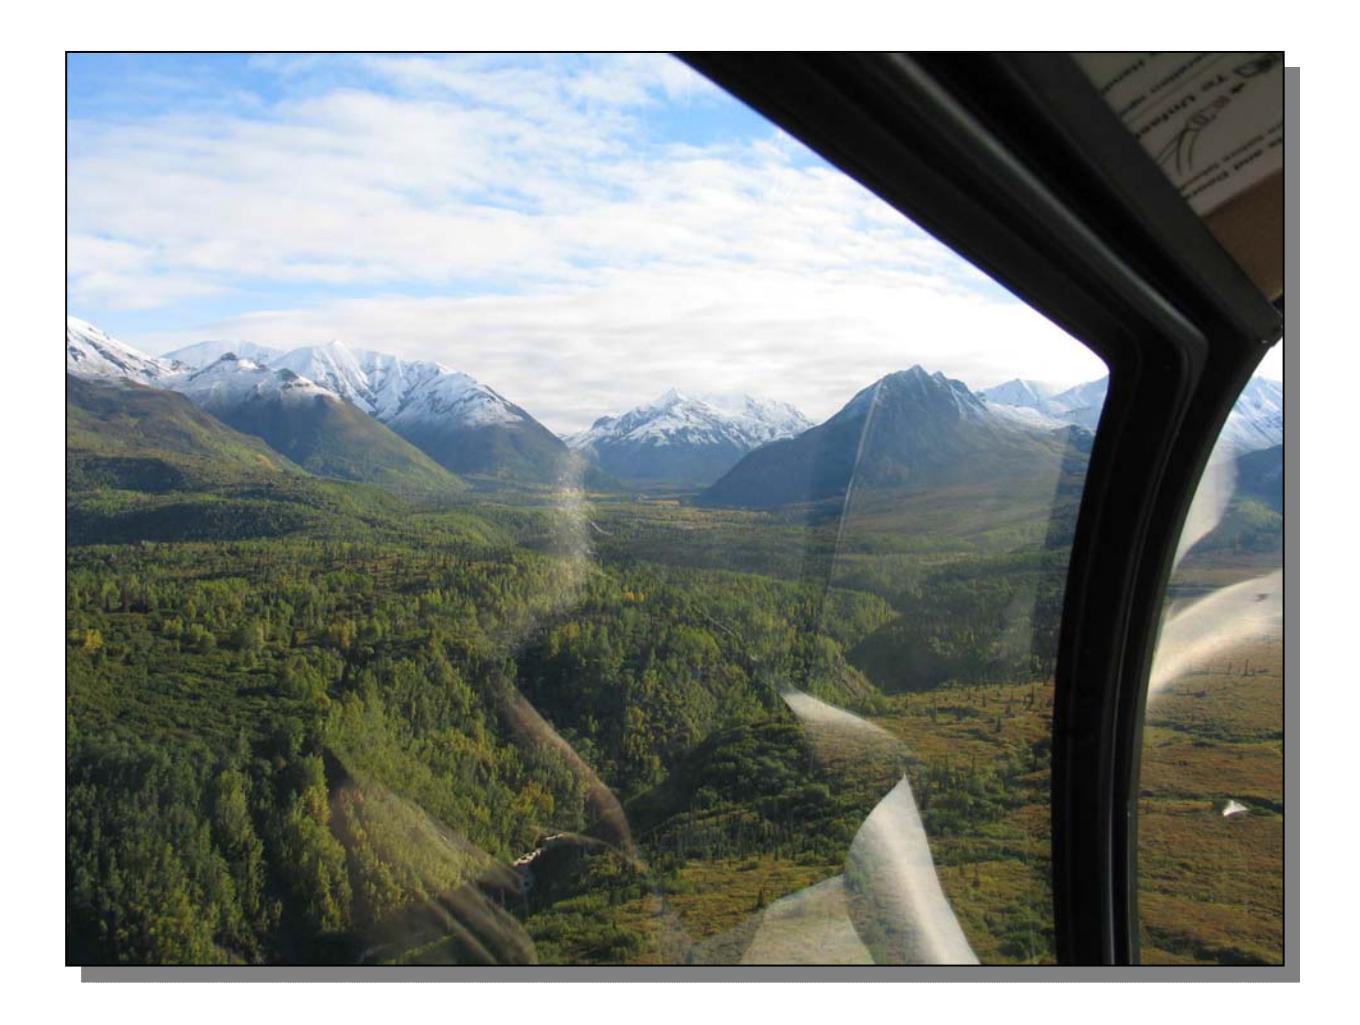
FIGURE 17

The eastern portion of the realignment is shown on Figure 17. The western portion of this realignment would traverse a bench along the south side of Castle Mountain. There were no readily apparent landslides along this part of the realignment. Large, steep colluvial deposits were observed on aerial photos uphill of the proposed realignment.

Looking north, upstream into the Boulder Creek Valley. The proposed pipeline realignment crosses the bottom of the slope on the left of the photo (MP 110-111). The eastern edge of the landslide can be seen on left edge of the photo. This landslide may have flowed down to Boulder Creek. September 2, 2005.

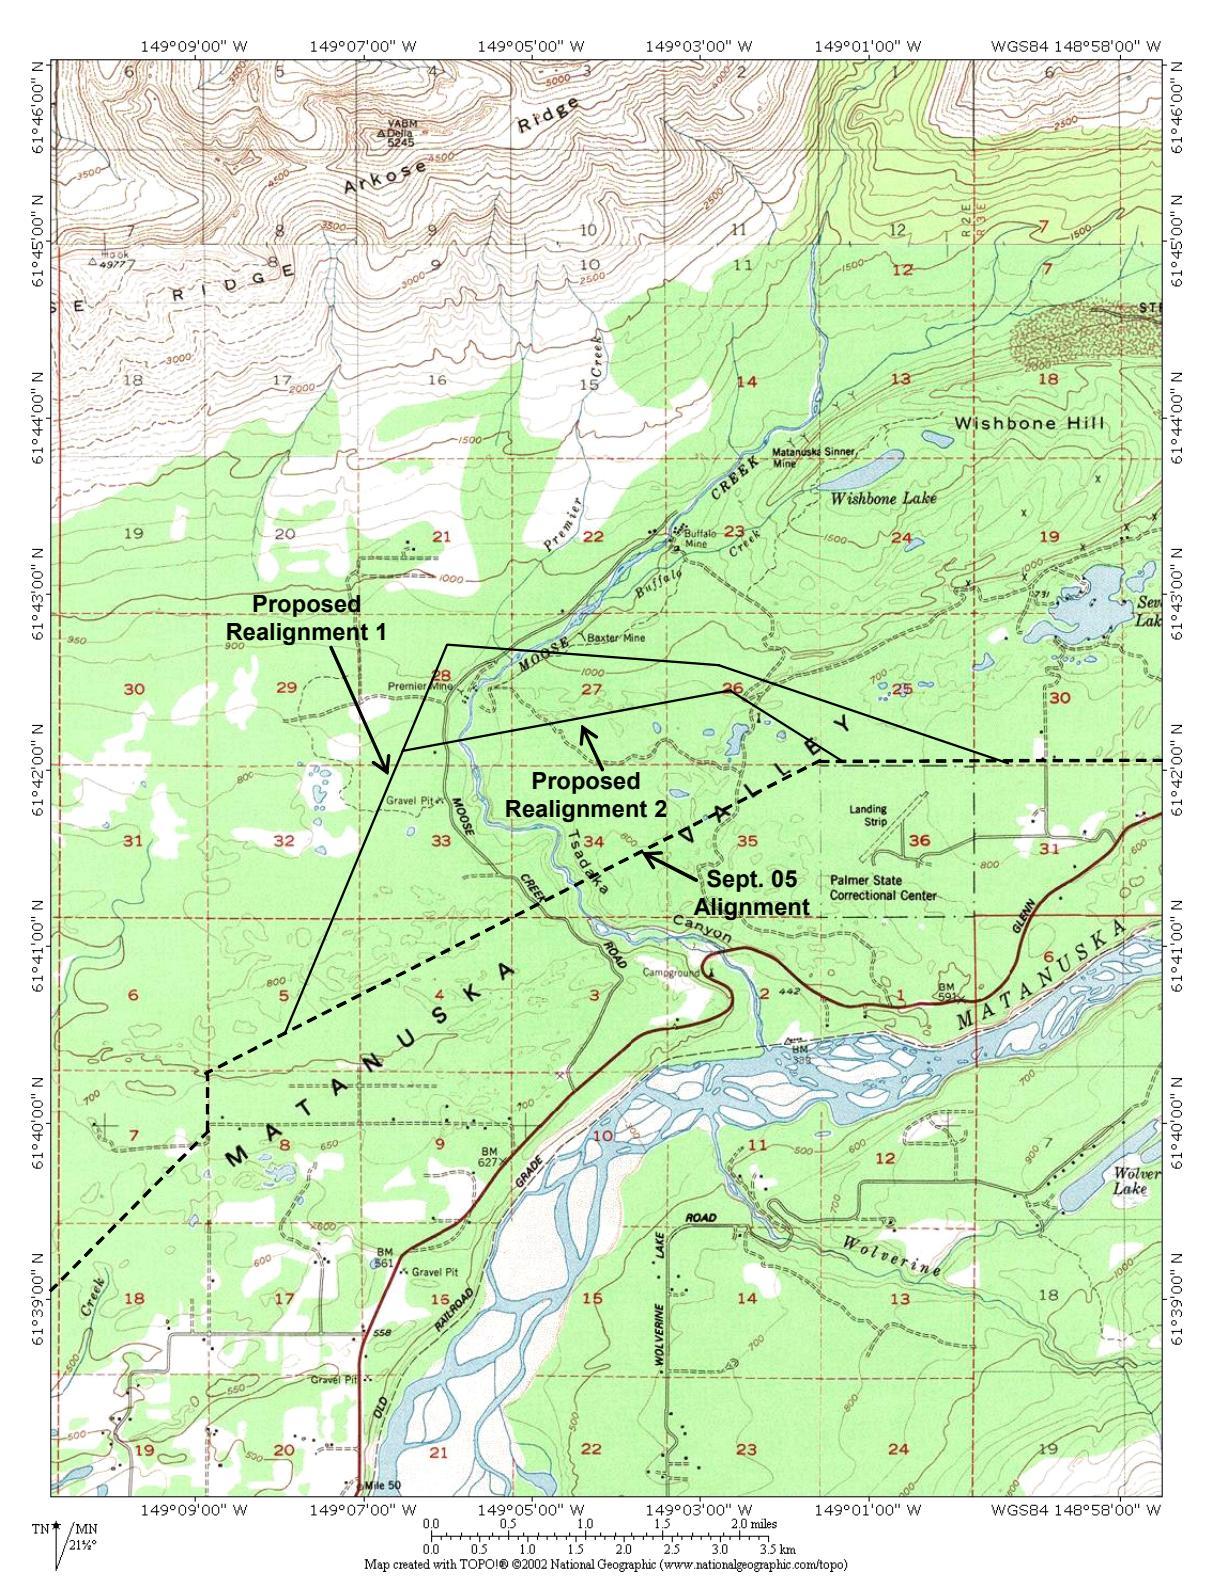
PROPOSED MOOSE CREEK CROSSING REALIGNMENT

The alignment at the present Moose Creek crossing traverses a narrow steep-walled canyon, approximately 200 feet deep, at the crossing called Tsadaka Canyon. There is a large actively eroding section of the canyon wall upstream of the crossing and fine-grained soils appeared to be eroding into the stream. The stream is anadromous fish habitat and it would be difficult to construct the pipeline on these slopes without causing siltation of the creek. *Therefore, we recommend that consideration be given to moving the crossing either upstream as shown on Figure 18 or downstream to a location between the Glenn Highway and the Matanuska River.*

Two proposed upstream realignments are shown on Figure 18. Realignment 1 is the longer of the two, crossing in a location where both canyon walls are significantly lower and not as steep. Realignment 2 also crosses the creek at a point where the canyon walls are lower and the creek floodplain is wider. However, at this location the west canyon wall is steep and it may be difficult to find an acceptable route up the canyon wall.
