Engineering/Fault Zone Crossing Design Glennallen to Palmer Spur Line

FINAL REPORT

October 2005

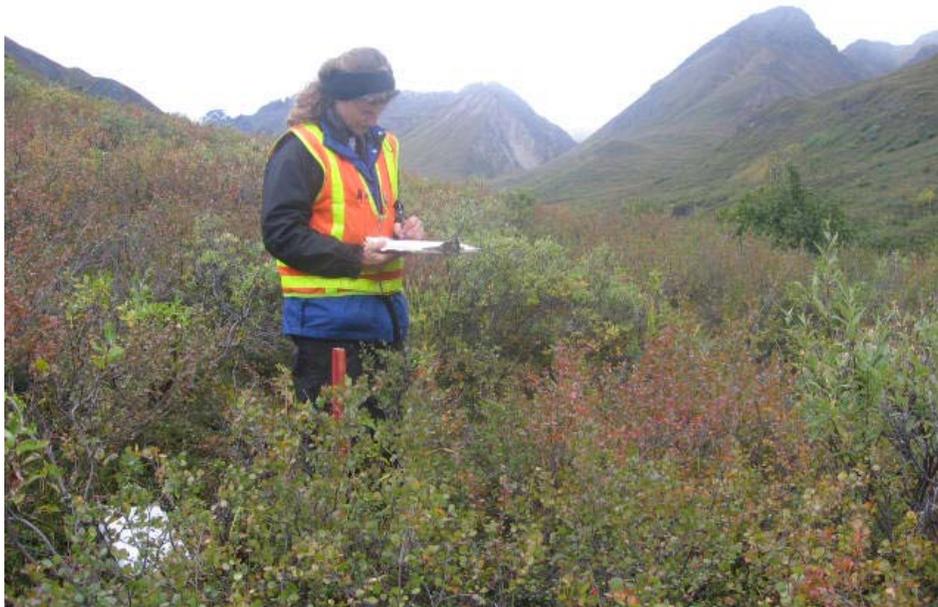
The staked location of the crossing was positioned on a small bench just downslope of the main bench on the south side of Chitna Creek, which is roughly defined by the 3,200-foot contour. No evidence of surface faulting was observed at the crossing in the field. Several notches and saddles were observed on the aerial photographs (Aeromap, 2004) along sharp bends in Chitna Creek; these are roughly coincident with the mapped trace of the fault or within the zone of uncertainty, and appear to be related to bedrock faulting and not necessarily rupture of surficial

Surface soils at the staked location consist of wet sticky clay with occasional cobbles, likely a glacial till-type soil deposit. Observations of soil exposures on the north side of Chitna Creek indicate this deposit may be on the order of 50 feet thick on top of bedrock. Numerous slides and slumps were observed along the Chitna Creek banks in this area, and the staked location of the crossing may be located on one such feature.

Photograph 1. Caribou Fault – East Crossing, MP 84.7-84.85: Chitna Creek is to right; fault follows bench on left (south) side of creek. Pipeline route coincides with fault for about 1,000 feet at this crossing, then crosses to north side of creek in center-right of photograph. Northeast splay of Caribou fault (MP 86.6) is in mountainside in center background.

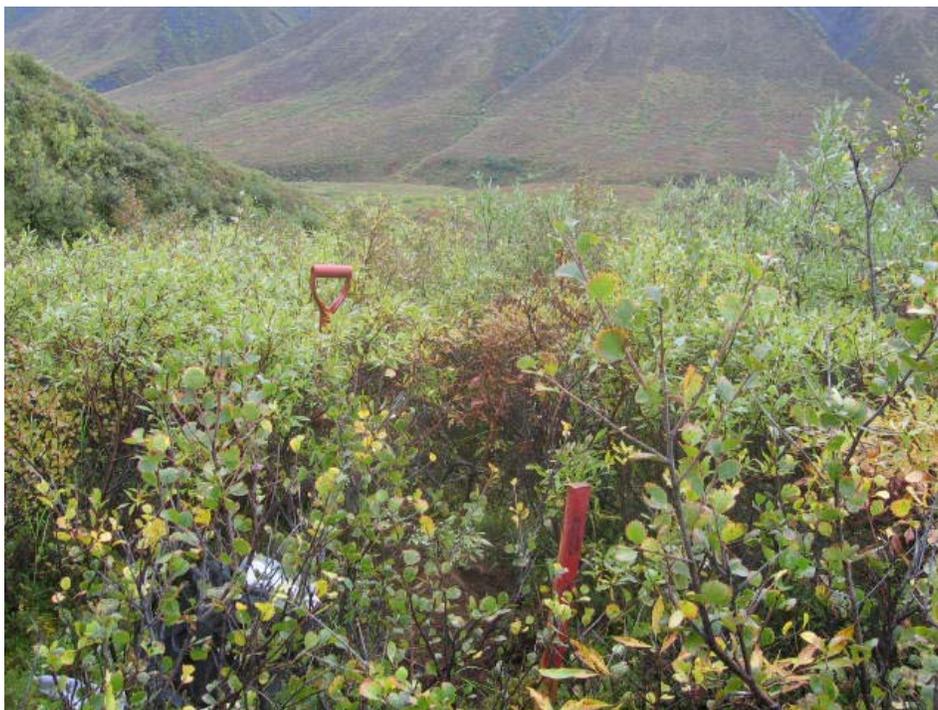
Photograph 2: Caribou Fault – Northeast Splay, MP 86.6: Looking southeast down pipeline route towards Chitna Creek valley from fault crossing. Fault trends sub-parallel to Chitna Creek valley into hillslope at left.

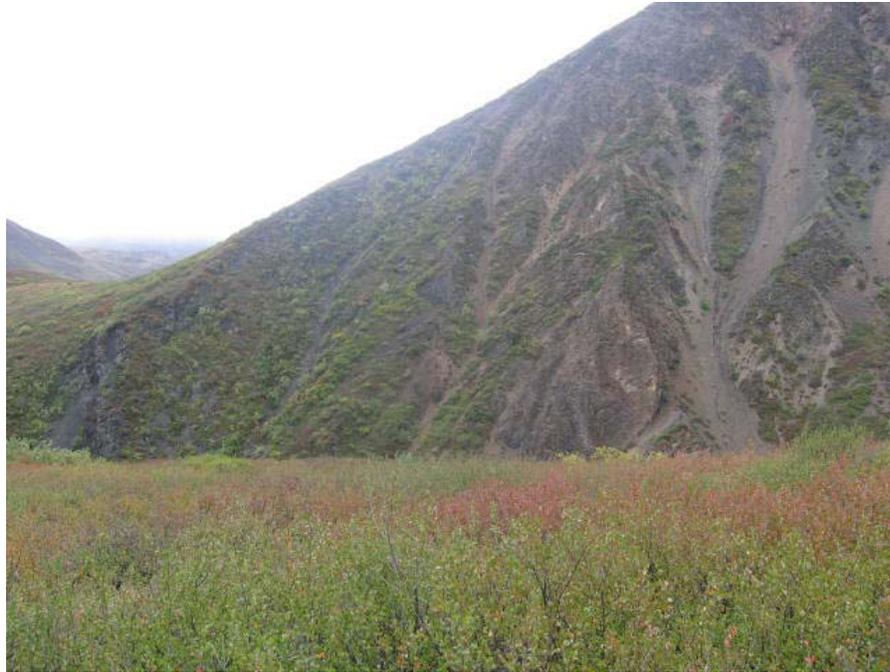
The landslide deposit lies in a relatively narrow canyon containing a south-flowing tributary to Chitna Creek. Bedrock exposures observed on the west side of the canyon contain the probable fault trace, as well as steeply dipping beds of the Chickaloon and Matanuska Formations (Appendix C, Photograph 3). Bedrock exposed at the base of the slope in the upper part of the east side of the canyon consisted of light green sandstone or andesitic volcanoclastic rock, likely part of the Talkeetna Formation mapped on the north side of the fault by Detterman et al. (1976). The fault and bedrock to the south were obscured by colluvium on the east side of the canyon. The dip of bedrock in both exposures is roughly 70 to 80 degrees north. The zone of uncertainty applied to the location of the fault at this crossing was considered to be about 200 feet due to the relatively well constrained fault location on the west canyon wall.

Photograph 3. Caribou Fault - Northeast Splay, MP 86.6: Looking southwest from fault crossing across at possible fault trace, noted by difference in bedrock type on either side of the gully in center of photograph. Fault and bedrock to left both dip steeply to north.

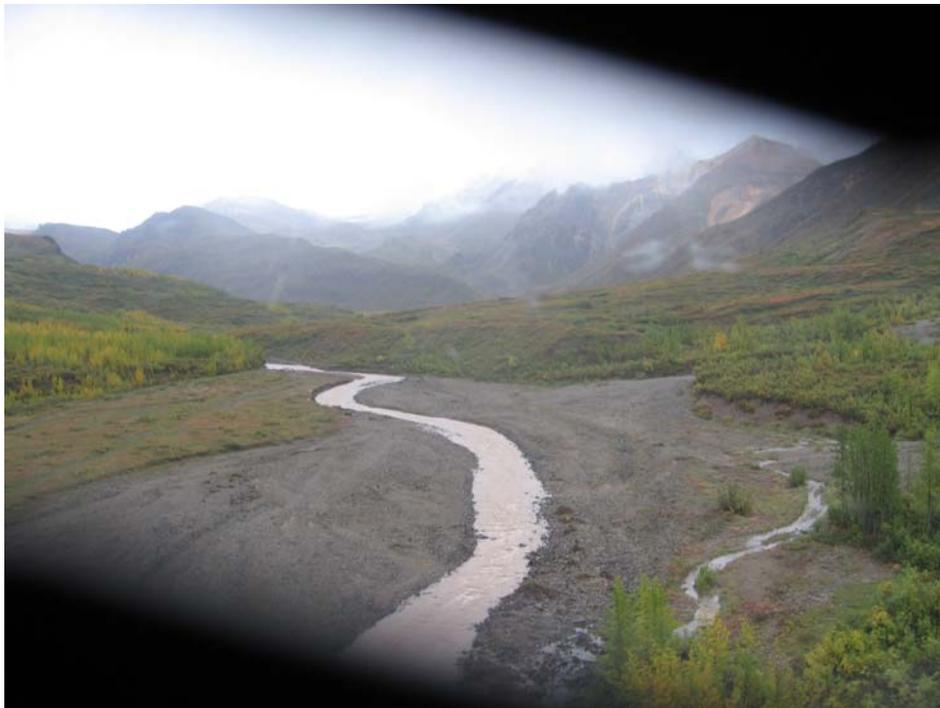
This 3-mile-long fault crossing was staked in the field at the approximate east and west endpoints (Photographs 4 through 9). There was no evidence of surface rupture at either location or along the pipeline route in between. Faint lineaments on aerial photographs and observations made from the air of this fault zone, described in Section 3.3.4, did not yield conclusive evidence of surface rupture. Because much of the interpretive variation surrounding this fault zone was incorporated into widening the mapped trace itself, the additional zone of uncertainty applied to this fault zone was minimal, about 200 feet perpendicular to strike at both ends (Table 1).

Photograph 4. Caribou Fault – East End of West Crossing, MP 96.5: Aerial view above crossing point looking upstream through upper Boulder Creek valley. Fault crossing is in alluvial fan/terrace material similar to right side of photograph. Pipeline route crosses photograph from right to left, trending north away from fault.

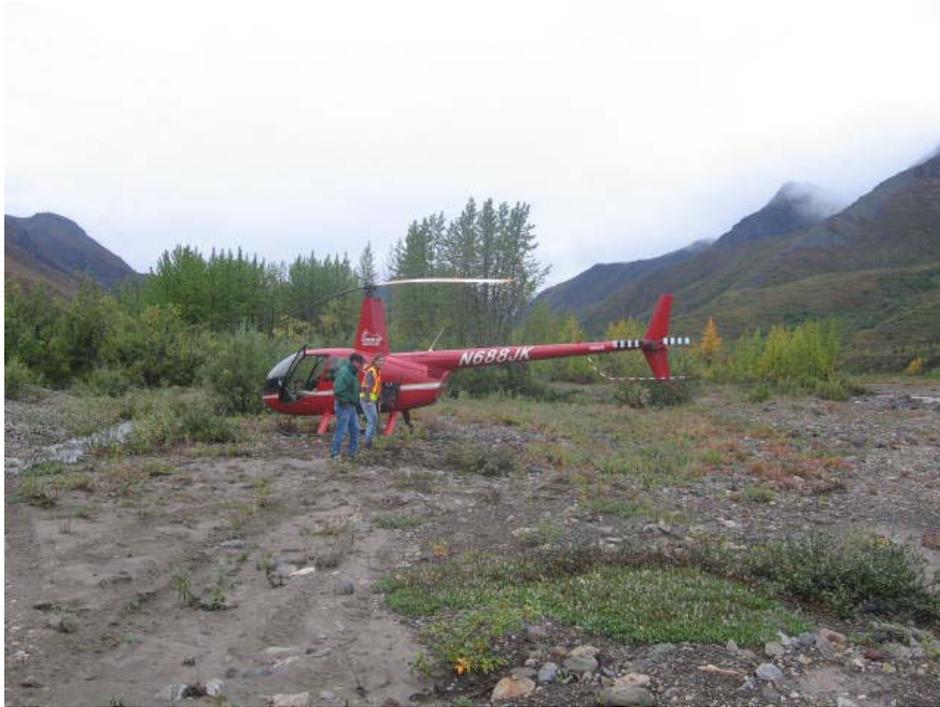
Photograph 5. Caribou Fault – East End of West Crossing, MP 96.5: Looking west, pipeline route runs along left side of photograph. East end of this 3-mile-long fault crossing is in trees beyond helicopter to left.

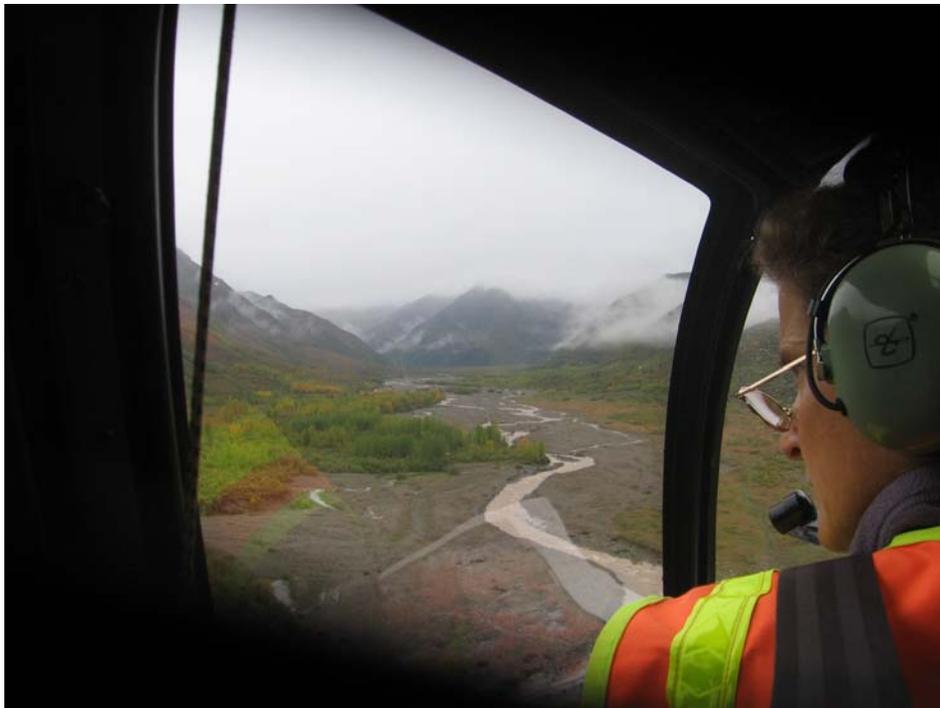
Photograph 6. Caribou Fault – West Crossing, MP 93.5-96.5: Aerial view near east end of crossing looking west down Boulder Creek valley. Pipeline route extends down left side of valley and lies within Caribou fault zone for about 3 miles. Fault zone gradually crosses Boulder Creek to right and trends into hill in center background.

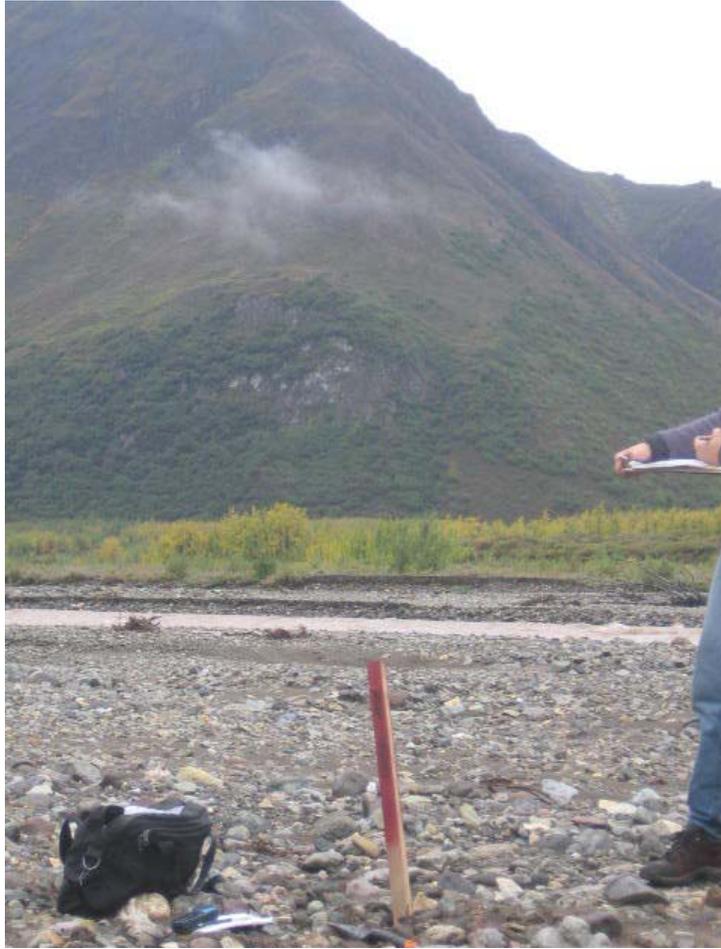
Photograph 7. Caribou Fault – West End of West Crossing, MP 96.5: Looking northwest across Boulder Creek valley toward possible fault race in hillslope.

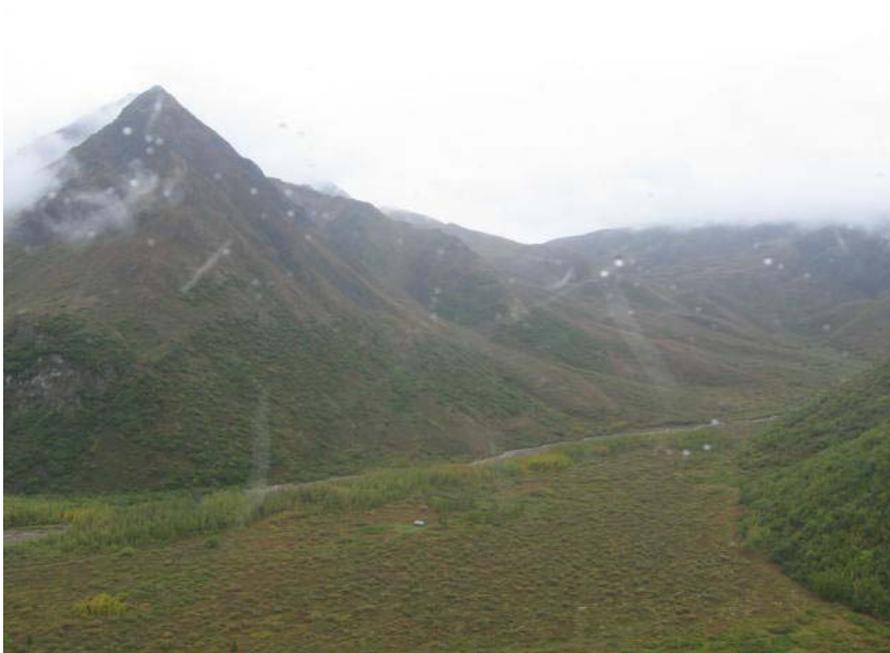
Photograph 8. Near Caribou Fault – West End of West Crossing, MP 96.5: Aerial view looking northwest across Boulder Creek valley. Fault interpretations vary between nose of slope at left (same as Photograph 7), to a line trending between base of slope at right and ridge notches in left-center. Area in between designated as Caribou fault zone.

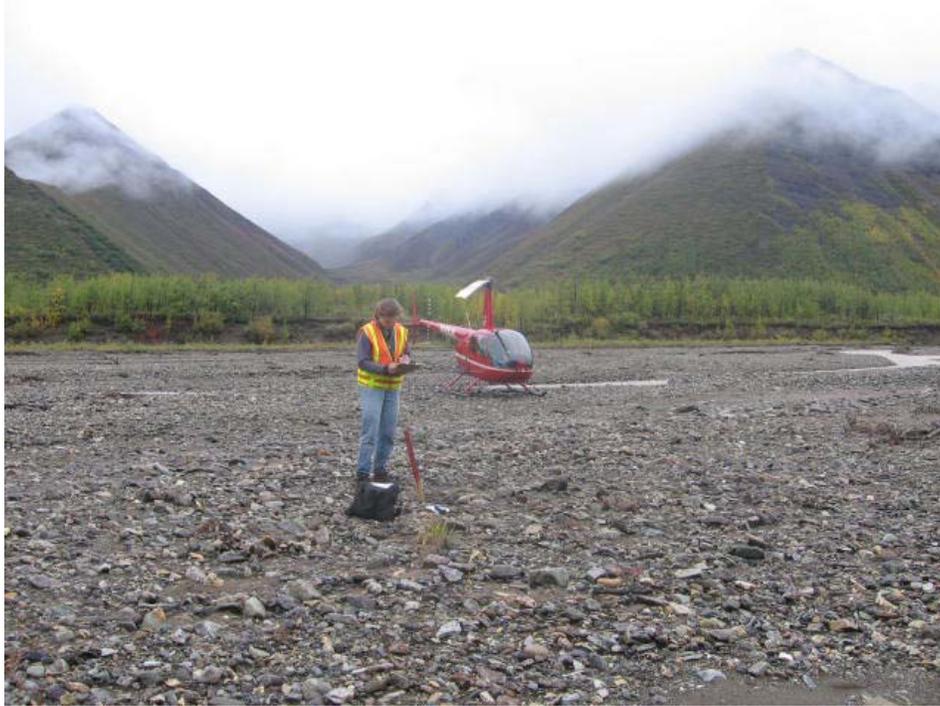
Photograph 9. Caribou Fault – West End of West Crossing, MP 96.5: Looking north across Boulder Creek valley from west end of fault crossing in modern alluvium. Fault zone may extend to base of slopes on north side of valley.

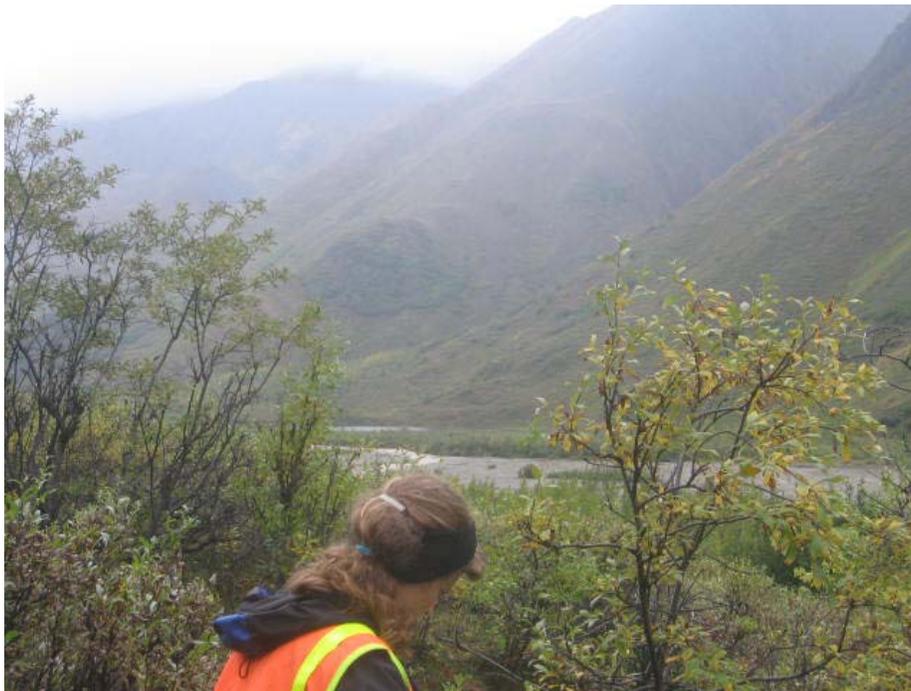
Photograph 10. Caribou Fault – Southwest Splay, MP 97.325: Looking south, fault extends across Boulder Creek valley and curves to right up tributary canyon in center background.

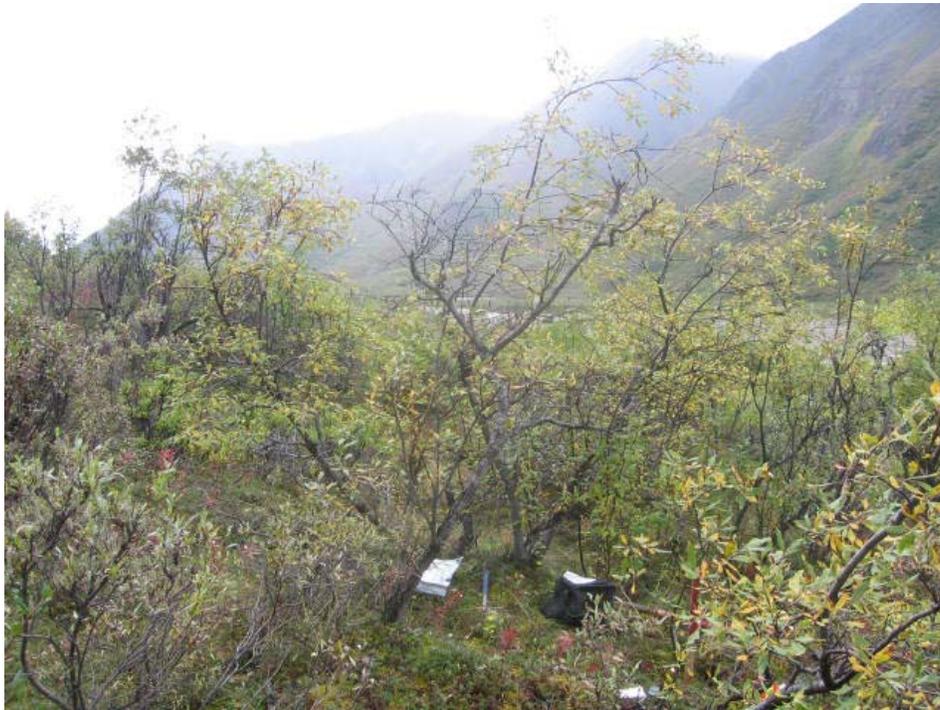
No evidence of surface faulting was observed on the aerial photographs in Boulder Creek valley Quaternary deposits, and no evidence was found in the densely vegetated alluvial fan deposits at the crossing (Appendix C, Photograph 11). Surface soils at this crossing consist of slightly silty, coarse sandy gravel.

Photograph 11. Caribou Fault – Southwest Splay, MP 97.25: Pipeline route crosses fault in densely vegetated alluvial fan material.

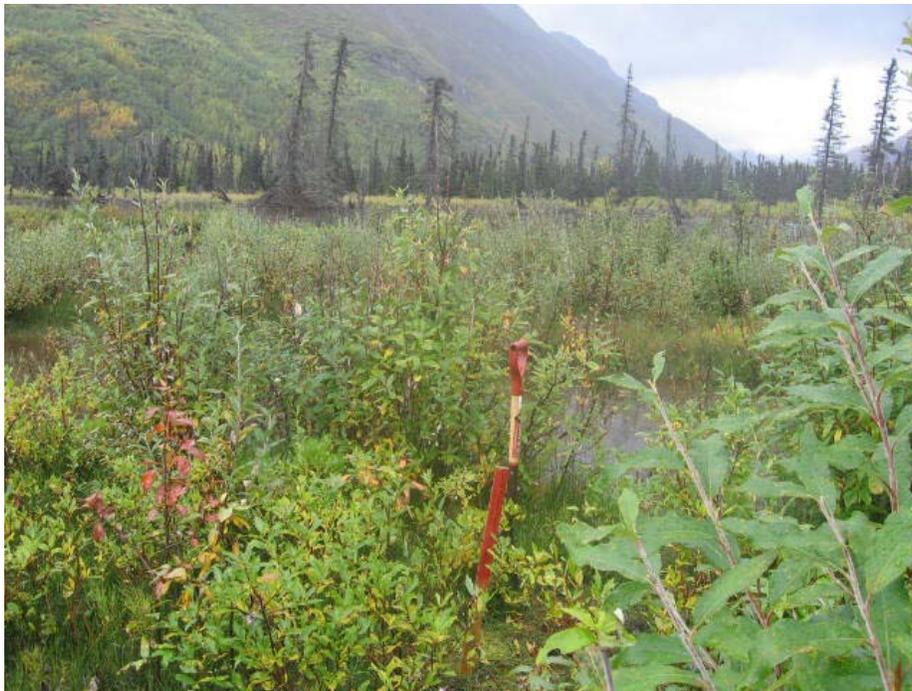
Because widening of the fault crossing was decided upon after the field visit, this crossing was staked only at its east end. The east end stake is located in the field about 350 feet south of the actual east end crossing point, due to the actual location being in a beaver pond (Appendix C, Photograph 14). Soil conditions at the staked location consist of sandy gravel of a Holocene gravel bar. Soil conditions beneath the beaver pond are presumed to contain organic-rich silt or other fine-grained material. Based on the aerial photographs, wetlands ground conditions appear to extend westward throughout most the 2,000-foot fault crossing, except at the approximate midpoint of the crossing where gravelly alluvium may be encountered.

Photograph 12. Castle Mountain Fault, MP102.0: Looking northeast across north side of Boulder Creek valley, east end of crossing is approximately 350 feet north of staked location in beaver pond, just beyond beaver house in left-center.

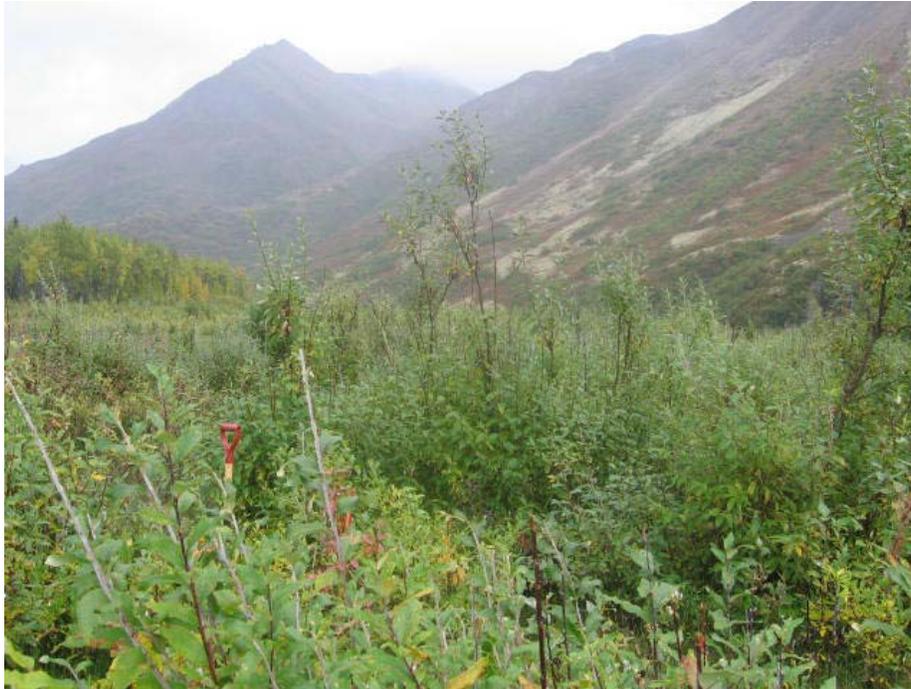
Photograph 13. Castle Mountain Fault, MP 102.0: Looking east across Boulder Creek valley from east end of fault crossing. Fault crosses north slope of Anthracite Ridge in center background.

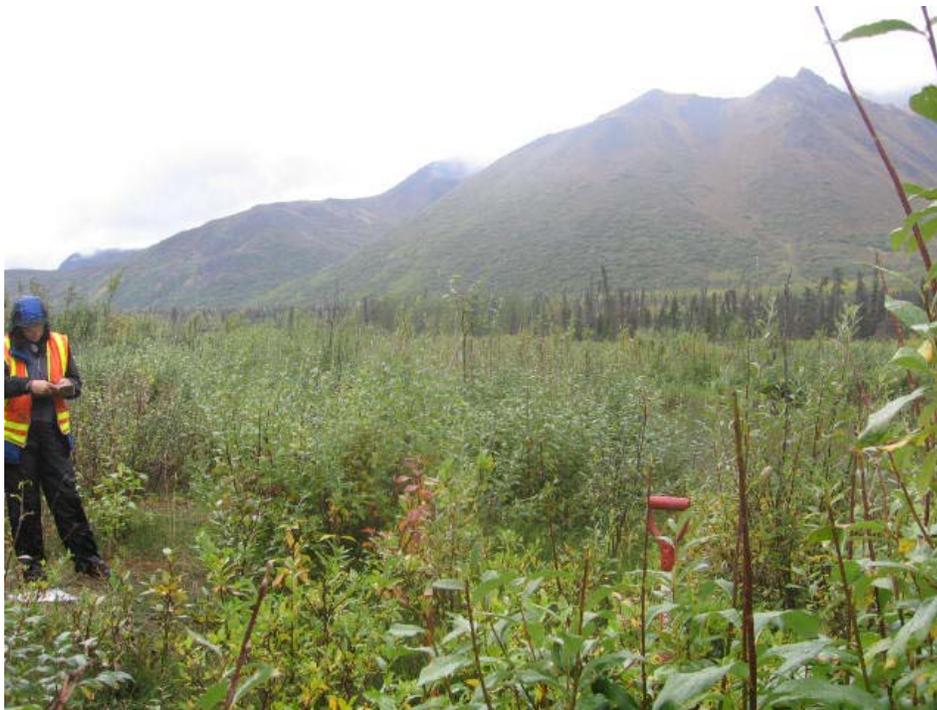
The spur line route approaches the Castle Mountain fault from the east-northeast at an angle of about 15 degrees, runs coincident with fault for about 2,000 feet, then bends away from the fault at about a 23-degree angle (Appendix A, Drawing 17). Faint lineaments seen on the aerial photographs (Aeromap, 2004) along the west side of Boulder Creek valley, described in Section 3.3.3, do not provide conclusive evidence of surface rupture. No evidence of surface rupture of Quaternary deposits was observed in the field.

Photograph 14. Castle Mountain Fault, MP102.0-102.4: Looking west from near east end of fault crossing, which is to right in wetlands/drunken spruce forest. Pipeline route coincides with fault zone for about 2,000 feet, then bends to southwest across left side of photograph. Fault zone continues into center-left background across south-dipping slopes.
