# **FINAL REPORT**

# GLENNALLEN TO PALMER GAS SPURLINE ARCHAEOLOGICAL STUDIES

ANGDA Contract No. 06-0407

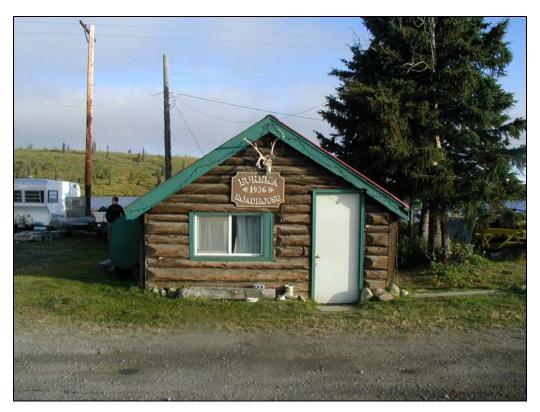
Photo 1: Eureka Cabin (ANC-486), PL MP

<u>Comments</u>: The AHRS card is outdated insofar as the original lodge has burned (date unknown) and was replaced by a modern frame building serving as a restaurant and gas station. The remaining log cabin "used by hunters" is situated in the middle of a complex of modern cabins and utility buildings. This small, one-story log cabin has a red metal roof, dimensional lumber for corner supports, and at least one addition of uncertain age which roughly doubles the size of the original building. A wooden sign on the front wall identifies the cabin as "Eureka Roadhouse, 1936." The cabin appears to serve as either a permanent residence or as a rental for travelers. The proposed pipeline route passes between the Glenn Highway and the cabin in question, possibly within the the proposed construction ROW corridor. This site's exact relative position to the ROW corridor should be verified by a land survey after final determination of the pipeline alignment and during the formal archaeological field survey as required by SHPO. See Appendix C, Photos 1-5.

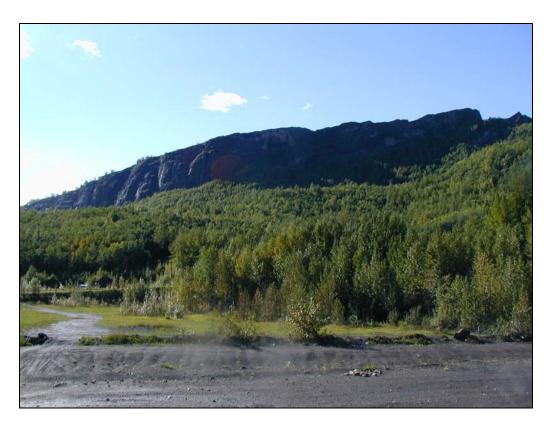
Photo 7: Jonesville R.R. Station Site (ANC-092), PL MP

<u>Comments</u>: The specific location of this AHRS site could not be field verified. A pedestrian reconnaissance of the Jonesville mine site revealed a vast waste pile of coal fragments and a road to the mine entrance blocked by steel bars. This site lies at least 2,000 feet from the proposed construction ROW corridor. See Appendix C, Photos 7 and 8.

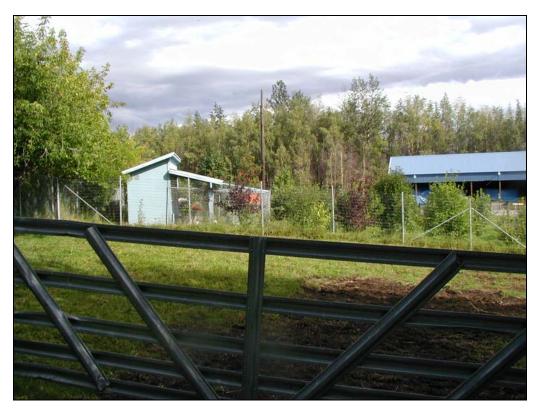
Photo 9: Vicinity of Roy Cornelius Homestead (ANC-474) at De Armoun Farm, PL MP

AHRS Description: This homestead was started in 1914 by Roy Cornelius, from Pennsylvania. There are two log cabins and a relatively new barn remains on the property. The first cabin was built in 1914 and served as the Cornelius's first house and later a chicken coop. The second cabin was built in 1917 and is in good condition. The cabins have been unoccupied since 1953. Comments: This AHRS site could not be field verified. A pedestrian reconnaissance of this site was not possible because permission could not be obtained to examine private property. It appears that the original Cornelius homestead lies within an active farm operated by the De Armoun family. The location of this site appears to lie in close proximity to the construction corridor of the proposed construction ROW corridor (possibly within 500 feet). See Appendix C, Photo 9.

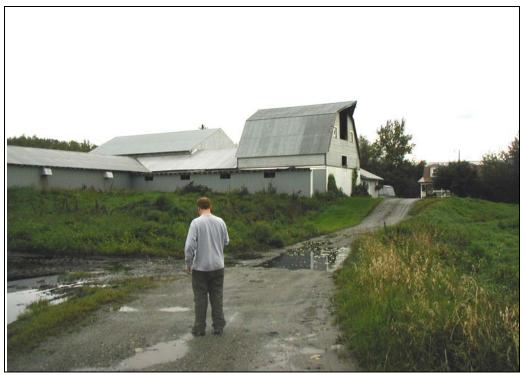
Photo 10: A. Havemeister Colony Farm (ANC-212), PL MP

Comments: This AHRS site could not be field verified. A pedestrian reconnaissance of this site was conducted. A large modern two-story residence and barn are the most prominent buildings. No structures of obvious historical significance were in evidence. The property appears to be an active farm operation. The location of this site appears to lie in close proximity to the proposed construction ROW corridor (possibly within 500 feet). See Appendix C, Photo 10.

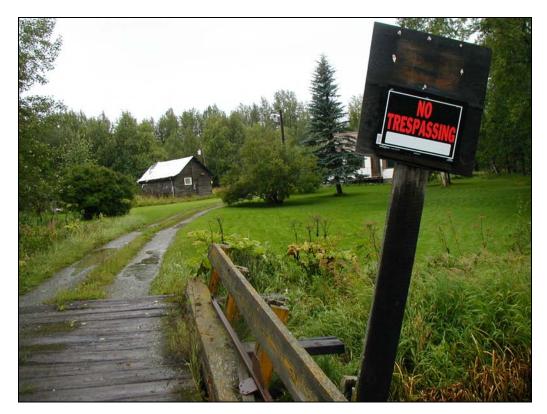
Photo 11: Vicinity of B. N. Dean Colony Farm (ANC-208), PL MP

Comments: This AHRS site could not be field verified. The AHRS file coordinates indicate that the property is located on the opposite side of an intractable swamp. The AHRS file coordinates are presumed incorrect. The written description of the property location led to a private one-story frame residence with a log outbuilding (1940s era structure) with squared logs and a corrugated aluminum roof. A close pedestrian reconnaissance of this site was not possible because a property owner at the location could not be located. The location of this site appears to lie in close proximity to the construction corridor of the proposed pipeline alignment (possibly within 250 feet). See Appendix C, Photo 11.

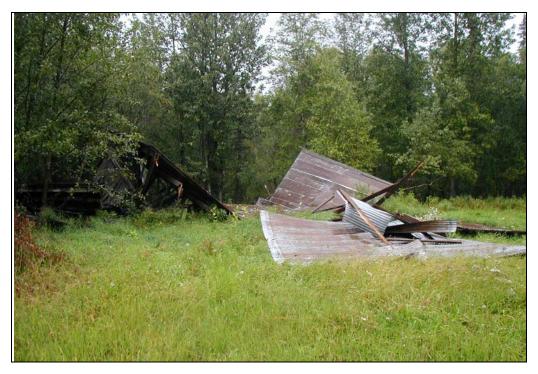
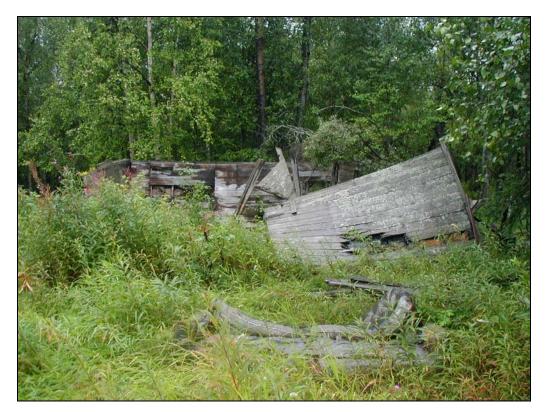
Photo 12: Oscar Anderson Farm (ANC-447), PL MP

*Comments:* The AHRS file coordinates were approximately 500 feet off location. A pedestrian reconnaissance revealed two collapsed frame wooden barns with metal roofs fitting the above AHRS file description. The location of this site appears to lie approximately 1,000 feet from the proposed construction ROW corridor. See Appendix C, Photos 12 and 13.

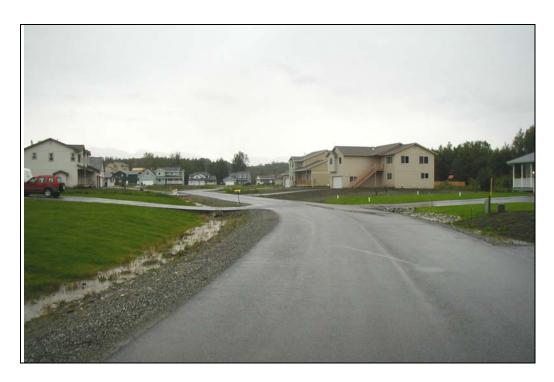
Photo 14: Subdivision at Site of Johnny Martin Homestead (ANC-458), PL MP

Comments: This AHRS site could not be field verified. According to the AHRS file coordinates, the location of this historic homestead is now the site of a new subdivision. No historic properties were in evidence during the field reconnaissance. A property owner in the vicinity confirmed that the historic homestead had been destroyed to begin construction of the subdivision. The location of this site appears to lie approximately 1,000 feet from the proposed construction ROW corridor. See Appendix C, Photo 14.

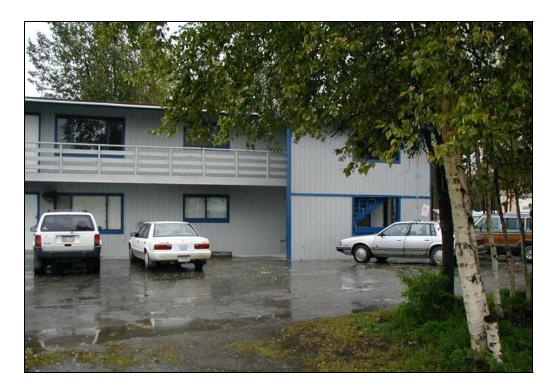
Photo 15: Apartment Building at Site of Marino House (ANC-497), PL MP

*Comments:* This AHRS site could not be field verified. The AHRS file coordinates lead to a 1980s era two-story apartment building. No log cabins were in evidence in the vicinity. The location of this site appears to lie approximately 1,000 feet from the proposed construction ROW corridor. See Appendix C, Photo 15.

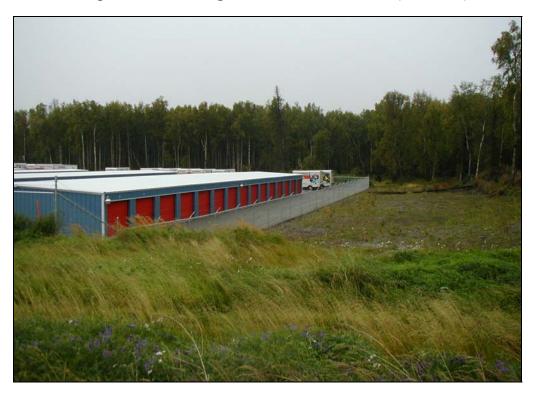
Photo 16: Vicinity of ARRC Camp 2 (ANC-190), PL MP

AHRS Description: This site contained the temporary housing camp for the Matanuska ARRC colonists while their own homes were being constructed. There is no trace of this camp. *Comments:* This AHRS site could not be field verified. The AHRS file coordinates lead to the fenced property of American Mini Storage. No historical material was in evidence. The location of this site appears to lie in close proximity to the proposed construction ROW corridor (possibly within 500 feet). See Appendix C, Photo 16.

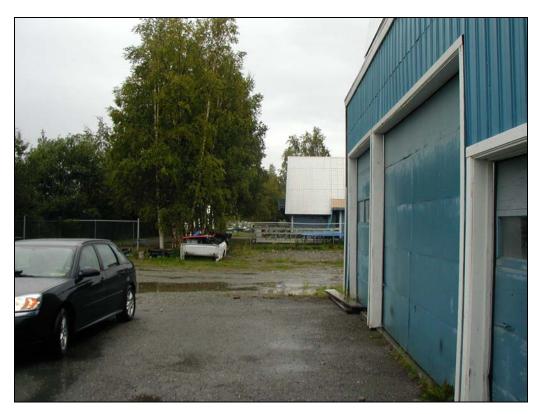
Photo 17: Vicinity of Dearborn Site (ANC-428), PL MP

private residences and a furniture dealership building. No archaeological material was in evidence. The location was covered with gravel fill. The location of this site appears to lie in close proximity to the proposed construction ROW corridor (possibly within 500 feet). See Appendix C, Photo 17.
