State Pipeline Coordinator's Office

Annual Report Fiscal Year 2009

The fiscal year 2009 State Pipeline Coordinator's Office Annual Report describes the status of jurisdictional pipeline right-of-way leases. This report integrates information from all State Pipeline Coordinator's Office activities and summarizes the prior calendar year's construction, operations, and maintenance activities on jurisdictional pipeline rights-of-way. The sections of this report include an overview of each jurisdictional pipeline, a summary of the annual reports submitted by the lessees, and a description of SPCO oversight programs and SPCO activities during the fiscal year 2009. This report does not provide a comprehensive record of all activities that are undertaken as part of the lessee's pipeline systems management; rather, this report highlights certain information and activities in order to demonstrate the implementation of SPCO lease oversight.

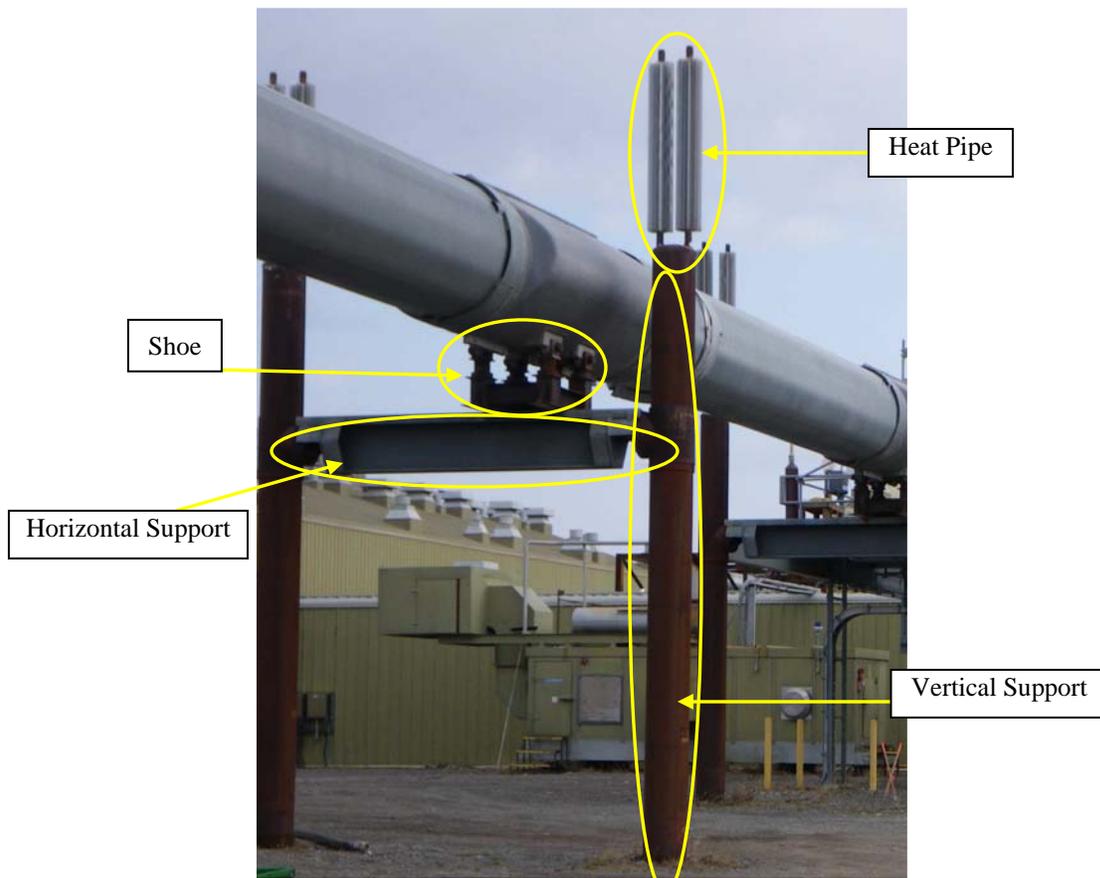
Figure 5. An example of a VSM found at TAPS PS 3.

VSMs are cooled by heat pipes. Heat pipes prevent the ground from rapid thaw that can cause jacking or subsidence of the VSMs.

In August 2008, a comprehensive “linewalk” was conducted, which assessed 850,000 attributes along the aboveground segments of the pipeline. A discussion of the heat pipes is included in this category, since all but 1,500 of the approximately 60,000 heat pipes monitored this year are part of the VSMs. Figure 5 and Figure 6 are examples of heat pipes found on TAPS.

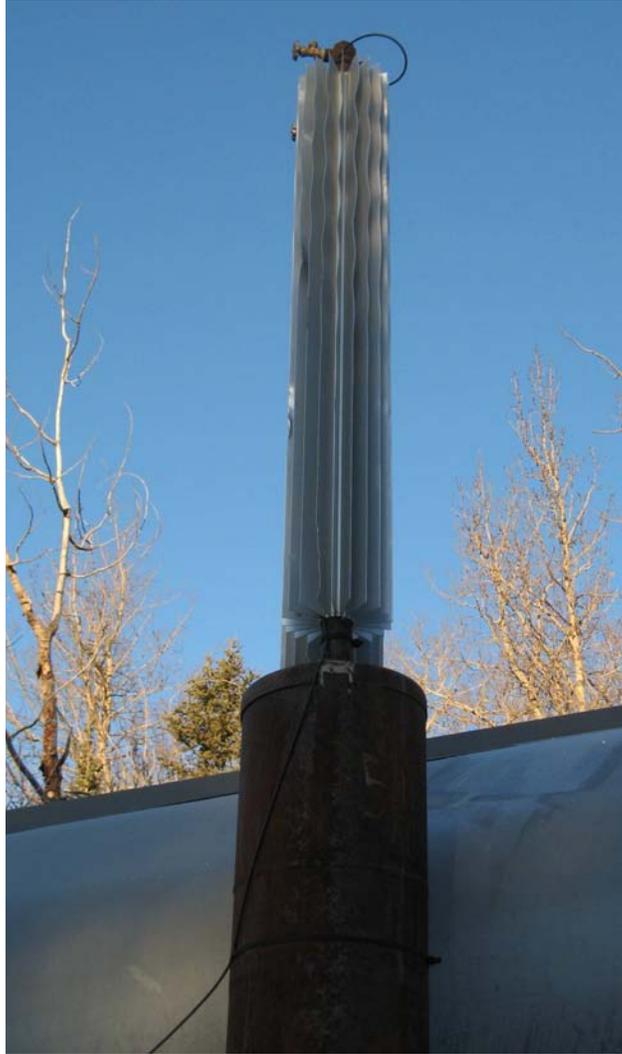
APSC reports no progress on its program to replace Getter Pins. Getter Pins are tapered steel pins containing zirconium dimanganese that absorb hydrogen. Hydrogen inhibits the heat-transfer exchange in the heat fins atop the VSMs. In 1983, APSC initiated a project to place Getter Pins on the heat pipes of the TAPS VSMs. This repair method, in general, was technically successful but abandoned when APSC decided to convert heat pipes from ammonia to a system using CO₂. Approximately 15% of the Getter Pins have failed. APSC estimates that between 1,500 and 1,800 heat pipes fail annually. Their repair backlog is about 8,000 units. To give a point of comparison, approximately 122,000 heat pipes were installed on the TAPS.

Heat pipes, however, have a built-in redundancy in most locations. Other safety factors were also applied to the heat calculations and fin surface area, in addition to the redundancy. The number of heat pipes reflect an almost 100% redundancy. Numerous safety factors were applied to the heat calculations and fin surface area, on top of the 100% redundancy. Therefore, heat-pipe maintenance can be approached as a long-term, multi-year remediation effort.

Figure 6. Heat Pipe and radiator at Squirrel Creek.

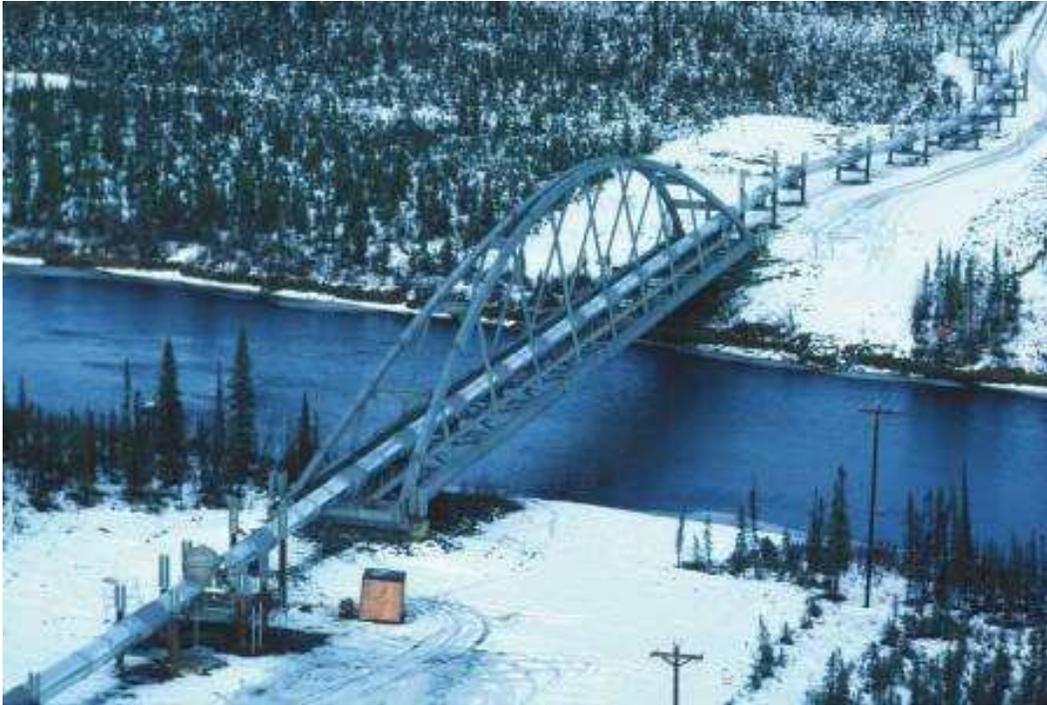
No major work on bridges was performed during this reporting period. Bridge projects scheduled for CY09 included removal of the Gulkana River Pipeline Bridge access walkway and guardrail upgrades at four sites. Figure 7 is a photograph of the Gulkana River Pipeline Bridge, before the upgrades were completed.

Figure 7. *The TAPS as it crosses the Gulkana River on a pipeline bridge.*

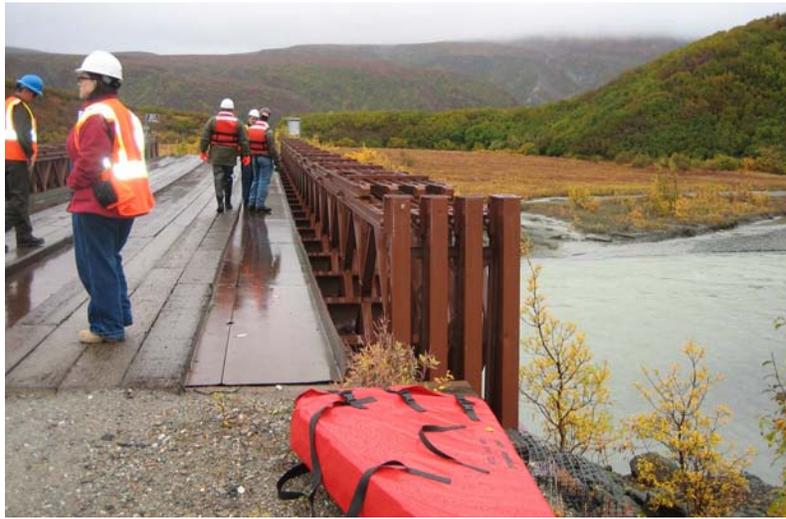
APSC reported no major flood damage during CY08. The company characterized spring breakup and aufeis conditions along TAPS as mild to moderate (aufeis formations occur when ground water or some other water source seeps and freezes causing ice layers). There was minor damage due to aufeis formation in the Mark Creek area (PLMP 68-76). The Sagavanirktok River experienced less than average summer flooding and almost no significant bank erosion. There was moderate to average-size floods in the Dietrich and Koyukuk Rivers, resulting in bank erosion at the Dietrich River (PLMP 200) and the Koyukuk River (PLMP 208). An armored revetment is planned to mitigate and control erosion at the Dietrich River upstream of the pipeline. There were no major floods along the Delta or Tanana Rivers. The only damage requiring additional reinforcement was at the Access Road 36 and the bridge abutment on Phelan Creek (PLMP 599). Figure 8 shows the Phelan Creek Bridge.

Figure 8. *Phelan Creek, September 11, 2008.*

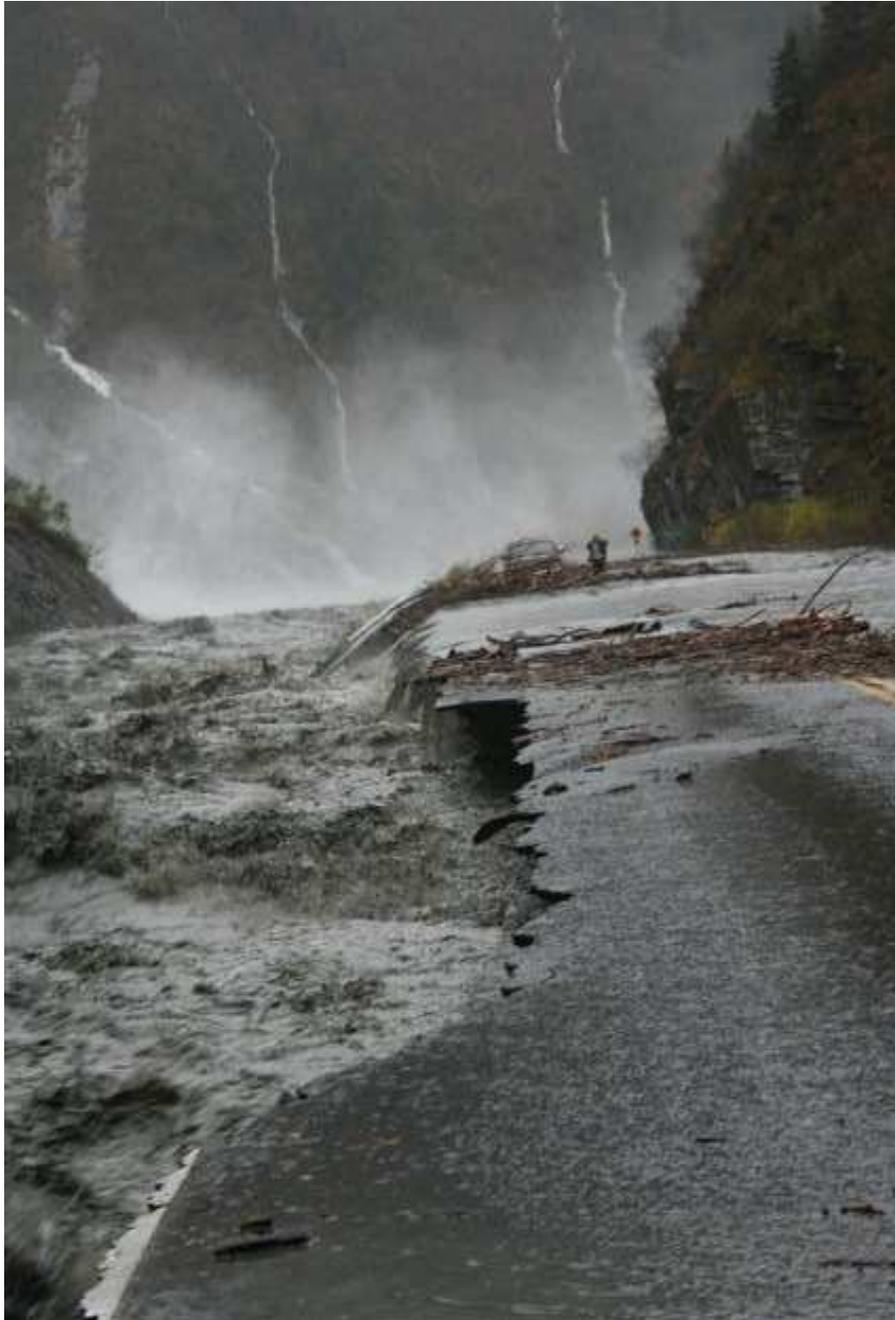
In August 2006, the southern end of the TAPS experienced flooding estimated to be of a 500-year return interval. APSC made emergency repairs that have held up well over the two years since the flooding occurred. The most prominent repairs took place at the Tonsina River and Stuart Creek. Figure 9 illustrates damage caused by the flooding.

Figure 9. *October 2006 floods -- Richardson Highway in Keystone Canyon.*

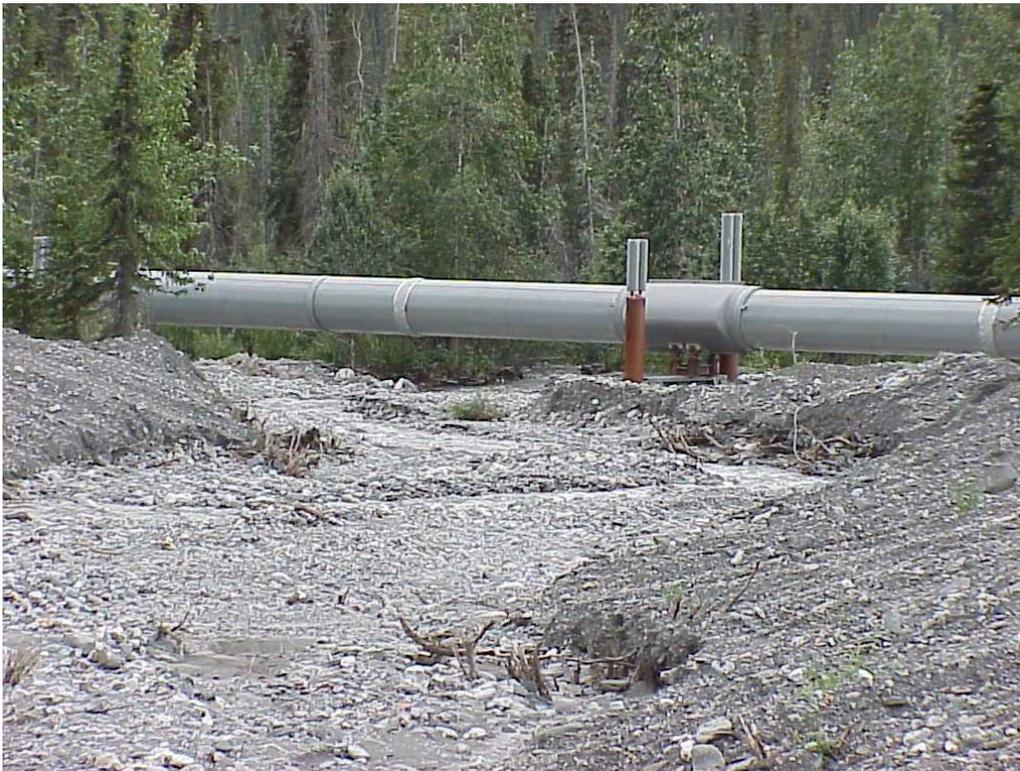
Figures 10 and 11 illustrate an example of erosion from water flow transport at Oskar's Eddy (PLMP 178.79). Oskar's Eddy is identified as a fish stream and the TAPS crossing is maintained to provide fish passage. Figure 10 shows erosion damage of the streambed and Figure 11 shows the remediation work performed by APSC.

Figure 10. *Oskar's Eddy in 2000, prior to the remediation efforts of APSC.*

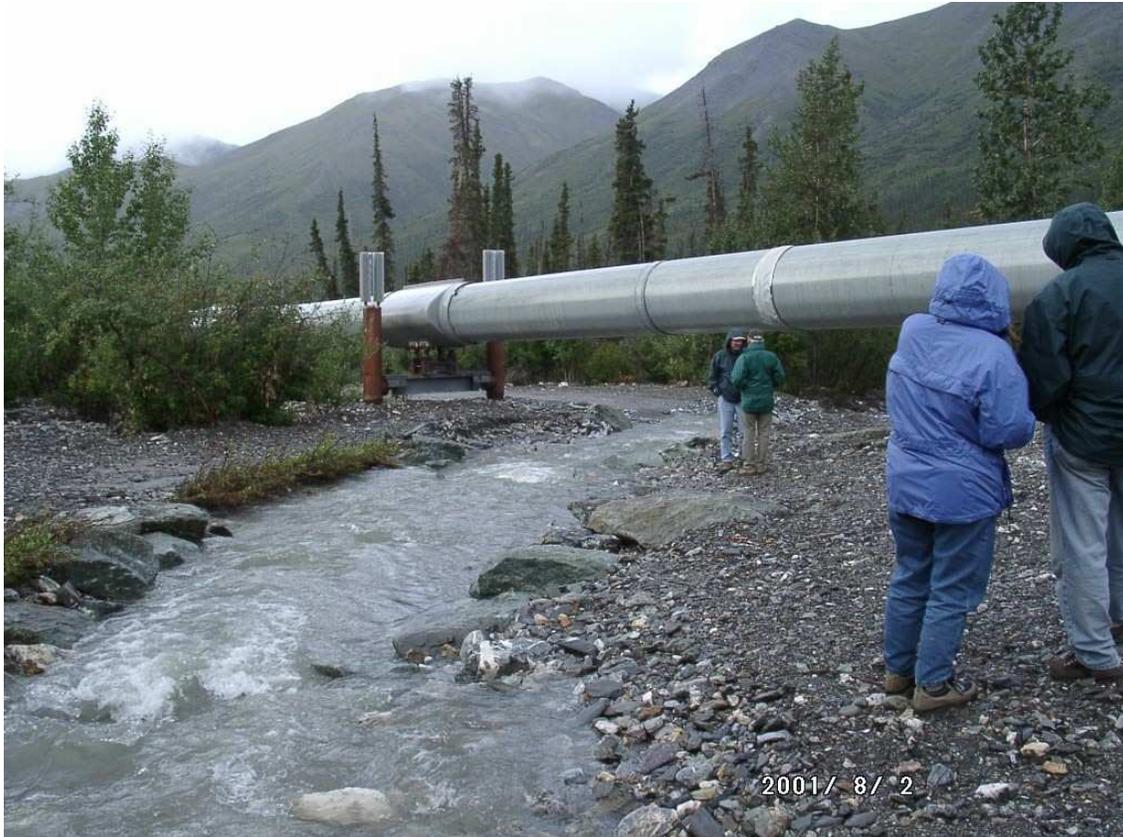
Figure 11. *Oskar's Eddy in 2001, after remediation efforts by APSC.*

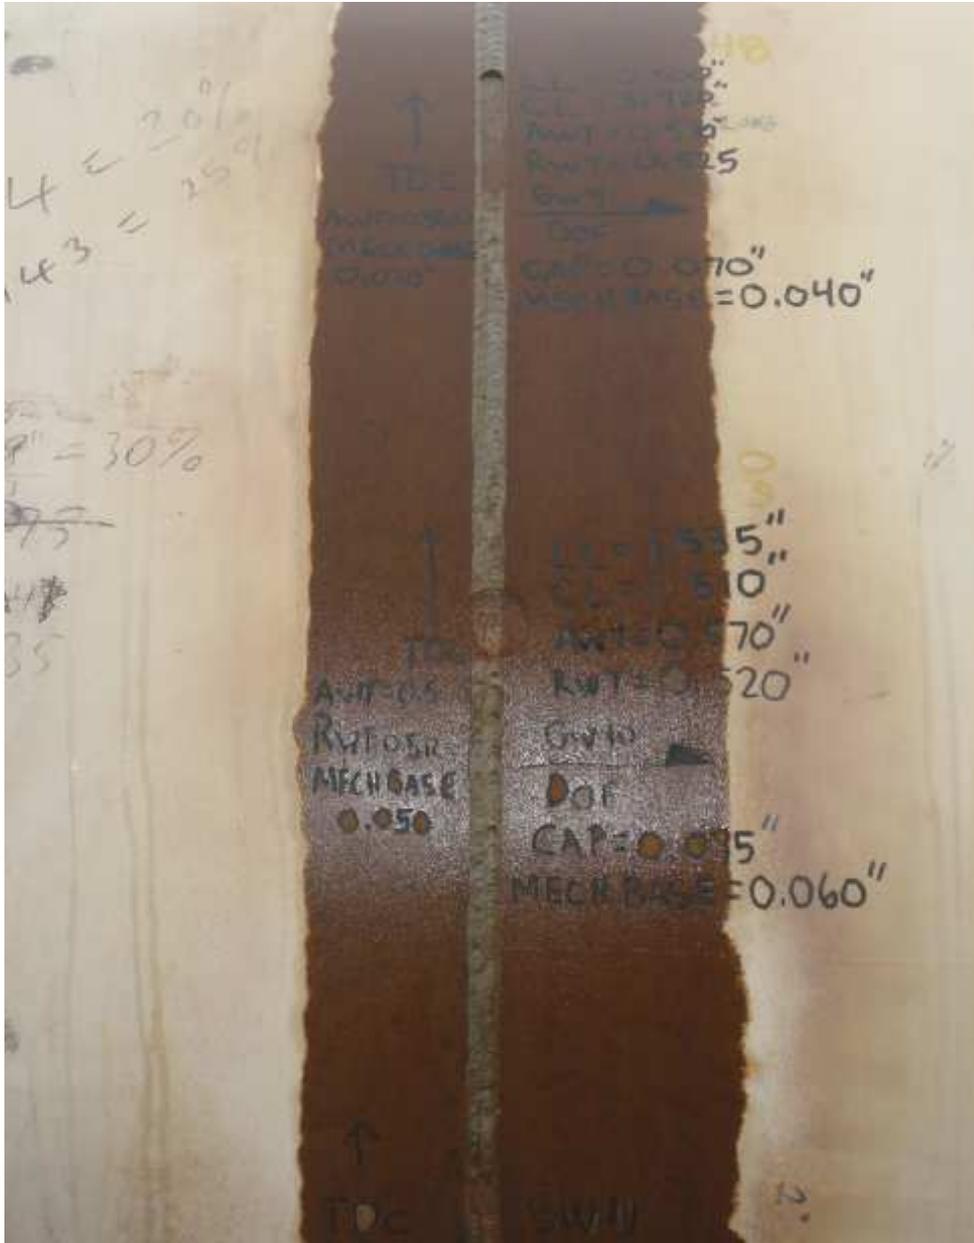
Figure 12. A close-up look at anomalies in the new pipe segment at PS 2.

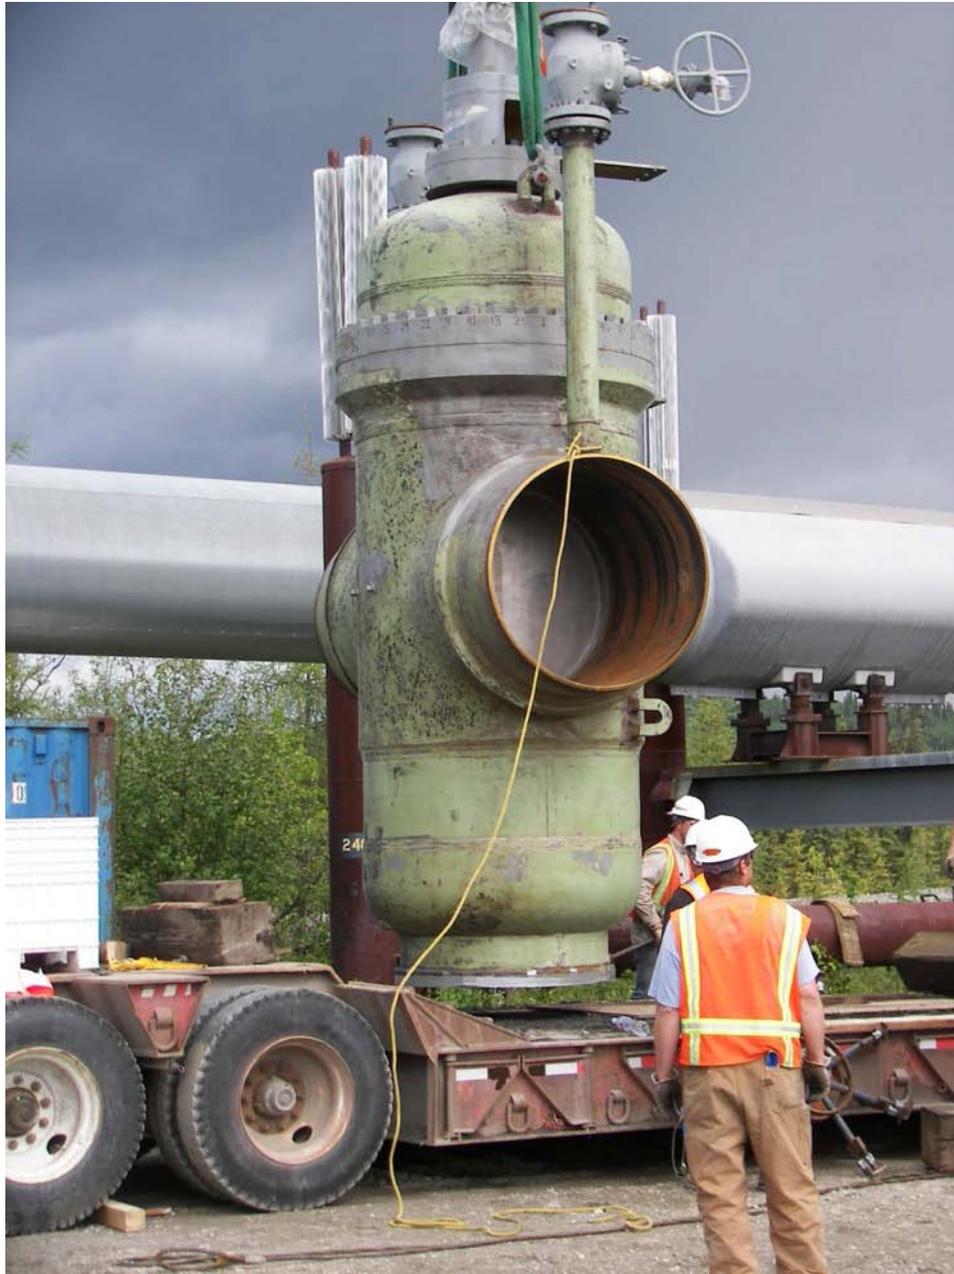
Figure 13. *The RGV 72 replacement valve.*

A remote gate valve (RGV) 72, was replaced during a scheduled pipeline shutdown in the summer of 2008 because its leak-through rate fell short of performance standards set by APSC. Figure 13 shows the replacement valve being lifted into an upright position so pipe extensions could be welded on before it was set into place, and was provided by BLM/JPO. Technicians tested RGV 72 in September 2007 and determined that the valve was not sealing as designed. APSC reported that the replacement work was successful.

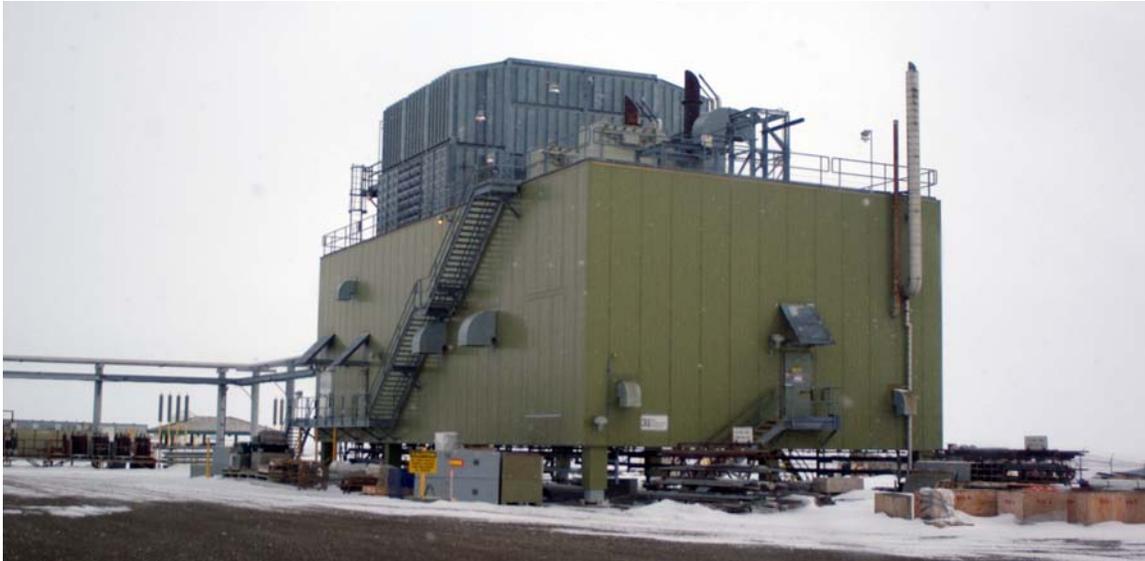
The FGL program addresses monitoring and maintenance activities performed on the TAPS FGL. Natural gas for the FGL originates at the Prudhoe Field Fuel Gas facility. It provides fuel gas to Pump Stations 1, 3, and 4. In the late 1990s fuel gas was no longer provided to power facilities at PS 2 due to lower throughput. The FGL is important to the continued functioning of TAPS. Figure 14 shows the FGL compressor skid, located at PS 1, where natural gas is processed prior to being transported to PS 2, PS 3, and PS 4. In the event that the fuel gas line becomes disrupted one of two turbine generators (TGs) located at PS 3 and PS 4 are equipped to operate on diesel fuel.

Figure 14 *FGL compressor skid located at PS 1.*

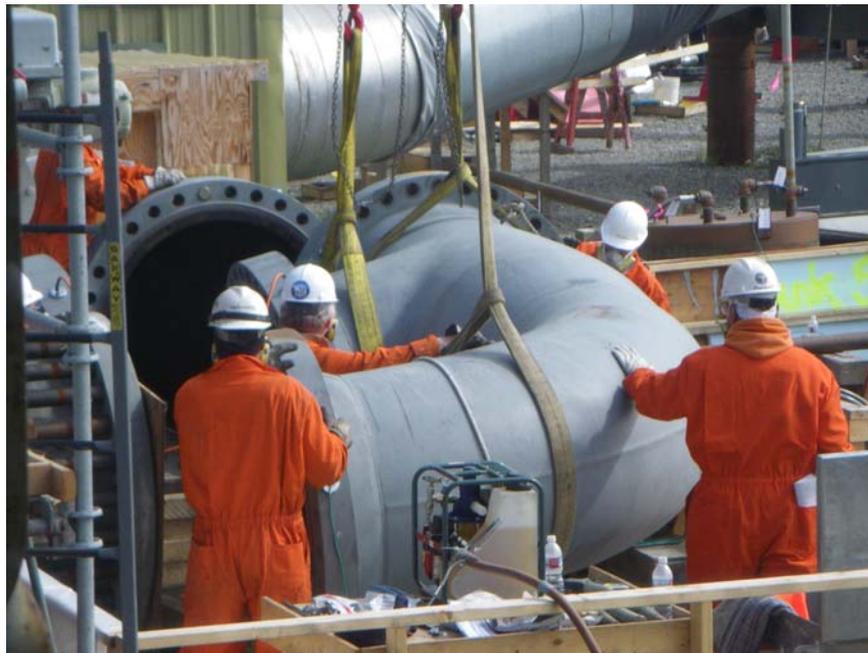
Figure 15. Work crews during the June shutdown at PS 3.

APSC is proceeding with plans to de-man PS 3 and to retire many of its facilities. The “legacy” pump station facilities were placed in cold standby after the oil piping connections between old and new facilities were removed. Figure 15 shows work crews removing the “T” from the legacy piping during the June shutdown at PS 3.

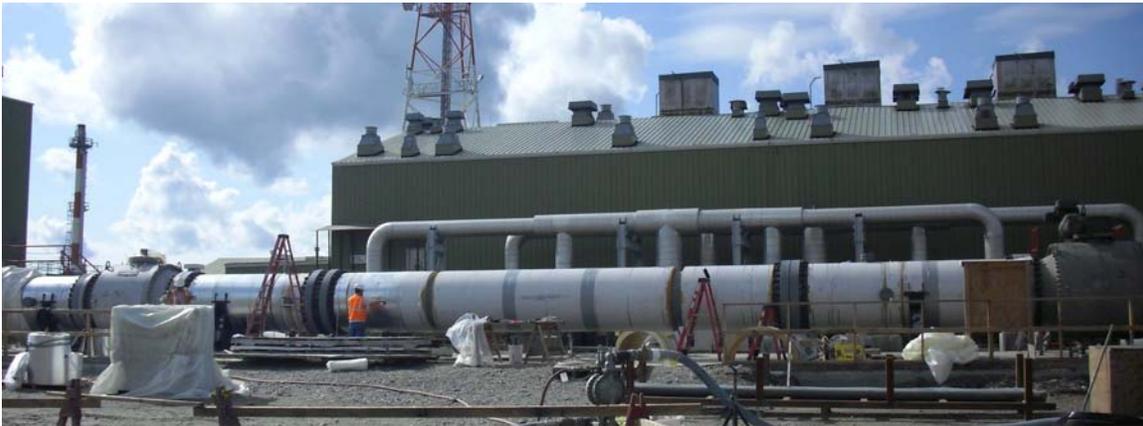
A “smart pig launcher” was installed at Pump Station 8 (Figure 16) near the Salcha River, approximately 40 miles outside Fairbanks, in summer 2009. The launcher will enable workers to put a “smart pig,” a corrosion-detecting device, or other ILI device into the mainline at that point, rather than at PS 4, north of Atigun Pass. This will reduce the travel distance for the ILI device from approximately 600 miles to approximately 400 miles. This modification was performed during a regular semi-annual maintenance shutdown. APSC has stated that the new launcher may not be used for all ILI runs and is not planned for it to be utilized for maintenance pigging. It will be kept as a contingency option if a pig cannot provide an acceptable “run” from PS 4 to the VMT.

Figure 16. The pig launcher at PS 8.

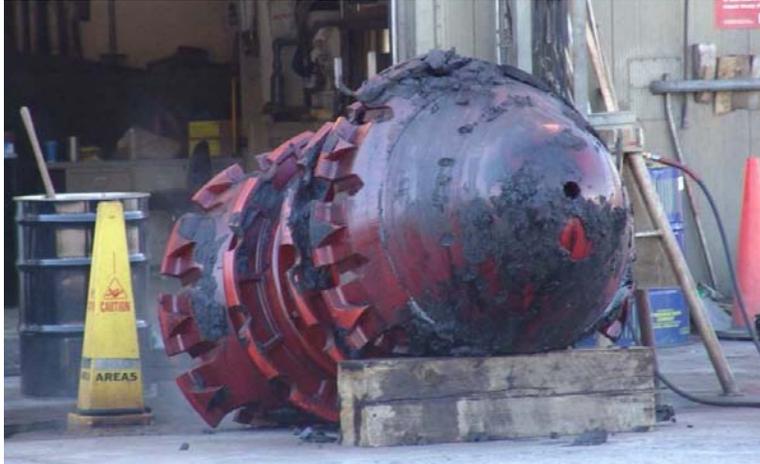
Figure 17. Maintenance Pig used to clean the pipeline.

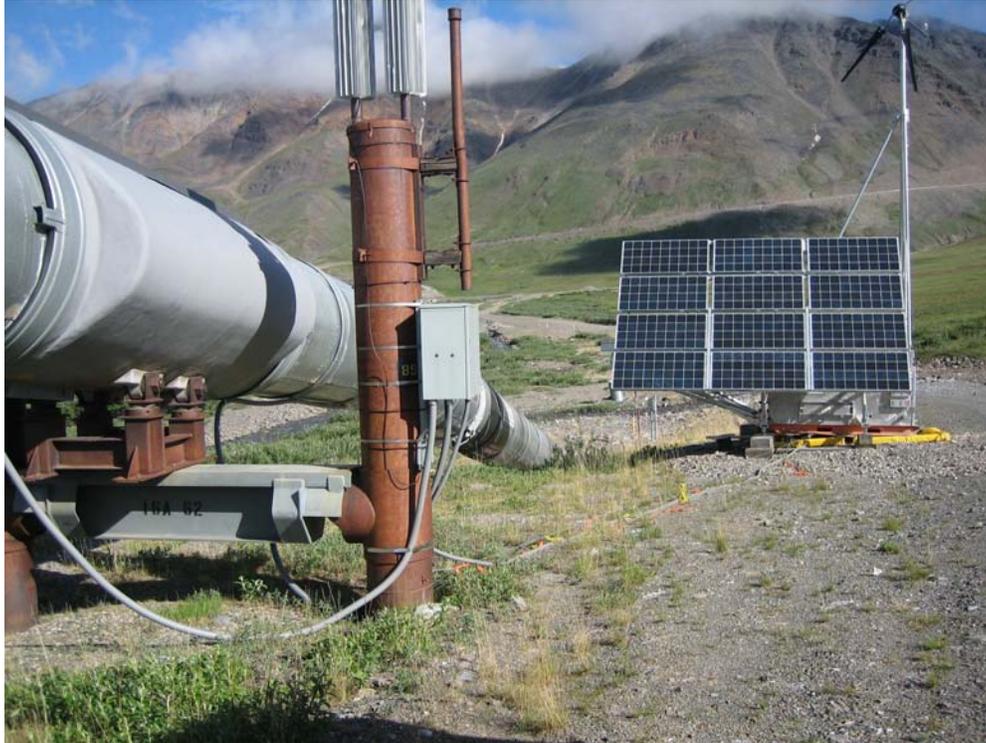
The pipeline vibration issues at Atigun are similar to those experienced at Thompson Pass over a decade ago. The same mechanism is operating at both sites. There are three major passes in the TAPS ROW corridor, Atigun, Isabel and Thompson. Ten years ago at Thompson Pass lower throughput caused vibrations that were felt as far away as Valdez. This problem was remediated by supplying backpressure at the bottom of the slope, which caused the liquid level in the pipe to rise and the elevation drop in the slackline to be reduced. The vibrations at Atigun are of lower amplitude and are consequently less severe than the vibrations were at Thompson Pass. It should be noted that Isabel has a smaller elevation change and unusual vibrations have not been reported at that site. APSC has installed solar powered data loggers at the base of Atigun Pass, just south of PLMP 169 (Figure 18).

Figure 18. TAPS PLMP 169 near Atigun Pass. The solar panel provides power to vibration sensors and data loggers.

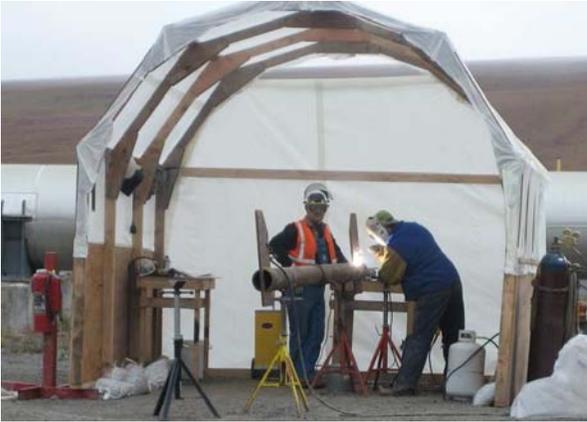
Figure 19. *A brace being assembled.*

The second type of pipe vibrations involved vibrations in the piping outside the new pump modules installed under SR. Initially, many assumed that this vibration so close to the pump must be caused by the machinery. An analysis has shown that the vibrations are generated within the supply and return piping to the pumps. This is called flow-induced vibration. APSC contracted with an engineering firm that specializes in vibration problems, and they recommended upgrades to reduce the flexibility of the piping supports. These upgrades were made at PS 9, which displayed the greatest vibrations, and PS 3. They also recommended adding minor supports to branch connections and instrumentation located within the pump modules. Testing after PS 4 SR startup indicated that vibrations at that location were within nominal values. Therefore, no work is planned at PS 4. Figure 19 shows the bracing for PS 3 being fabricated, Figure 20 shows the first brace being installed on one of the pump modules at PS 3, and Figure 21 shows the underside of the pump module after the bracing was installed.

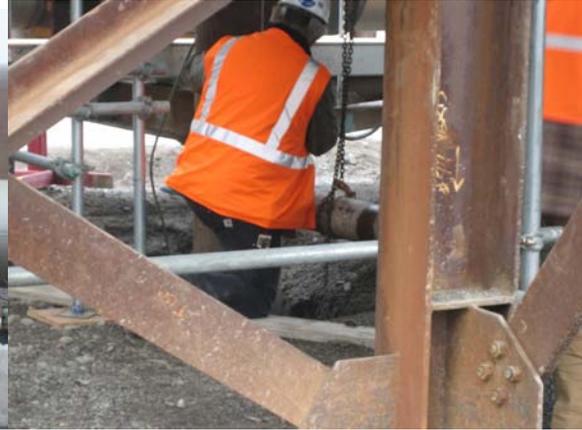
Figure 20. *First brace being installed at PS 3.*

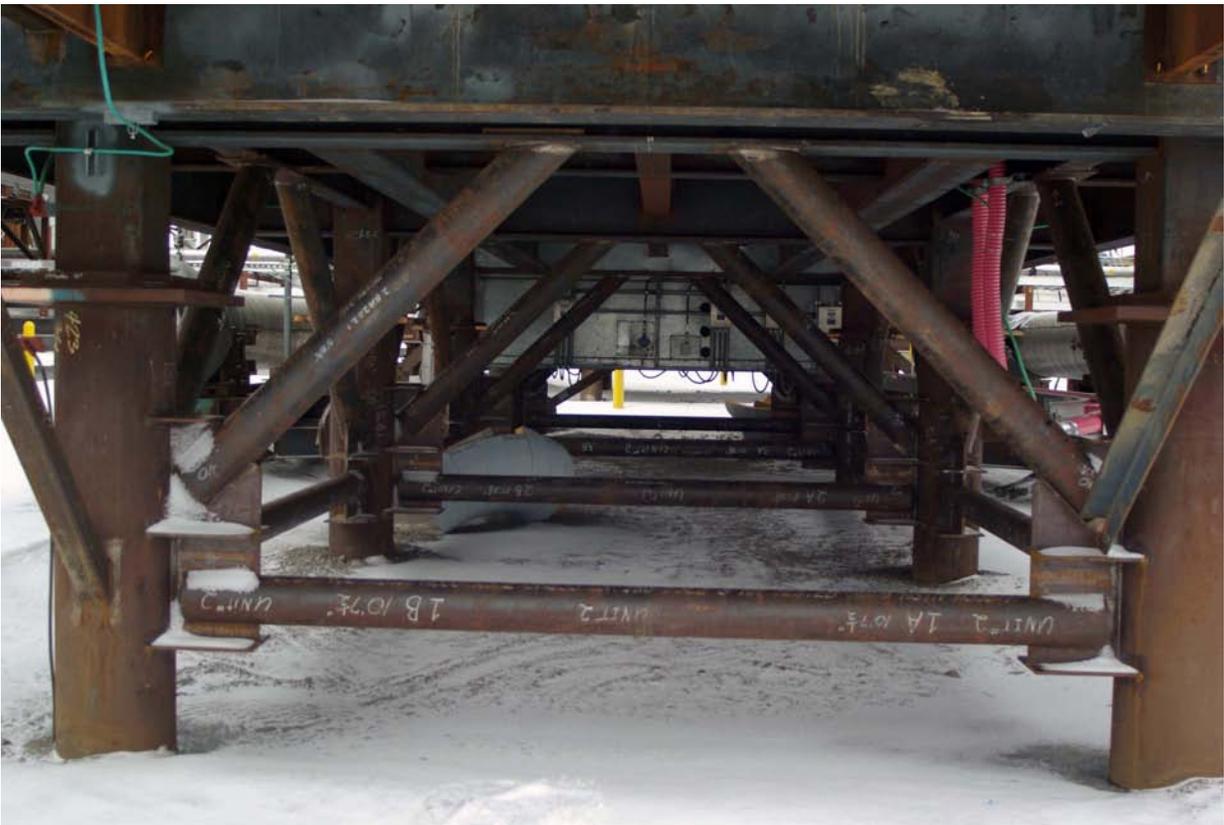
Figure 21. *Bracing installed under pump module at PS 3.*

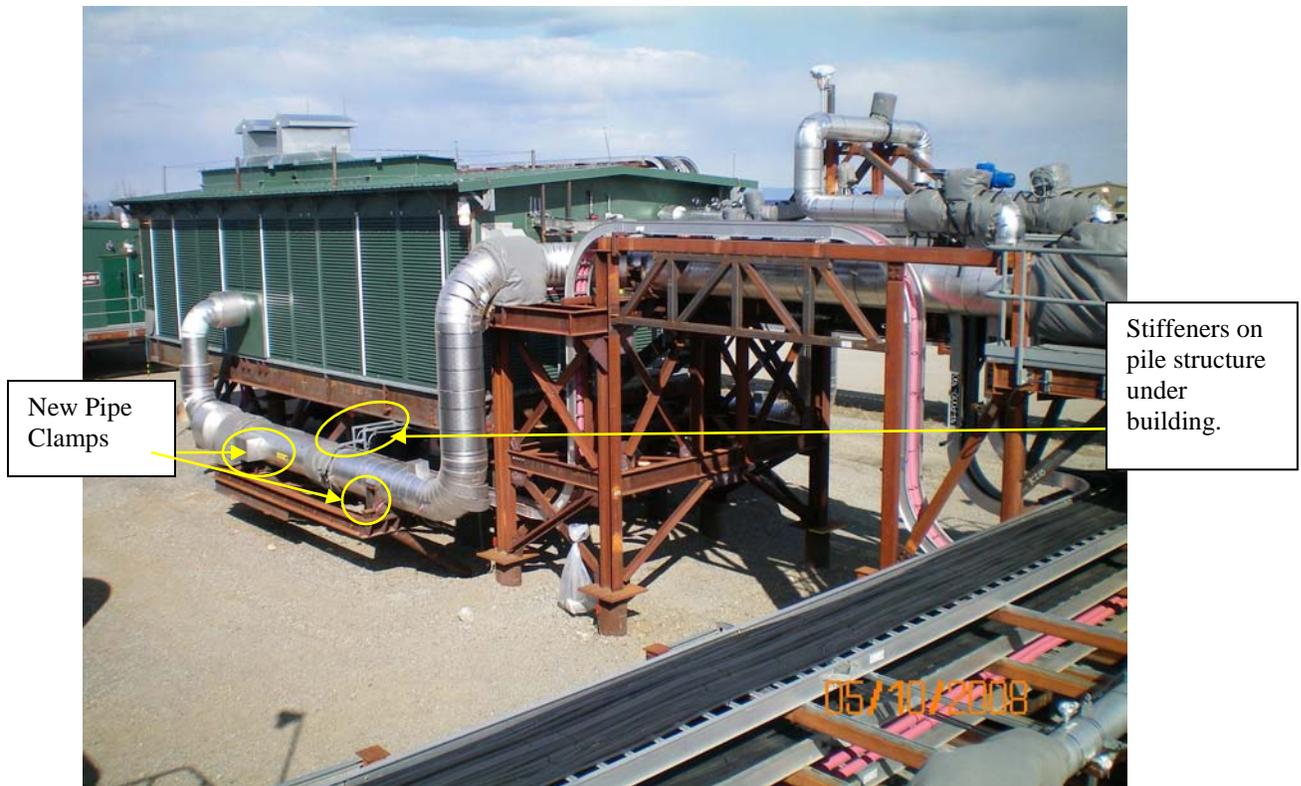
Figure 22. *The pipe configuration causing vibration at PS 9.*

Figure 22 illustrates the stiffeners and pipe clamps that were installed at PS 9, new supports were installed on both sides of the building.

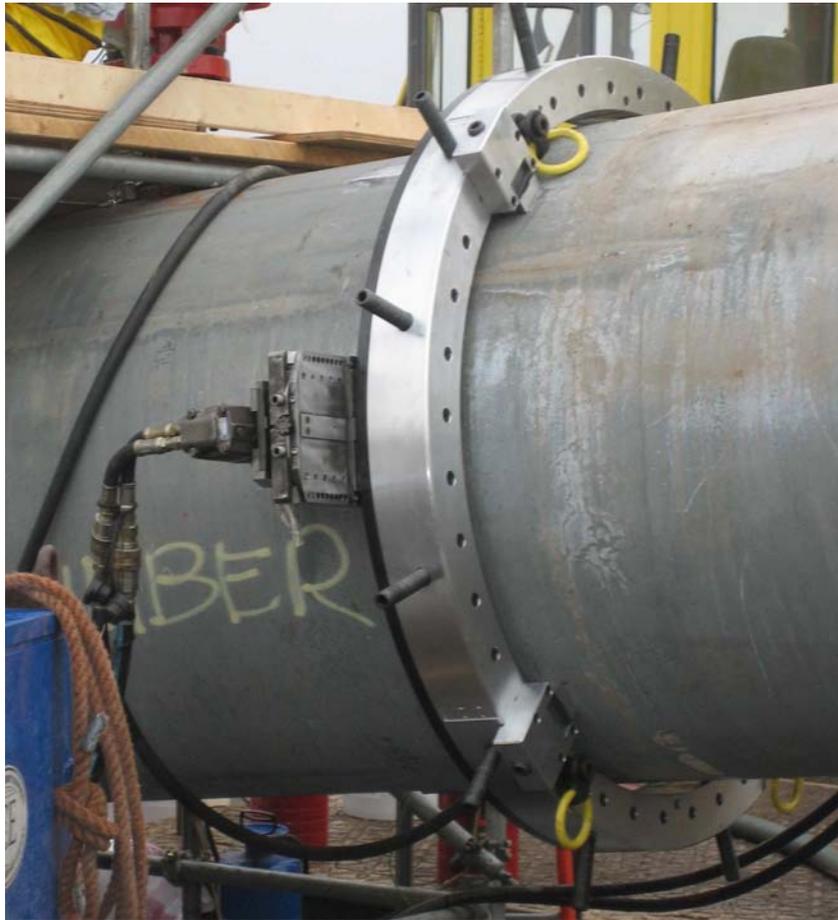
Two Compliance Section staff members monitored the reroute of the mainline pipe that put into place a 1,700-foot, aboveground pipeline segment that bypassed the PS 2 manifold building and other legacy equipment. The final tie-in for the re-route project occurred during the August 16, 2008 shutdown. Part of the new pipe segment had machined anomalies (Figure 12), both internal and external, which would aid in pig calibration. Work to cut the mainline and connect it to the new section of pipe at the south end went smoothly. Figure 24 shows the automated beveling machine that was used to cut the pipe before welding. PHMSA issued an approval to sleeve a weld on out-of-round pipe.

Figure 24. *Automated Beveling Machine at the PS 2 Re-route Project.*

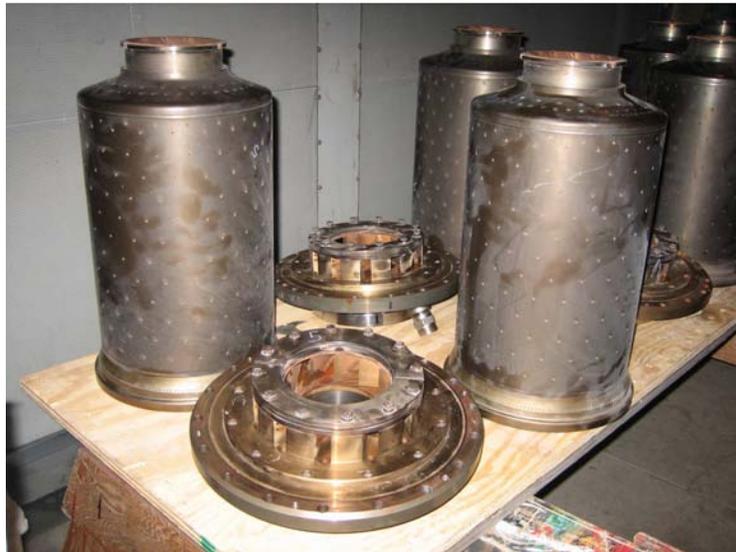
During a planned shutdown in August 2008, JPO staff noted that the TG-1 burner cans assemblies (Figure 25) were laid out on a table in the module. Prior to shutdown, TG-1 shut down and would not restart. Evidence of natural gas liquids (NGLs) were found in the burner assemblies. It was determined that an upset at PS 1 introduced unprocessed NGLs into the fuel gas line and then into the turbine generator's burner assemblies. Replacement assemblies were installed. The original, damaged, assemblies were sent out for refurbishing.

Figure 25. Burner Can Assembly Removed from TG 1 at PS 3 on 8/18/2008.

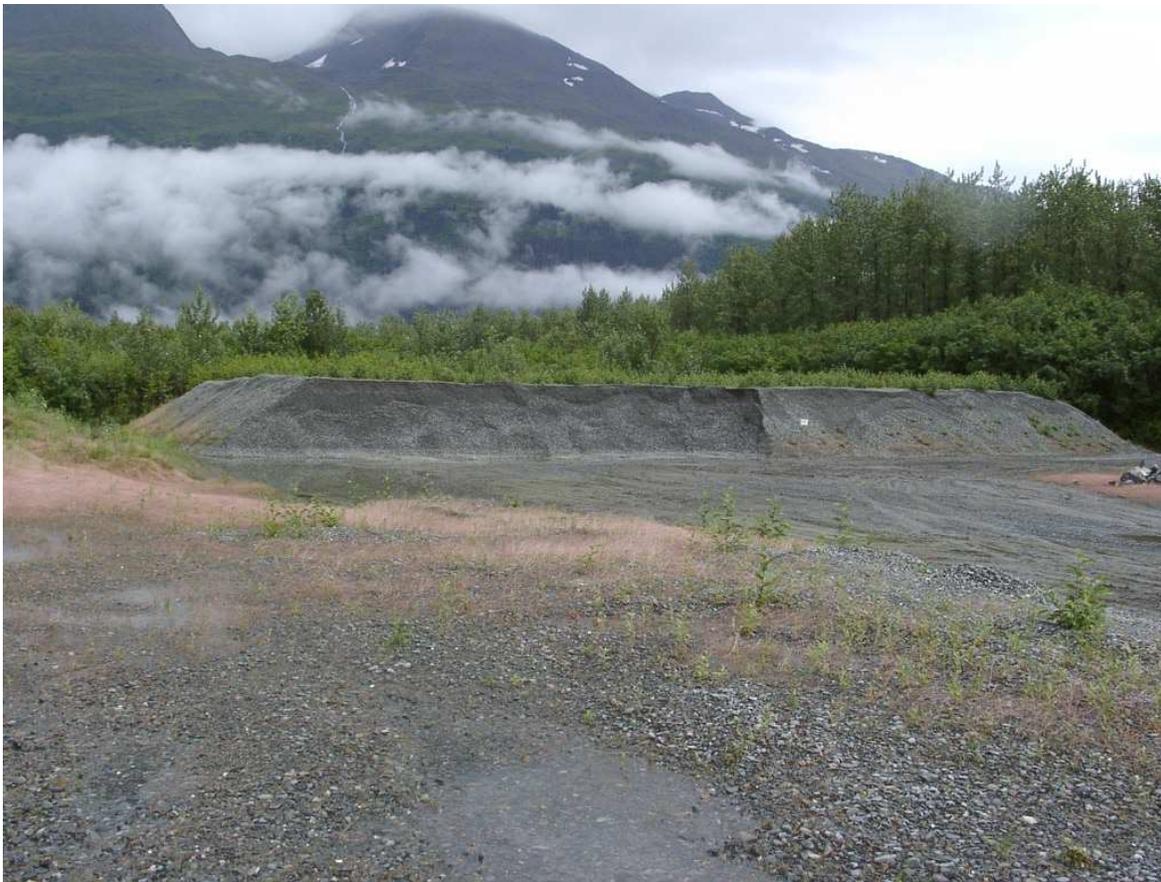
Figure 27. *OMS 3-1.1, accessed by TAPS Access Road 2-APL-1 from Dayville Road MP 1.03.*

During FY09, the SPCO ROW Section conducted inspections and completed surveillance reports for twenty of the twenty-nine operating material sale sites on state land along TAPS (Surveillance Report Numbers 08-TAPS-S-088 through 08-TAPS-S-117). The sites were inspected between July and September 2008 to determine compliance with the material sale contract, mining and reclamation plans, and TAPS Lease Stipulation 2.6, Material Sites. The material sites were found to be generally clean, well-maintained and met requirements. A minor unsatisfactory observation was reported at OMS 14-0. Also, a minor unsatisfactory observation was reported OMS 41-3. Both unsatisfactory observations pertained to one attribute regarding side slopes on the rock face, which appeared to be steeper than provided in the mining plan. These unsatisfactory conditions were later addressed by APSC. Figures 27 and 28 show the conditions of OMS 3-1.1 when ROW Section staff inspected the site during the summer of 2009.

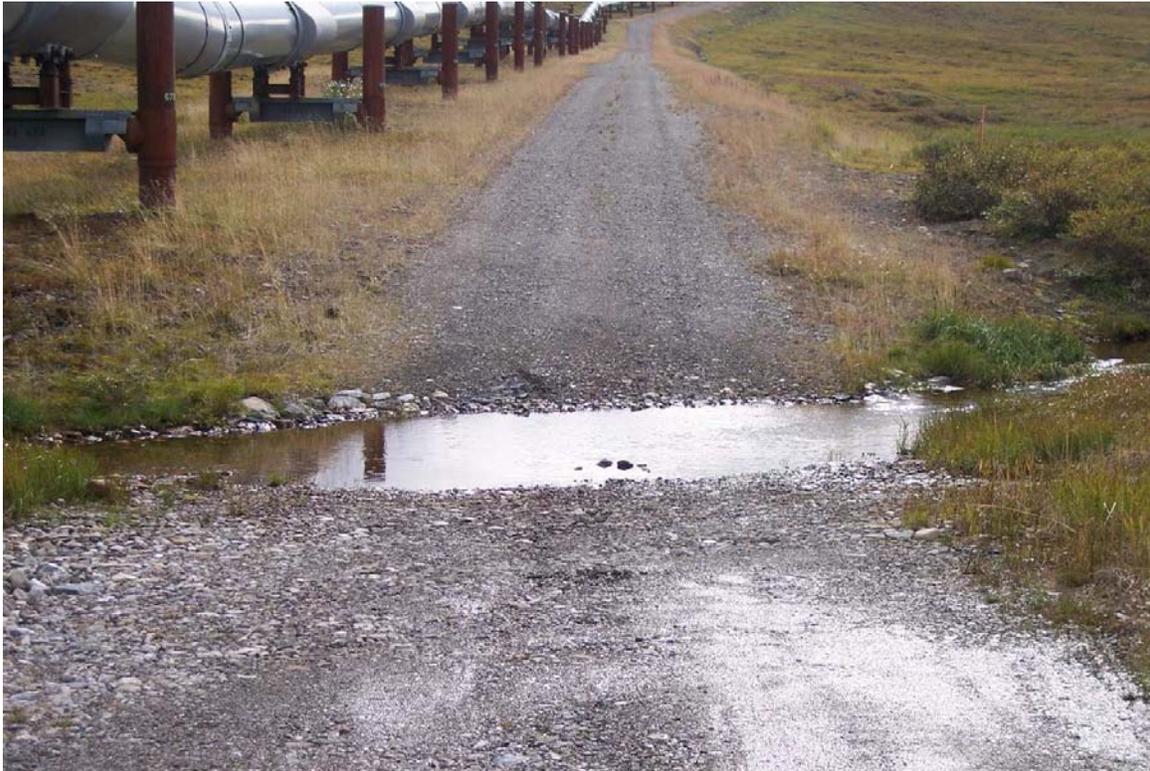
In FY09, the ADF&G Liaison conducted 47 surveillances along the TAPS ROW. Most of these surveillances, 30, involved LWC. Figure 31 is a photograph of the upper Becky Creek LWC, which allows access to a known Arctic grayling overwintering area upstream.

Figure 31. *Upper Becky Creek LWC.*

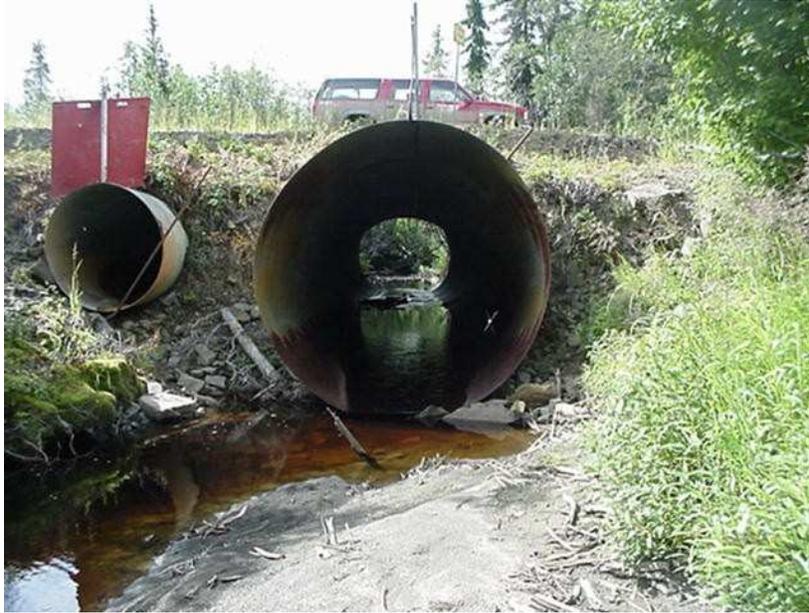
The remainder included a mix of culvert inspections, revetments, guide banks, and ramps. One such culvert inspection was conducted on Slate Creek near TAPS PLMP 408.35. The main channel culvert was replaced by a 10-foot diameter by 70-foot long corrugated metal pipe culvert. The overflow culvert was replaced by another 5-foot diameter corrugated metal pipe culvert. The culvert was properly installed; it replicated natural-stream channel conditions within the barrel. Sediment transport, flood and debris conveyance, and fish passage function as they would in a natural channel. The culvert has been sized to match (at least 90 percent) the natural channel width (reference reach). The culvert was buried at least 20 percent and the pipe backfilled with a layer of Class I riprap, gravel, and fines to simulate natural channel materials. Class I riprap, gravel, and fines were placed as an apron at the culvert outlet to preclude scour pool formation, and prevent French draining. This is a good example of a proper culvert installation. Figure 32 is a photograph of culvert at Slate Creek, taken in 2001, that illustrates susceptibility to perching at the culvert inlet.

Figure 32. *Slate Creek culvert, 2001.*

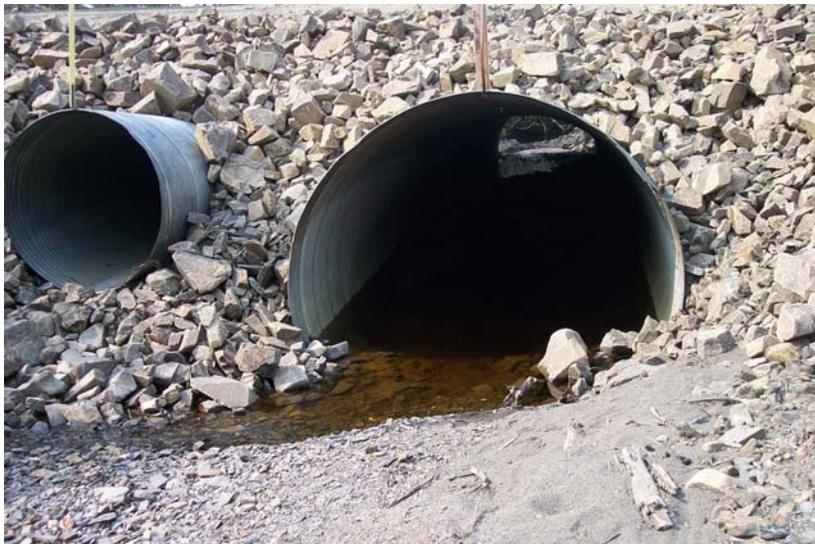
Figure 33. *Slate Creek culvert, 2009.*

Figure 33 shows the Slate Creek culvert in 2009, after APSC remediation was completed. The culvert was imbedded to reduce the likelihood of perching and to provide fish passage during low-flow conditions. The smaller diameter culvert was installed to manage overflow during high-water conditions.

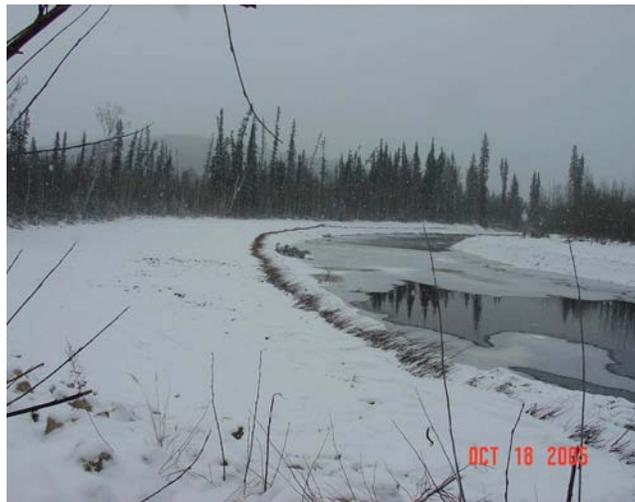
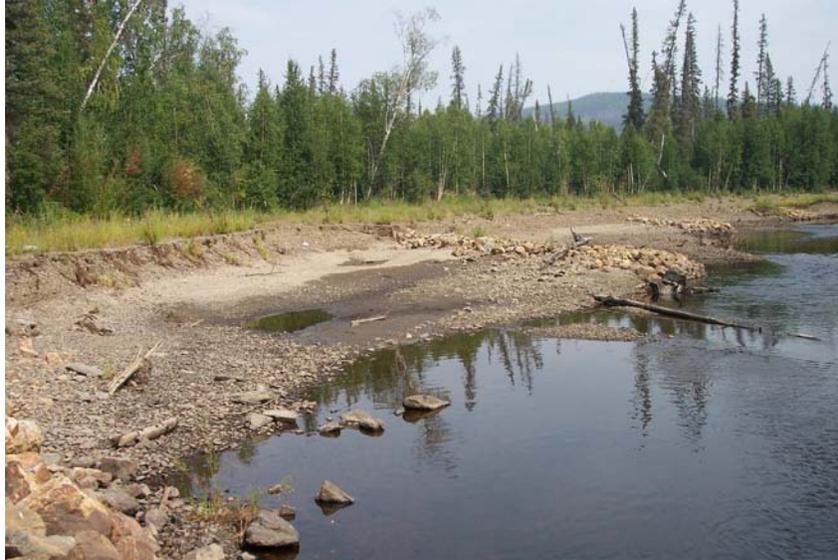
3. Hess Creek, PLMP 378.6 received an unsatisfactory surveillance report for non-compliance with Lease Stipulation 2.4.3.1. Against the advice of the JPO Habitat Biologist in 2005, APSC installed rock vane structures that are angled downstream and designed to be overtopped at ordinary high water, or near bankfull flows (see Figure 34). This configuration redirects flowing water into the bank (or floodplain) that is being protected, thus exposing it to direct erosion during bankfull flows. As a result, the constructed floodplain has now eroded to within 13 feet of the upper terrace (at its closest point). Figure 35 for illustrates the current state of the location. An estimated 1,100+ cubic yards of gravel material and about 160 linear feet of willow cuttings (live dikes) placed between the rock vanes have eroded into the active channel during four mild break-up events and were transported downstream. The ADF&G recommends that this experimental design not be used in the future.

Figure 34. Hess Creek, 2005.

Figure 35. Hess Creek, 2009.
