State Pipeline Coordinator's Office

Annual Report Fiscal Year 2009

The fiscal year 2009 State Pipeline Coordinator's Office Annual Report describes the status of jurisdictional pipeline right-of-way leases. This report integrates information from all State Pipeline Coordinator's Office activities and summarizes the prior calendar year's construction, operations, and maintenance activities on jurisdictional pipeline rights-of-way. The sections of this report include an overview of each jurisdictional pipeline, a summary of the annual reports submitted by the lessees, and a description of SPCO oversight programs and SPCO activities during the fiscal year 2009. This report does not provide a comprehensive record of all activities that are undertaken as part of the lessee's pipeline systems management; rather, this report highlights certain information and activities in order to demonstrate the implementation of SPCO lease oversight.

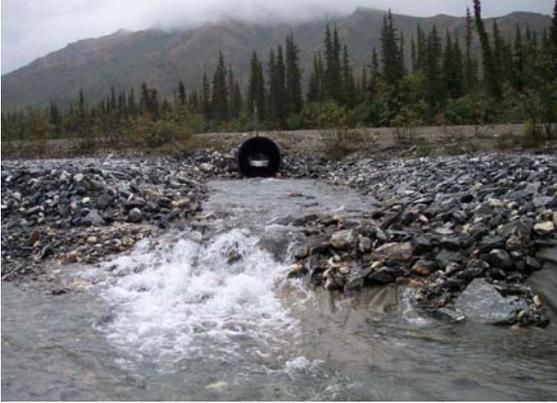
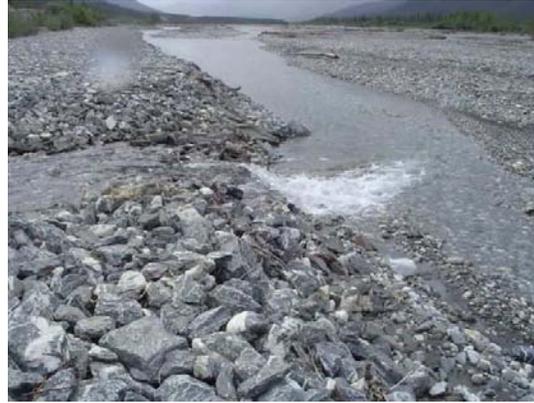
One example to illustrate the APSC Civil Maintenance Program monitoring of fish passage is the channel changes and fish passage problems at Beaver Dam Brook (stream). These problems were first observed and monitored by members of the APSC Environmental Team and Civil Maintenance Program. The ADF&G has been advised that APSC is actively working on a solution to the site problems to correct fish passage. Since APSC has detected the deficiency (using their Environmental Surveillance Program), reported the fish passage deficiency to the ADF&G, and is actively working on a solution to reestablish fish passage, the ADF&G will not issue a Notice of Violation for failure to provide efficient fish passage at this location during 2009. In the interim, APSC is expected to continue working on a rapid solution to re-establish fish passage and keep the ADF&G informed of their progress. The site did receive an unsatisfactory observation on Surveillance Report 09-TAPS-S-086 for failure to provide fish passage as required in Grant Stipulation 2.5.1. The ADF&G is concerned that if the problem is not fixed prior to the spring breakup, Arctic grayling migration into Beaver Dam Brook may not occur in this spawning and rearing area.

Figure 36. *Beaver Dam Brook.*

Figure 37. *Beaver Dam Brook confluence with the Dietrich River.*

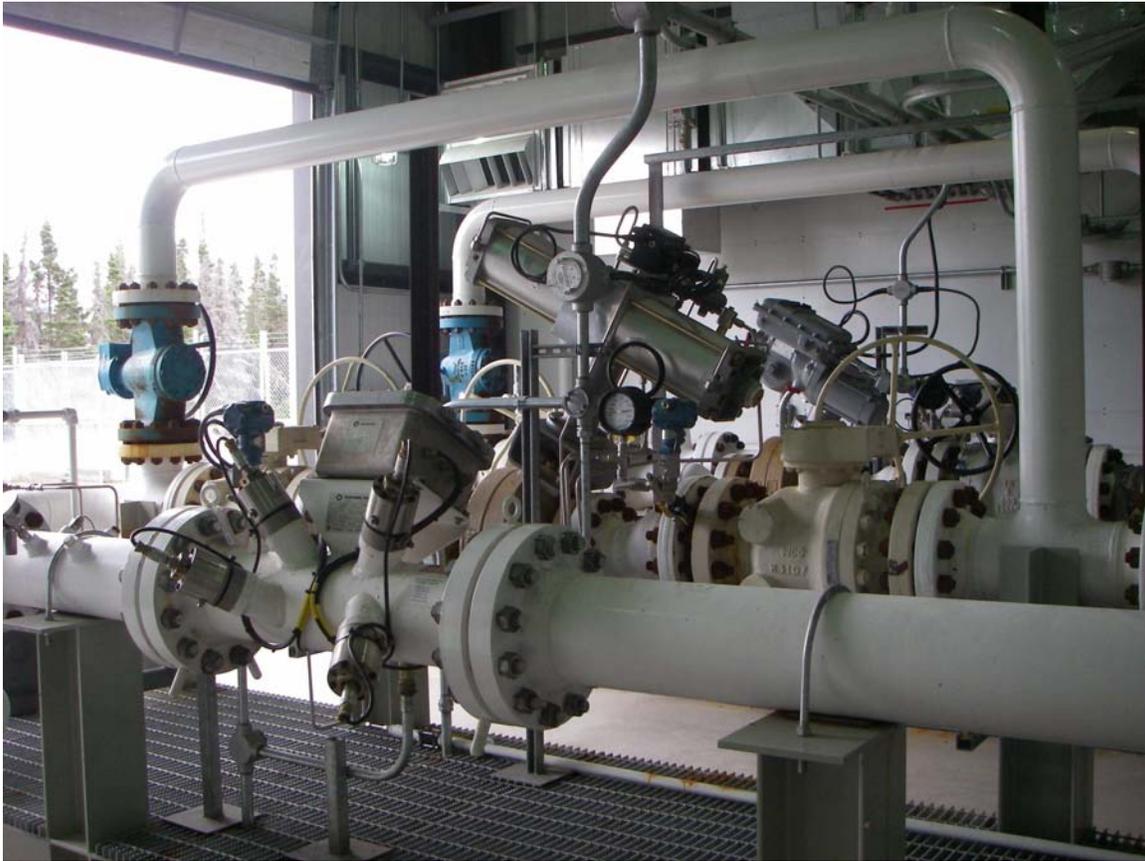
Figure 39. *KKPL, inside the 500 Master Meter Building.*

KKPL begins at the Happy Valley production pad and ends at the Marathon Oil Company 500 Master Meter Building (Figure 39), running generally south to north. Seven Cook Inlet wells currently transport natural gas through KKPL. Some natural gas is distributed from KKPL for local use.

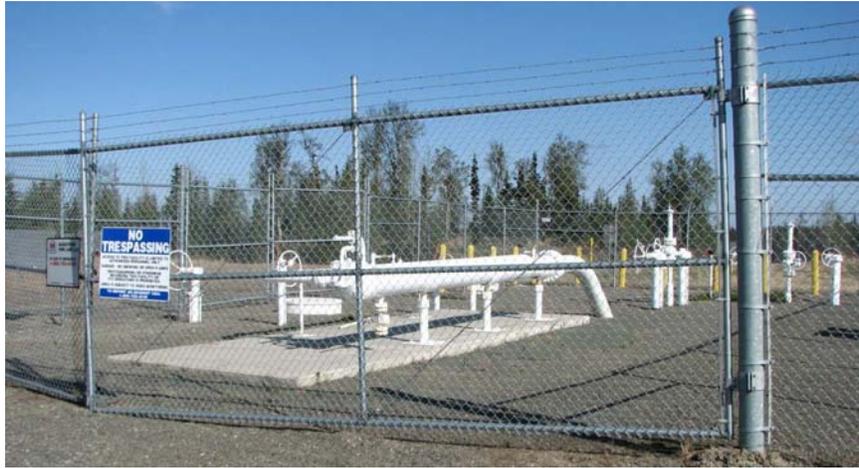
Figure 40. *KKPL pig launcher at the HVE.*

No. 08-043-CT). Figure 40 is a photograph of the pig launcher at the HVE taken on the May 2009 trip. A request from SPCO regarding the status of MPLDOT006 – Integrity Management Risk Management Process Standard, remains open.

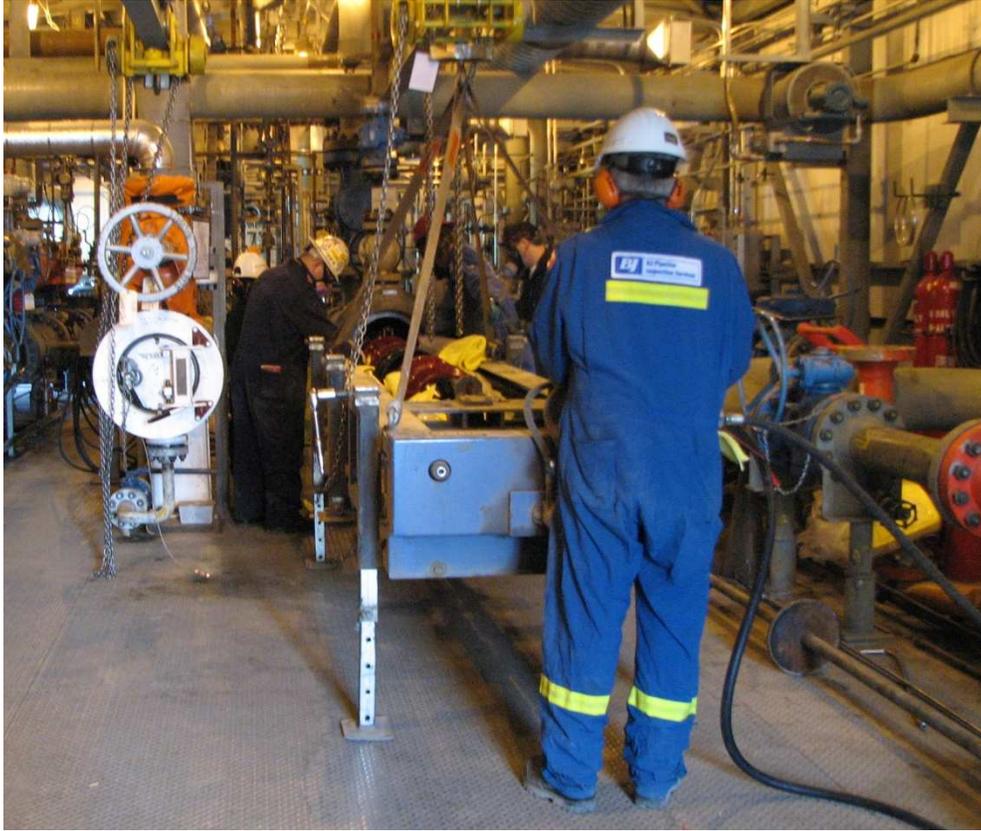
Figure 46. *The pig receiver for the Alpine Oil Pipeline.*

SPCO Compliance staff observed both the launching and receiving of a smart pig in the Alpine Crude Oil Pipeline. All standard operating procedures were followed and the subsequent launching/receiving was a smooth process. 98% of data collected by the pig was recovered. CPAI deemed the ILI successful. Figure 46 depicts CPC specialists and contractors as they extracted and inspected a "smart pig" after the Alpine Oil ILI run on June 12, 2009.

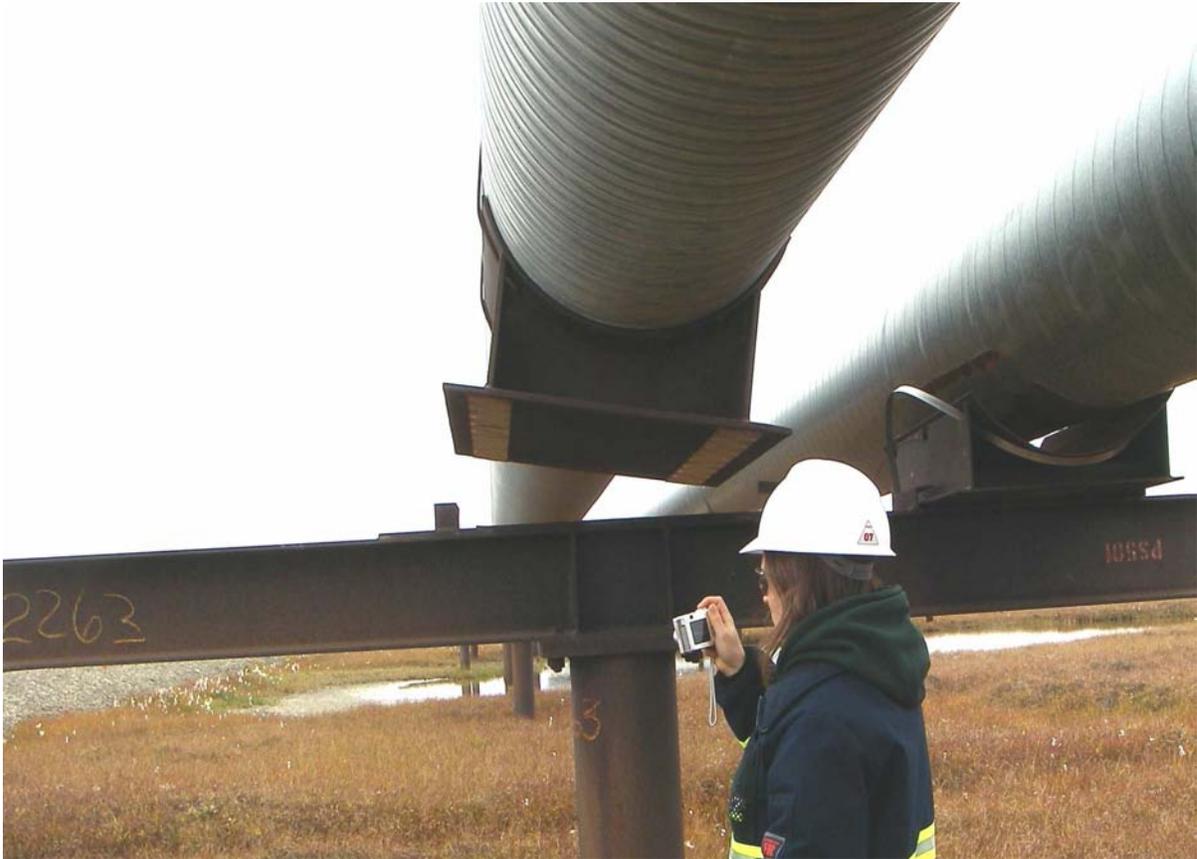
Figure 50. *Kuparuk and Oliktok Pipelines, shoe off of supports, August 2008.*

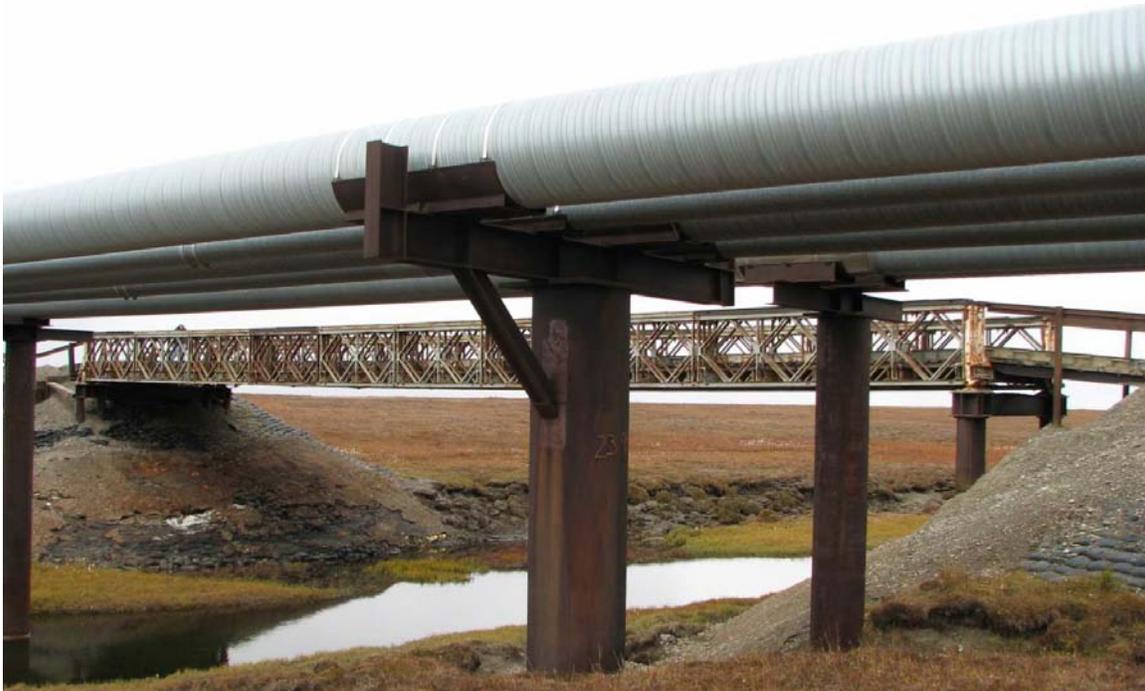
Figure 51. *Kuparuk Pipeline (and Bailey Bridge) crossing Smith Creek.*

A planned replacement of the Bailey Bridge crossing over Smith Creek (Figure 51) was deferred by KTC. Although an ice road was built and snow removal occurred at the site and was observed by the SPCO on the February 2009 trip, no other activities were observed for this project and the Regulatory Compliance Coordinator indicated that the project had been deferred.

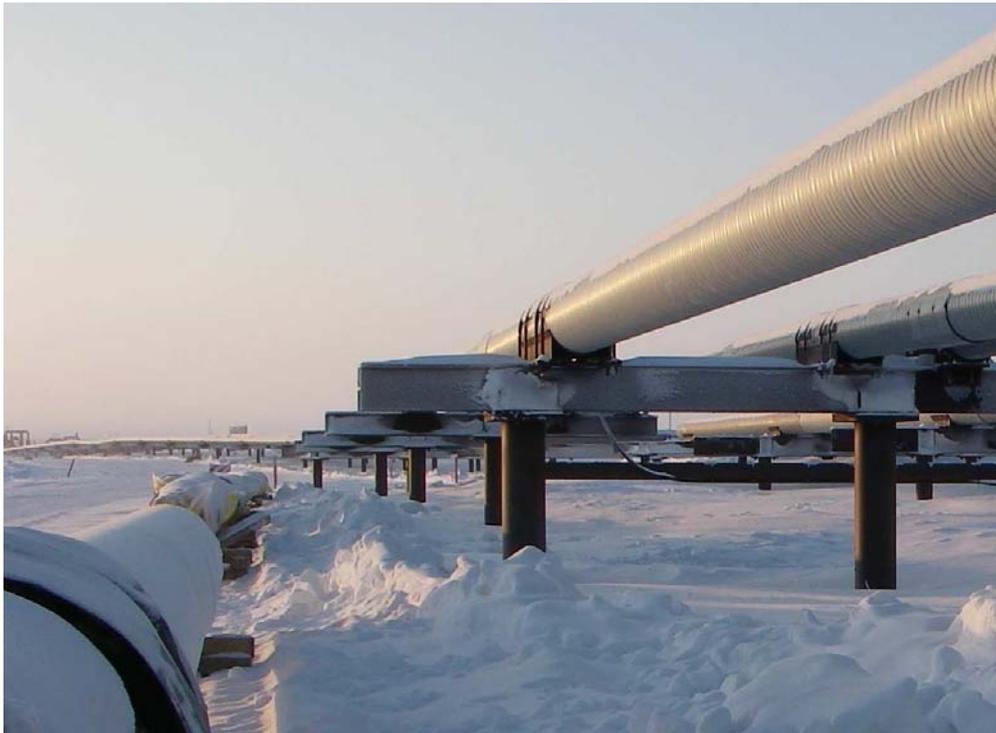
Figure 52. *Old 12-inch KPE pipe removed from the rack leaving space for the new 18-inch pipe to be installed.*

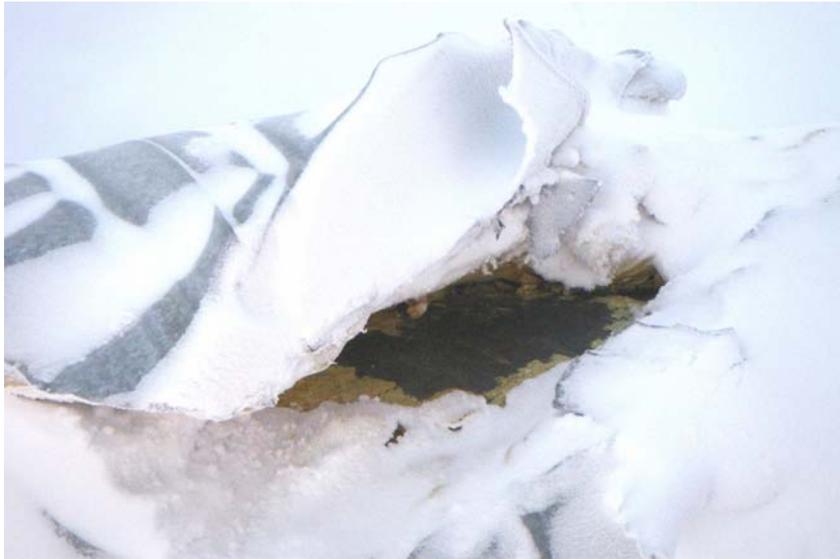
Figure 53. Jacket damage to a pipe *adjacent to* Kuparuk from snow excavation incident.

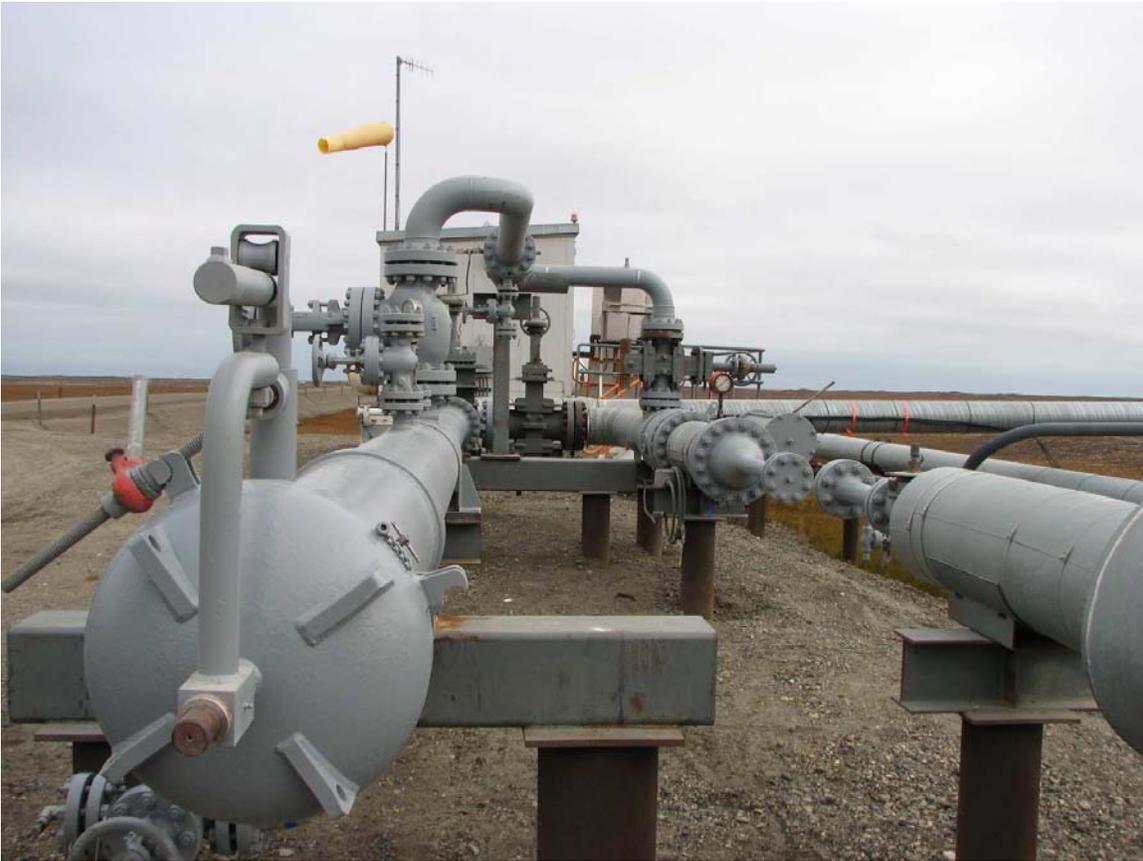
Figure 54. *Pigging facilities near the Badami Sales Oil Pipeline tie-in to the Endicott Pipeline.*

The Badami Pipelines connect the North Slope's easternmost oil development, Badami Oil Field, to the Endicott Pipeline. The 12-inch Badami Sales Oil Pipeline begins at the Badami Central Production Facility, where the pig launcher, mainline pumps, and metering equipment are located ([Appendix E](#), Physical Characteristics of SPCO Jurisdictional Pipelines). It ends approximately 25 miles to the west at the tie-in with the Endicott Pipeline, where there is a pig receiver (Figure 54).

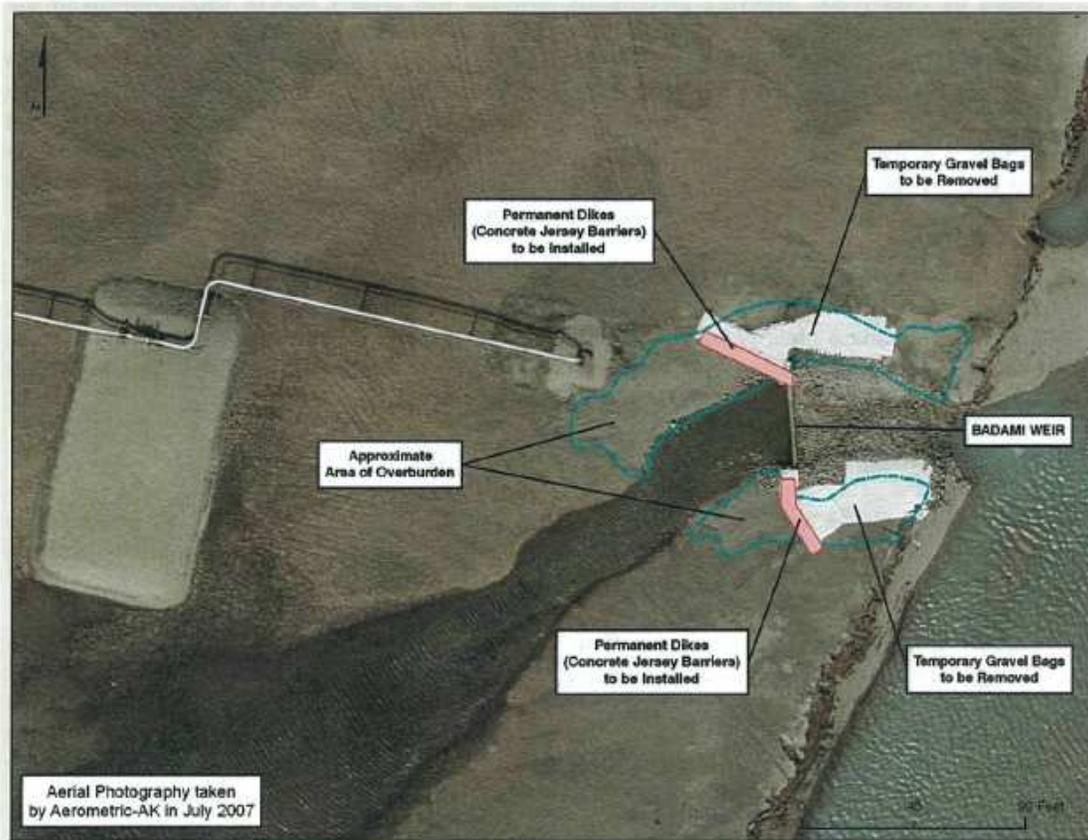
Figure 55. Aerial photo of Badami Weir taken in 2007.¹³

The weir was initially constructed in 2002 to mitigate the erosion and drainage problems resulting from construction of the pipeline river crossing on the East Channel of the Sagavanirktok. By 2007, it became apparent that the weir performance was not acceptable. An interim solution provided bank stabilization and minimized erosion using sand and gravel bags (Figure 55). Plans for a more permanent weir structure that could maintain the stability of the adjacent wetland communities, mitigate accelerated erosion and thwart possible impacts to the Badami Pipelines over the long-term was approved and modifications to the existing weir were completed during the 2008 winter season. These modifications included removing the two temporary dikes and the hundreds of gravel bags installed in 2007. They were replaced with two dikes formed with precast concrete jersey barriers. These barriers are designed to direct the flow of water over the weir, restoring the original surface flow patterns and maintaining the elevation of an upstream oxbow lake.

Modifications to the existing weir were completed during the 2008 winter season. These modifications included removing the two temporary dikes and the hundreds of gravel bags that had been installed in 2007 (Figure 55) and replacing them with two dikes comprised of precast concrete jersey barriers that are 63 feet long. The jersey barriers will corral and direct the flow of water sending it over the weir, further reducing erosion and sedimentation along the East Channel of the Sagavanirktok River Crossing. On January 29, 2009, BP submitted the Rehabilitation Plan for Badami Pipeline Weir in accordance with a general condition of USACE issued Department of Army Permit POA-1994-700-2.

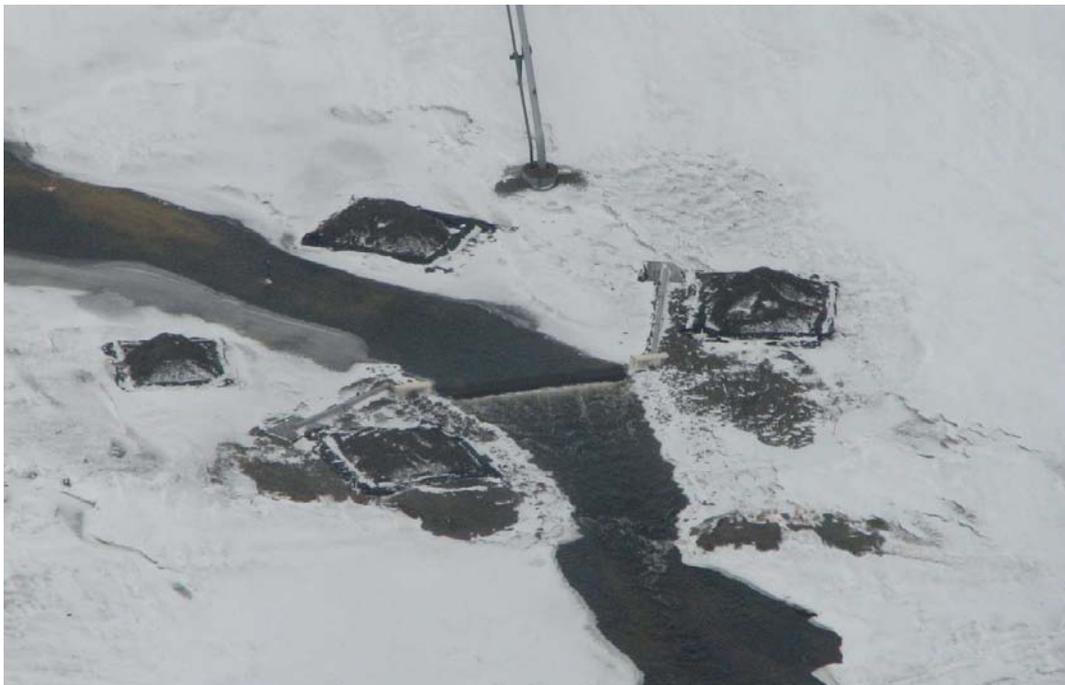
Figure 56. Stockpiles of overburden are to be spread around the Badami Weir late August 2009.

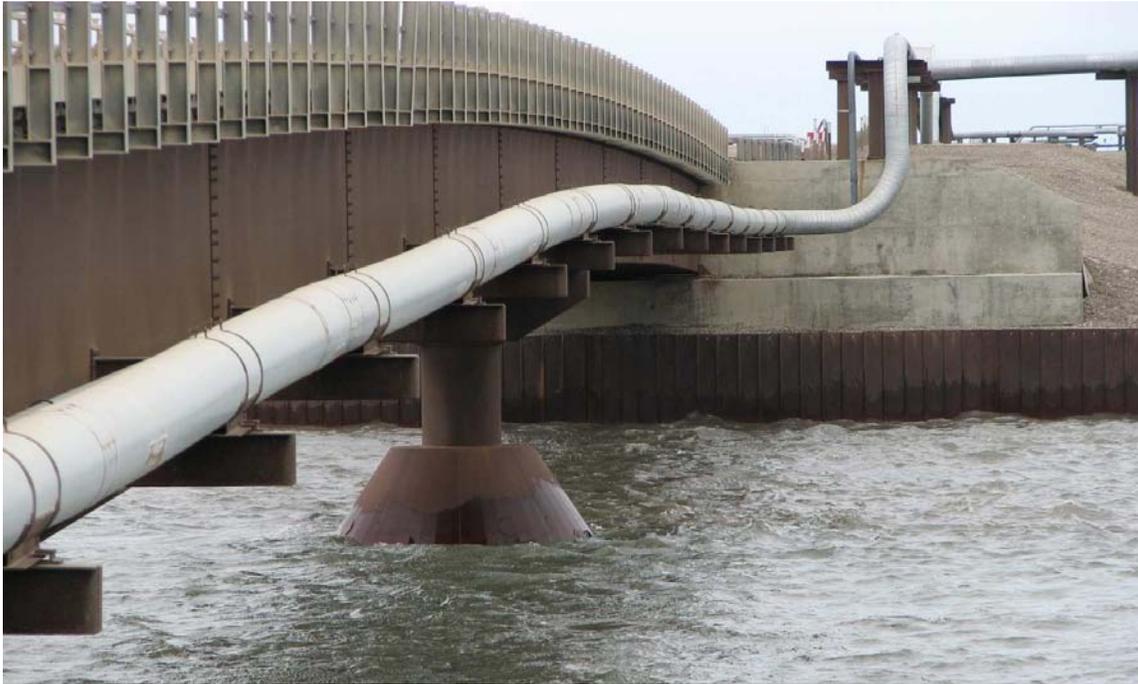
Figure 58. *Endicott Causeway, Bridge number 2, N 70.31290, W 147.88312.*

On the August 28, 2008 trip, the Compliance and Engineering sections accompanied BPTA and BPXA staff to the Endicott Main Production Island. During the trip, the SPCO staff noted that Endicott has had an ongoing and successful participation in the VPP. Following a tour of the Main Production Facility, the SPCO staff returned to the BP Operations Center, stopping at three bridges along the causeway, and the crossing at the Sagavanirktok River to take Global Positioning System set points and photograph the

vehicular and pipeline bridges. Figure 58 is a photograph of Endicott Causeway Bridge 2, which was taken on the August 28, 2008 trip.

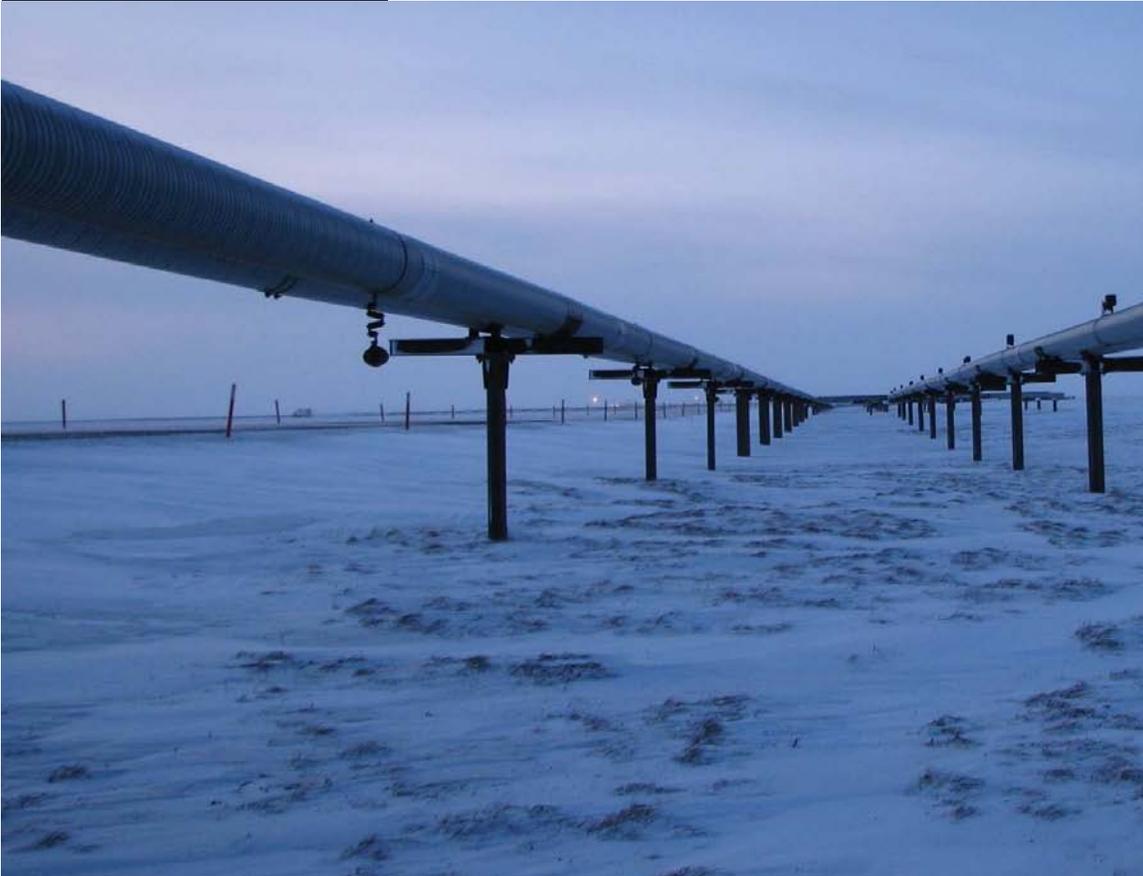
Figure 59. *Milne Point Product and Milne Point Oil are the pipelines on the left side of the photograph.*

There are two SPCO jurisdictional pipelines associated with Milne Point operations, a sales oil pipeline, the Milne Point Pipeline and a NGL product supply pipeline, the Milne Point Product Pipeline. Figure 59 is a photograph of both of the Milne Point pipelines. Milne Point Pipeline was built in 1984-85 to transport processed sales oil from the Milne Point Unit to the Kuparuk Pipeline System. The approximately 10-mile Milne Point Pipeline connects the Milne Point Central Facilities Pad (CFP) at Module 58 to the Kuparuk Pipeline at a point that is shortly beyond Module 68, after crossing under Spine Road, just east of CPF-1. The Milne Point Pipeline is piggable from the Milne CFP to Module 68. A pig receiver, metering equipment, and leak detection equipment are at this location.

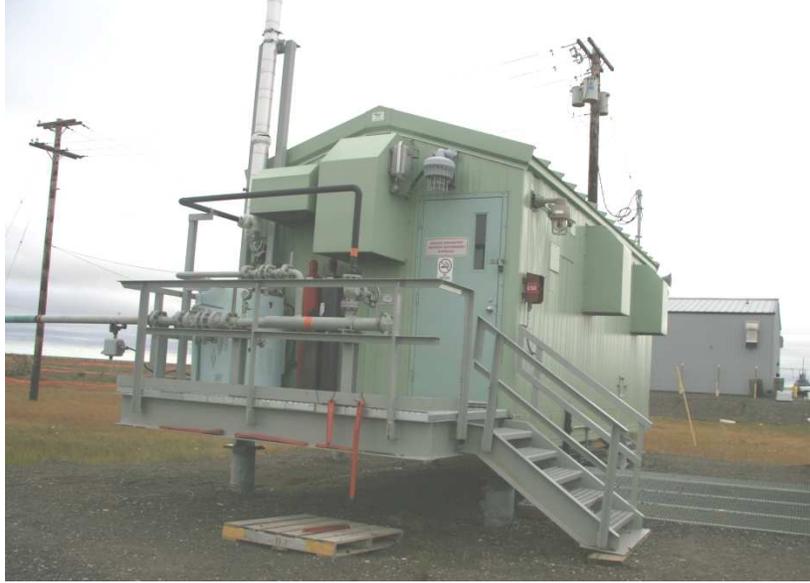
Figure 61. NNGP Operations building housing control center, valve room, pig launcher/receiver.

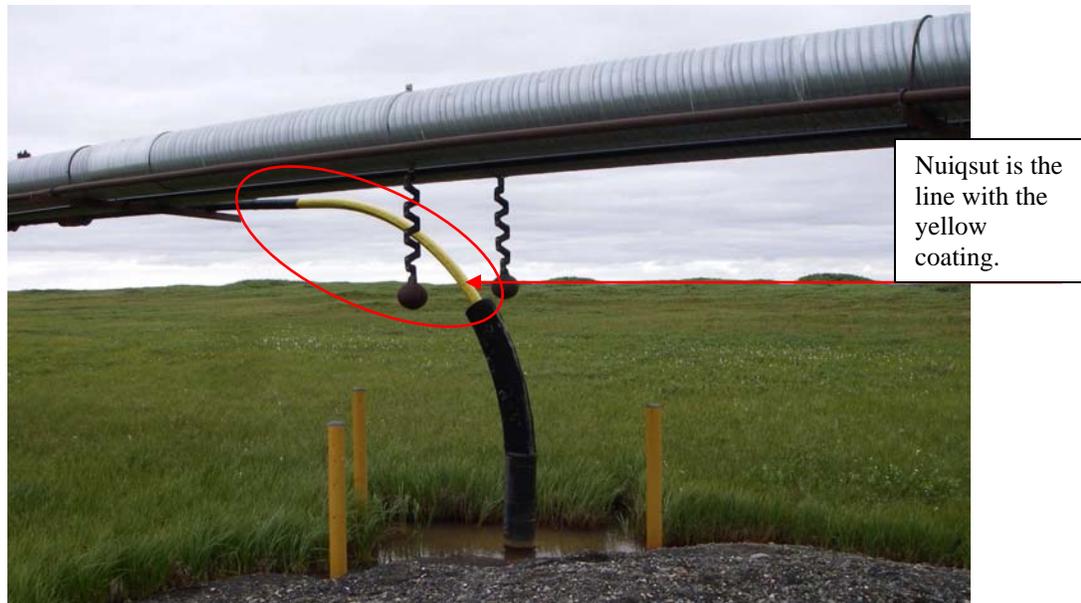
Figure 62. Point where NNGP transitions from aboveground to belowground.

The NNGP is a three and one-half inch diameter coiled tubing pipeline with a wall thickness of 0.203 inches designed to operate at 1,440 psig. The NNGP was supplied with an external coating applied at the factory. A continuous magnesium strip cathodic protection system was installed on the belowground portion of the NNGP. The pipeline is subject to PHMSA jurisdiction and operates under 49 CFR 192 regulatory requirements.
