RE: State Pipeline Coordinator's Office Annual Report - Fiscal Year 2011

Errata Sheet for  
State Pipeline Coordinator's Office 2011 Annual Report  
Last Update: January 18, 2012

STATE  
PIPELINE  
COORDINATOR'S  
OFFICE

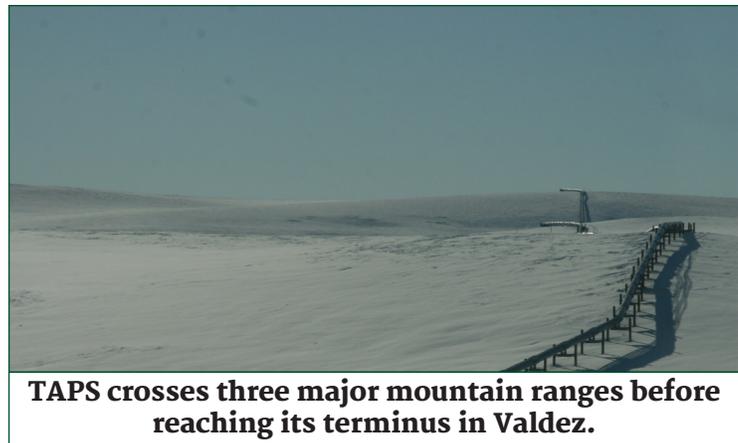
**TAPS crosses three major mountain ranges before reaching its terminus in Valdez.**

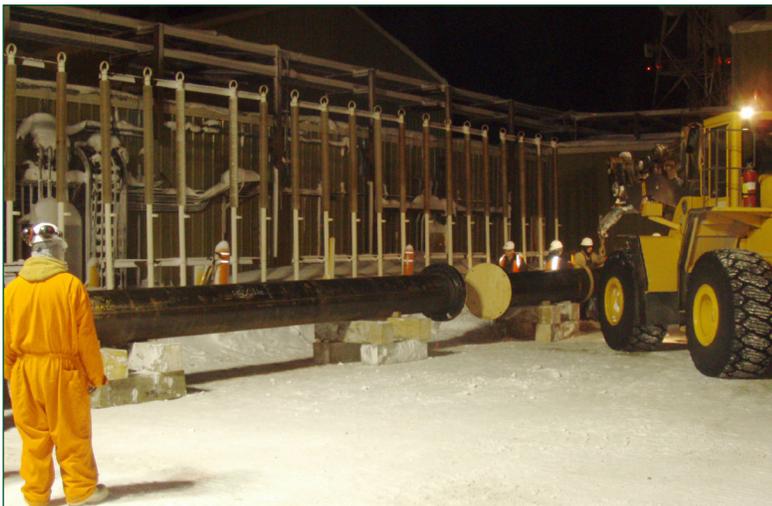
**Workers line up the pipe sections for connection into the bypass pipeline. The new line bypasses existing pipe, where a leak was discovered on January 8, and reroutes crude oil flow coming from the booster pump building.**  
Photo credit: ADEC

In response to the leak, APSC shut down the pipeline system and quickly developed plans to construct a 157-foot bypass pipe around the booster pump module. While TAPS was shut down, APSC evaluated options, planned

responses, procured materials and welded and installed the bypass pipe in order to restart the pipeline and proceed with repairs to the leak.

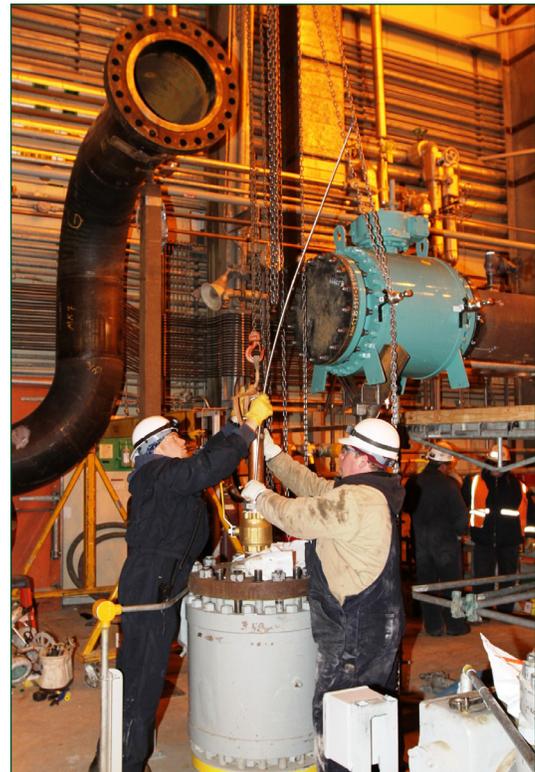
**Workers install the bypass pipeline inside the metering building.  
Photo credit: ADEC**

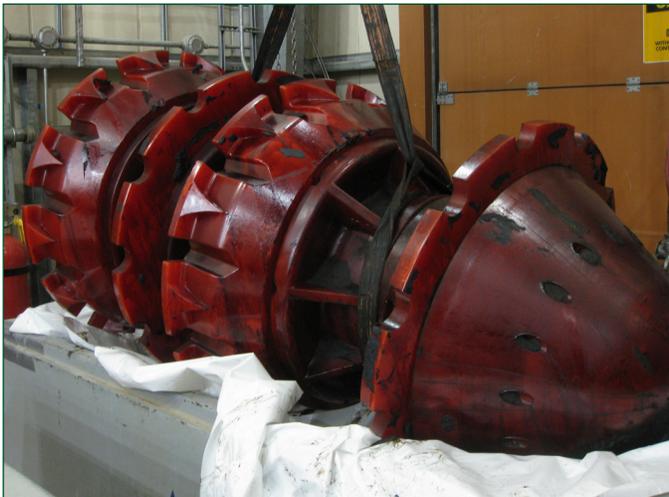
**A scraper pig similar to the two that were in the pipeline during the January shutdown.  
Photo credit: ADEC**

Two cleaning pigs were trapped in the pipeline when APSC shut down TAPS in response to the PS1 leak. During shutdown, excessive wax and solids can accumulate; the cleaning pigs push contaminants and can create a “debris cloud” that settles when a pig’s movement is interrupted. If a pig cannot resume movement, it can affect the flow of crude through the pipe and potentially stop other pigs in the pipeline.

On January 14, APSC crews retrieved one of the trapped cleaning pigs in a bypass that was originally intended to launch smart pigs. After the second restart, APSC retrieved

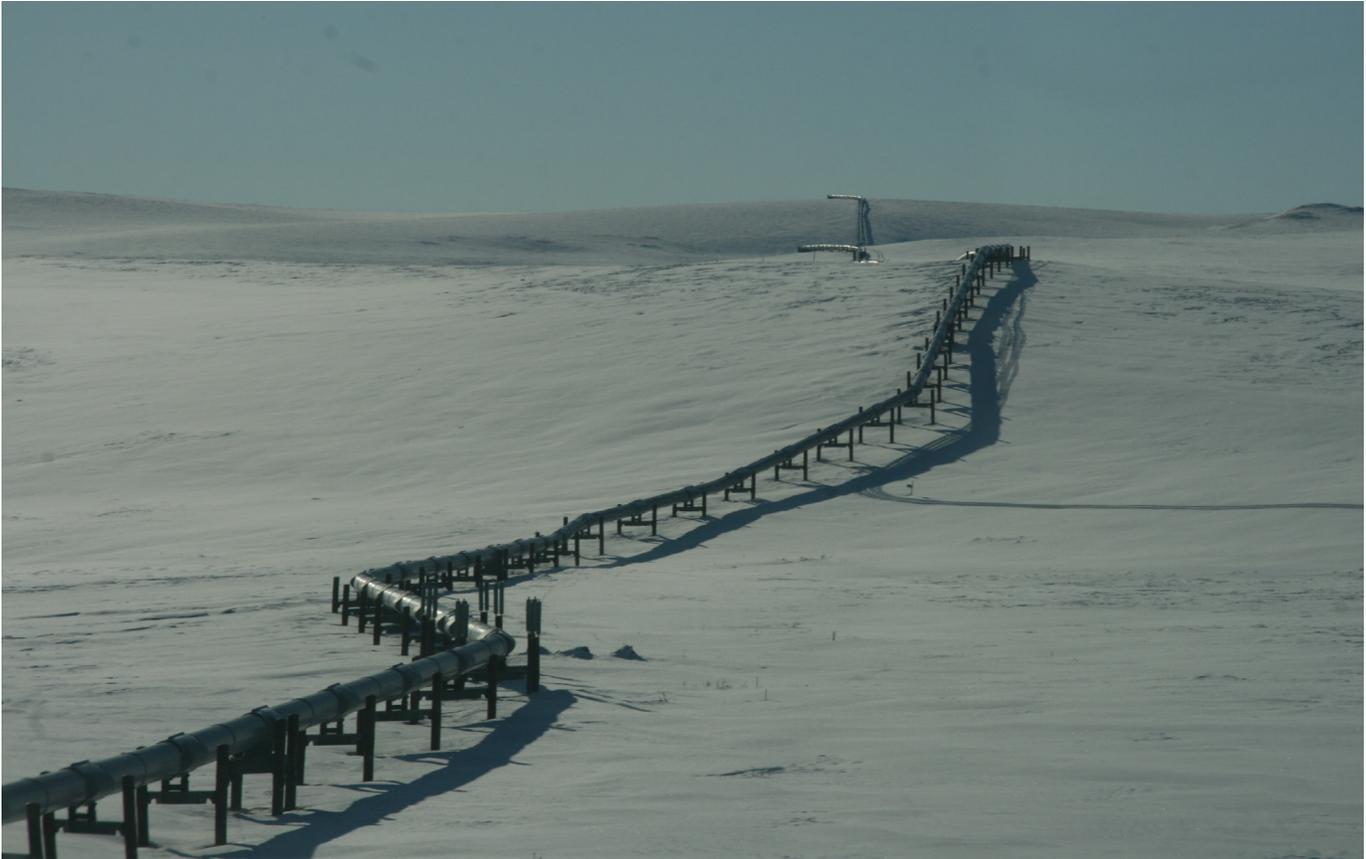
**During the shutdown in January of 2011, an SPCO observer noted that the crude oil temperature in TAPS dropped to 25.7 degrees Fahrenheit. The lowest temperature noted during previous winter shutdowns was 37 degrees Fahrenheit. APSC successfully operated TAPS in unprecedented conditions.**

An SPCO observer noted that the lowest fluid temperatures during this time reached 25.7 degrees Fahrenheit. The lowest temperature noted during previous winter shutdowns was 37 degrees Fahrenheit. APSC successfully operated TAPS in unprecedented conditions, outside of the bounds of the pipeline's original design basis.

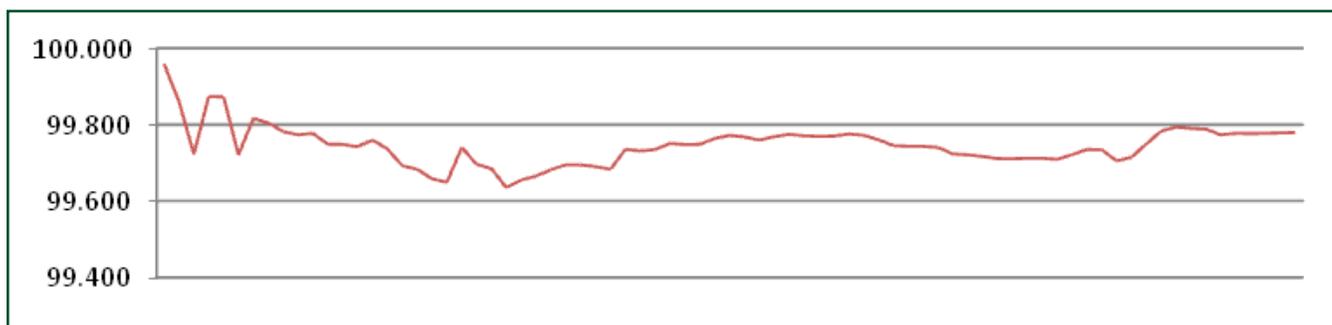
### **PS3 Availability**

The trend for availability of the strategic reconfiguration facilities, from startup to the present, is flat. The facilities continue to have minor sporadic outages that do not affect TAPS throughput. The root causes of the January 2011 PS1 booster pump incident did not involve any strategic reconfiguration equipment or facilities.

Strategic reconfiguration facilities operated as they have in previous years; several minor shutdowns occurred, but none lasted a significant amount of time or reduced TAPS throughput. Availability is defined as the percentage of time that a pump station is online and available for its purpose. The graph on the following page shows the record of PS3 after its second startup in March 2008 to the present. The design basis lists a target of 99.0% availability.

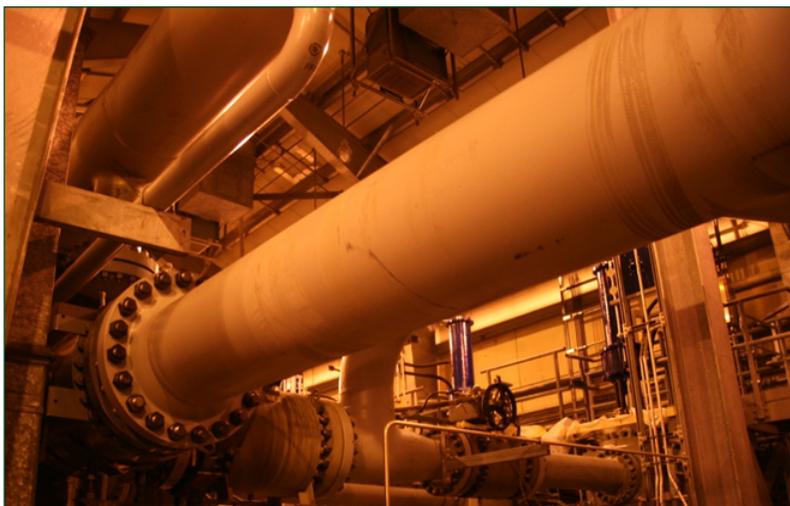
**Bypass piping installed at PS5 around obstructed discharge relief/ crude injection piping.**

The discharge relief piping is shared by the pump station crude injection system.

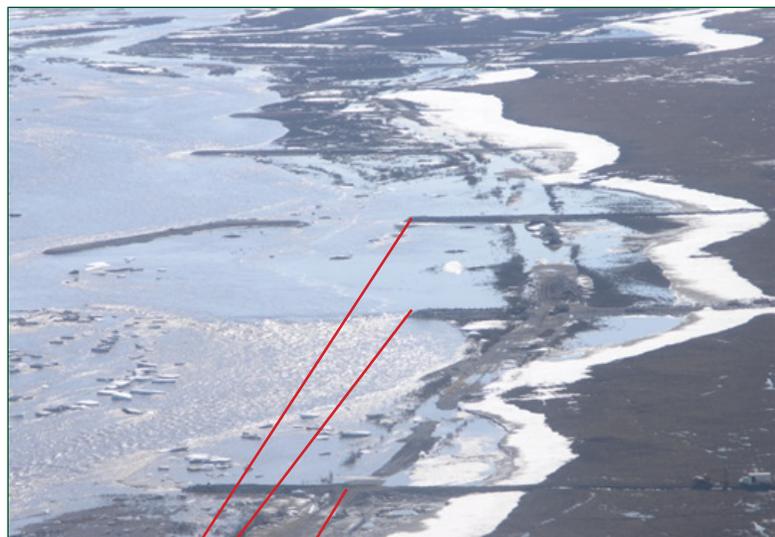
**Spur Dikes 6, 7 and 8 were partially breached during a May flood event on Sagavanirktok River.**

APSC permanent repairs consisted of repairing the dikes back to their existing conditions and then installing a three-foot windrow on the upstream sides to prevent future high water events from breaching the dikes. APSC crews installed a diversion dike to help keep the river away from the dikes during construction. The diversion dike will be left in as a sacrificial dike, giving TAPS an added layer of protection against the river.

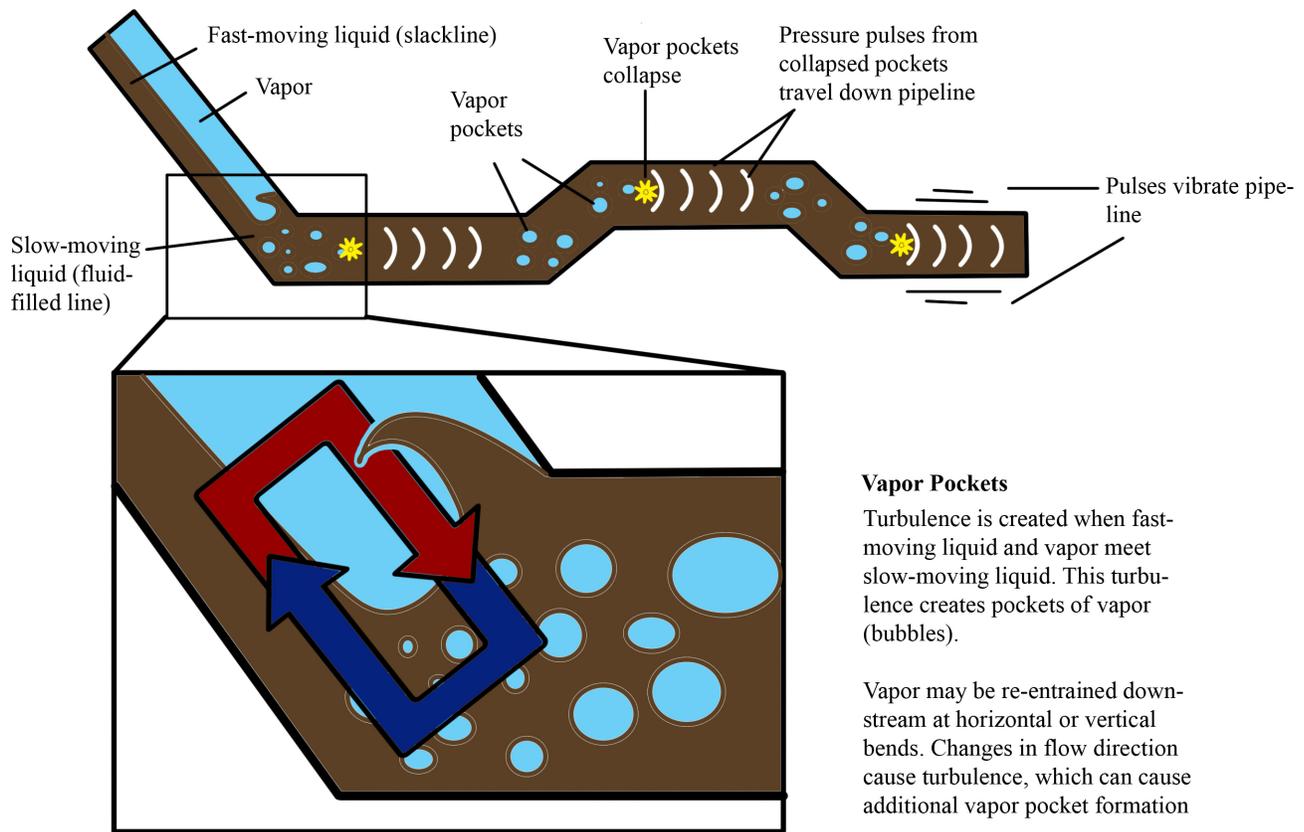
### Theorized Mechanism of Vibrations at Atigun Pass

Low throughput in TAPS causes the pipeline vibrations at Atigun Pass. The reduced flow creates a longer section of slackline, and hence a longer drop for fluids. Continued changes in the flow rates of TAPS may result in greater or lesser vibration in the future.

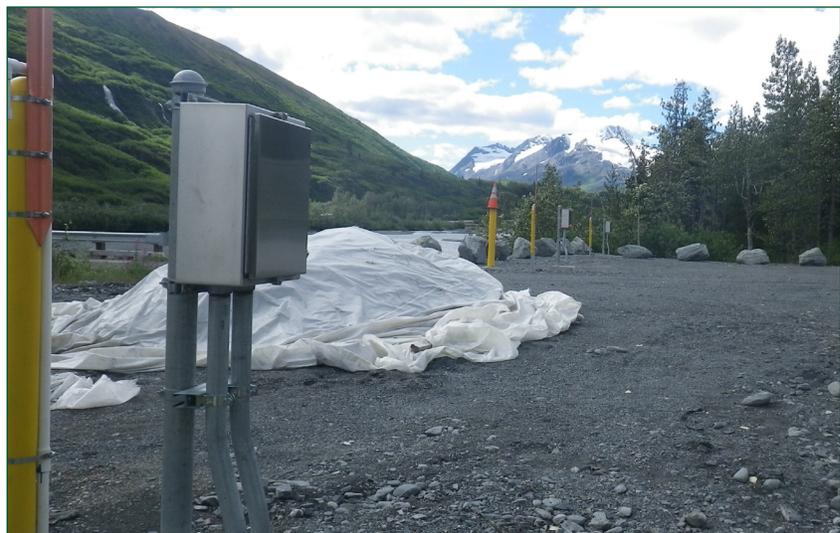
**In FY11, the SPCO ROW section issued an amendment for the construction and maintenance of a cathodic protection system between TAPS and the Tsaina River.**

APSC constructed two gravel pad extensions along the access road. The gravel pads provide cover for, and access to, a new underground 12,000-gallon propane tank and the area for the new generator building. The gravel pads also provide access to the four new semi-deep groundbed wells that were installed near the Tsaina River bank. The system will protect the below-ground TAPS by improving cathodic protection, thereby reducing corrosion between PLMP 758 and PLMP 766.

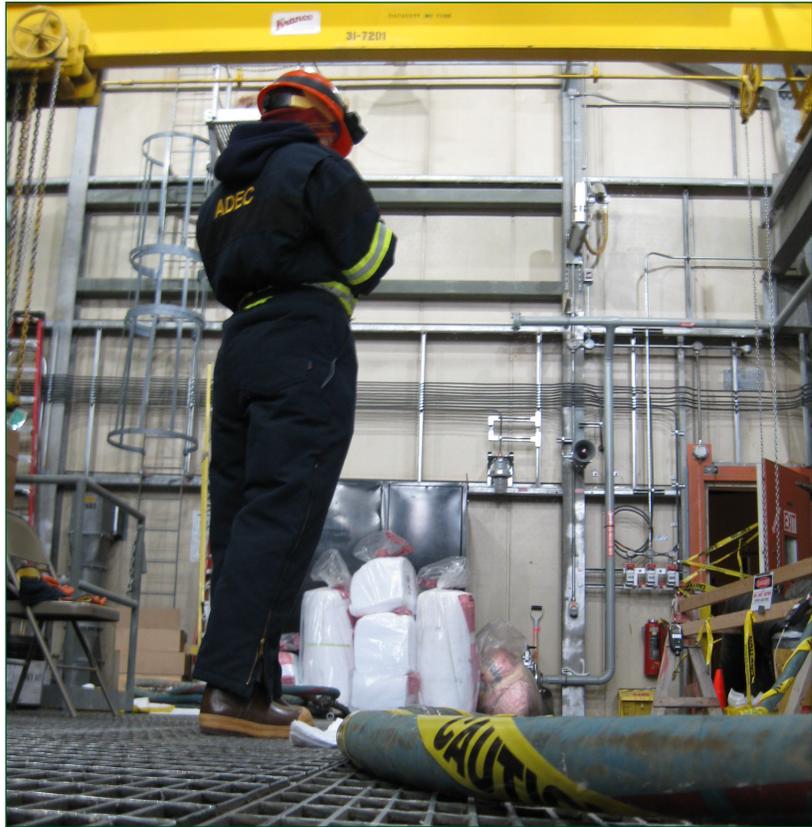
**An ADEC responder observes spill containment and recovery operations in the PS1 booster pump building.  
Photo credit: ADEC**

In order to facilitate the start-up process in a controlled leak situation, APSC constructed a containment vault around the leak and removed oil using vacuum trucks. The total recovery estimate was 317 barrels.

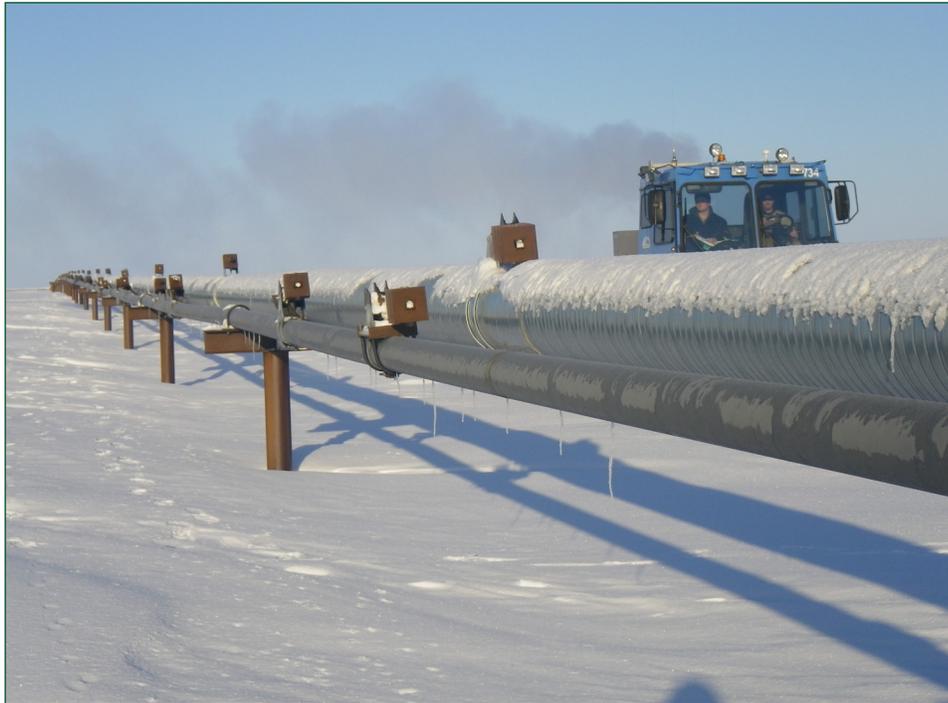
**BPXA typically conducts annual ground inspections in March or April, when snow still covers the pipeline.**

BPXA typically conducts annual ground inspections in March or April, when there is snow covering portions of the Badami pipeline system so not everything on the WSS checklist can be properly inspected. BPTA recognizes this concern and is in the process of planning for inspections of some items during snow-free periods. The SPCO approved the latest version of the BPTA surveillance and monitoring program

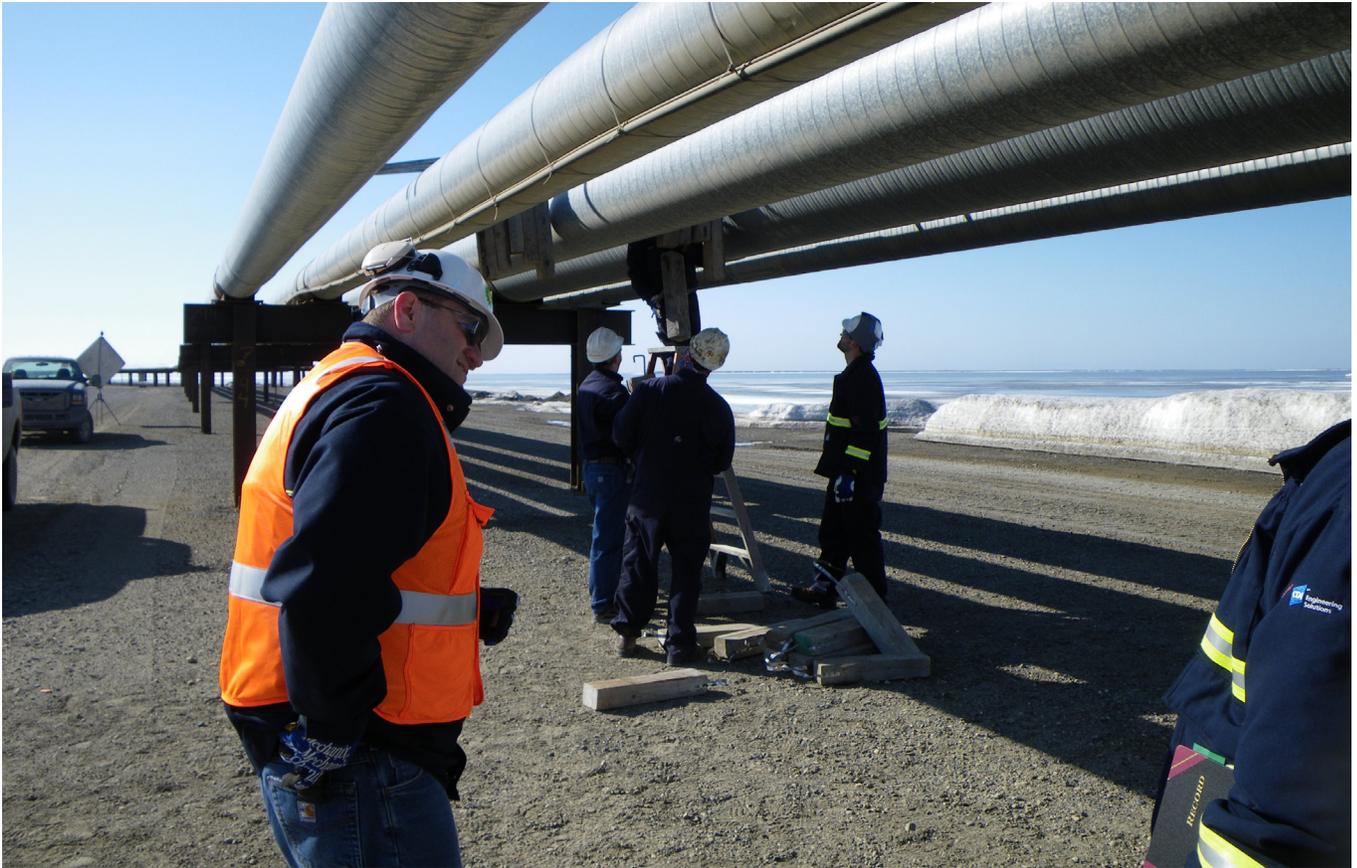
**BPTA contractors install shims to protect the pipelines from movement prior to a hot tap procedure for coupon and probe installation.**

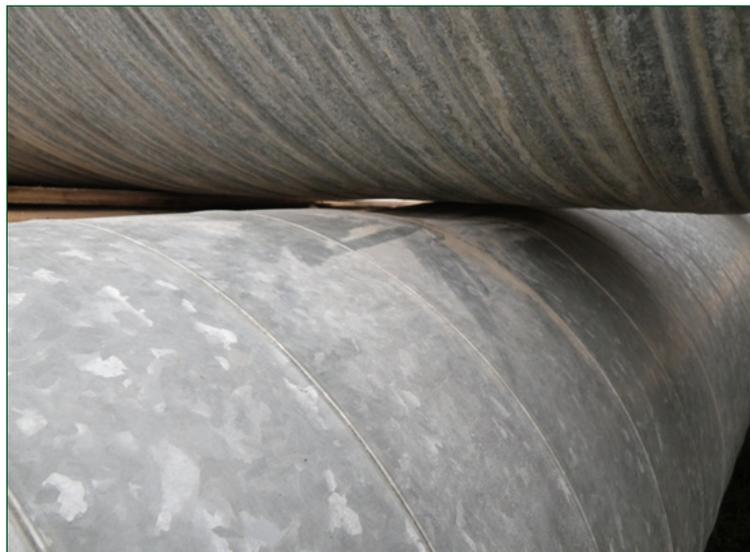
**Close-up view of pipeline resting on Endicott Pipeline**

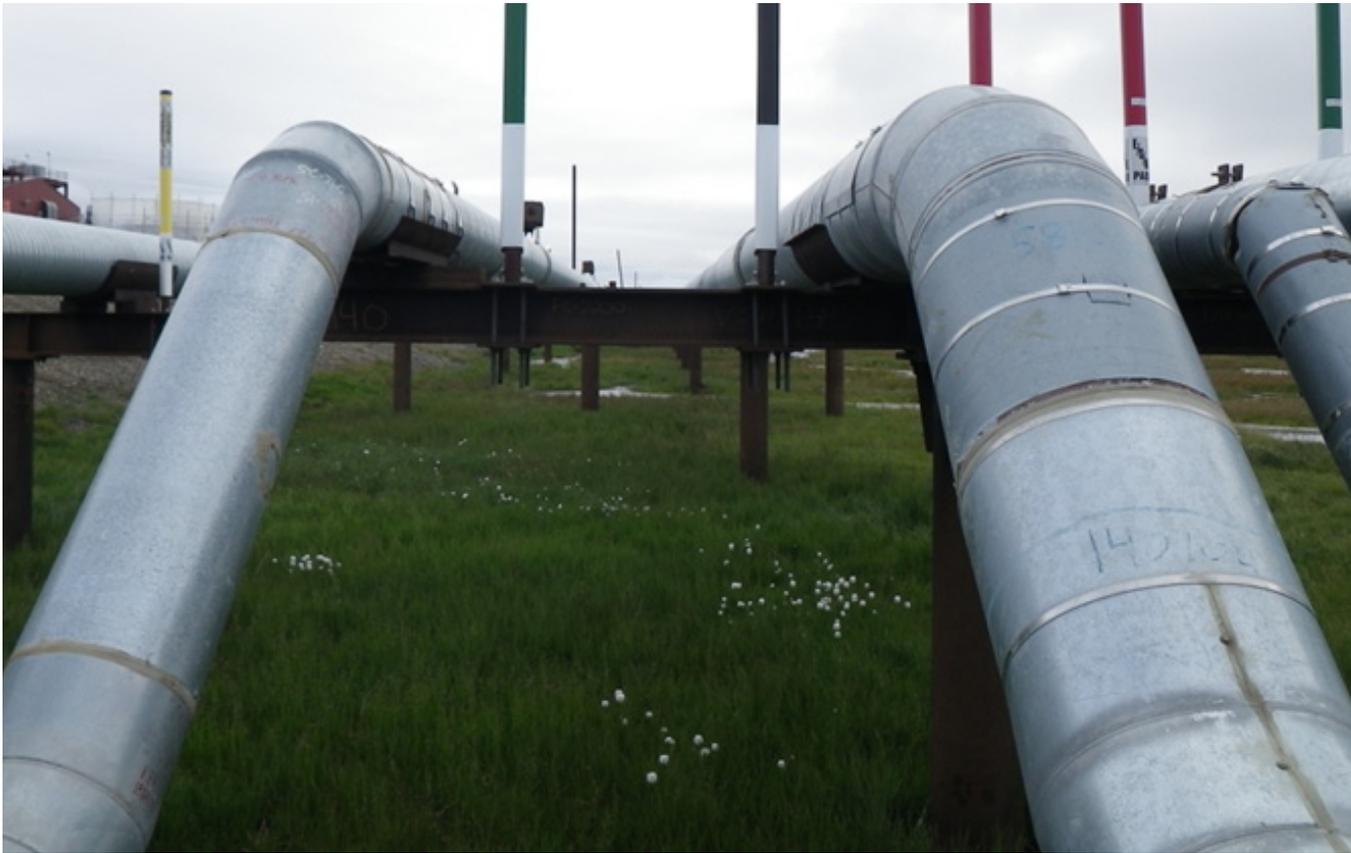
**The Milne Point products (left) and oil (right) pipelines**

**M**ilne Point oil pipeline construction began in 1984 and was completed the following year. The 14-inch diameter pipeline was designed to transport processed crude oil from Milne Point Unit, operated by BPXA, to Kuparuk Pipeline, operated by CPAI. Milne Point Pipeline originates at Milne Point Central Facilities Pad (CFP) Module 58, passes below Spine Road east of Central Processing Facility One (CPF-1) and terminates at the Kuparuk Pipeline connection near Module 68. Module 68 houses metering instruments, leak detection equipment and a pig receiver. In 2007, BPXA removed a section of Milne Point Pipeline inaccessible to pigging tools and replaced it with corrosion-resistant duplex stainless steel.

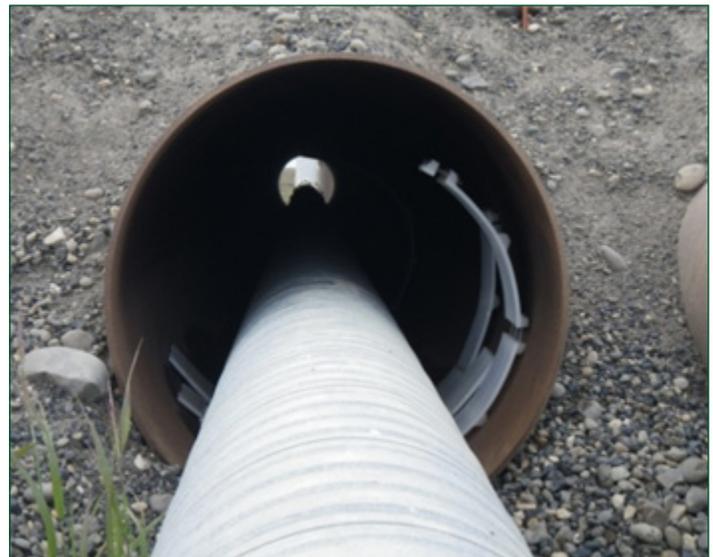
**Broken casing spacer at pipeline crossing  
outside Module 58**

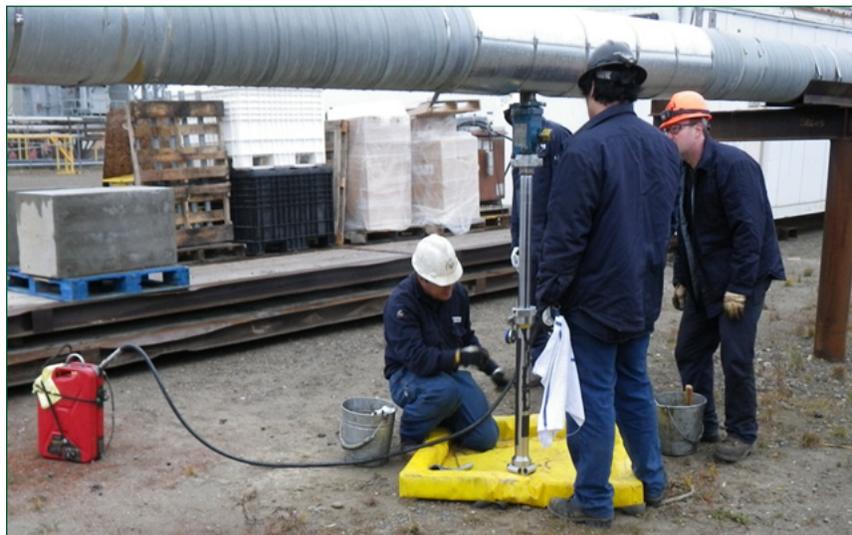
**Workers use a specialized tool to perform a hot tap procedure on the Northstar oil pipeline.**

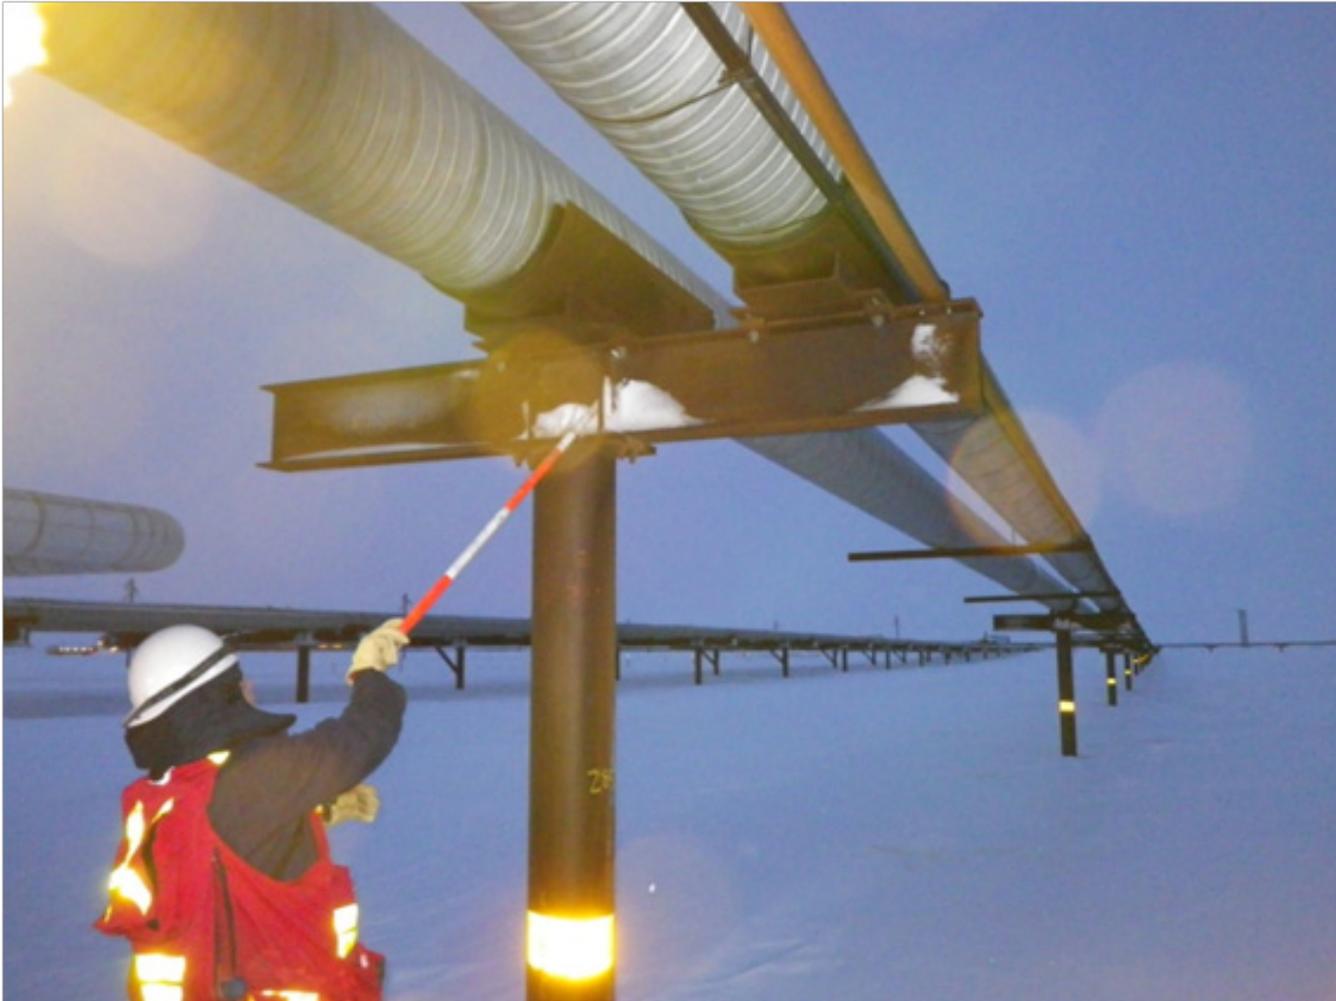
**A pipeline inspector clears snow from a horizontal support beam to visually inspect the Alpine oil (left), utility (center) and diesel (right) pipelines.**

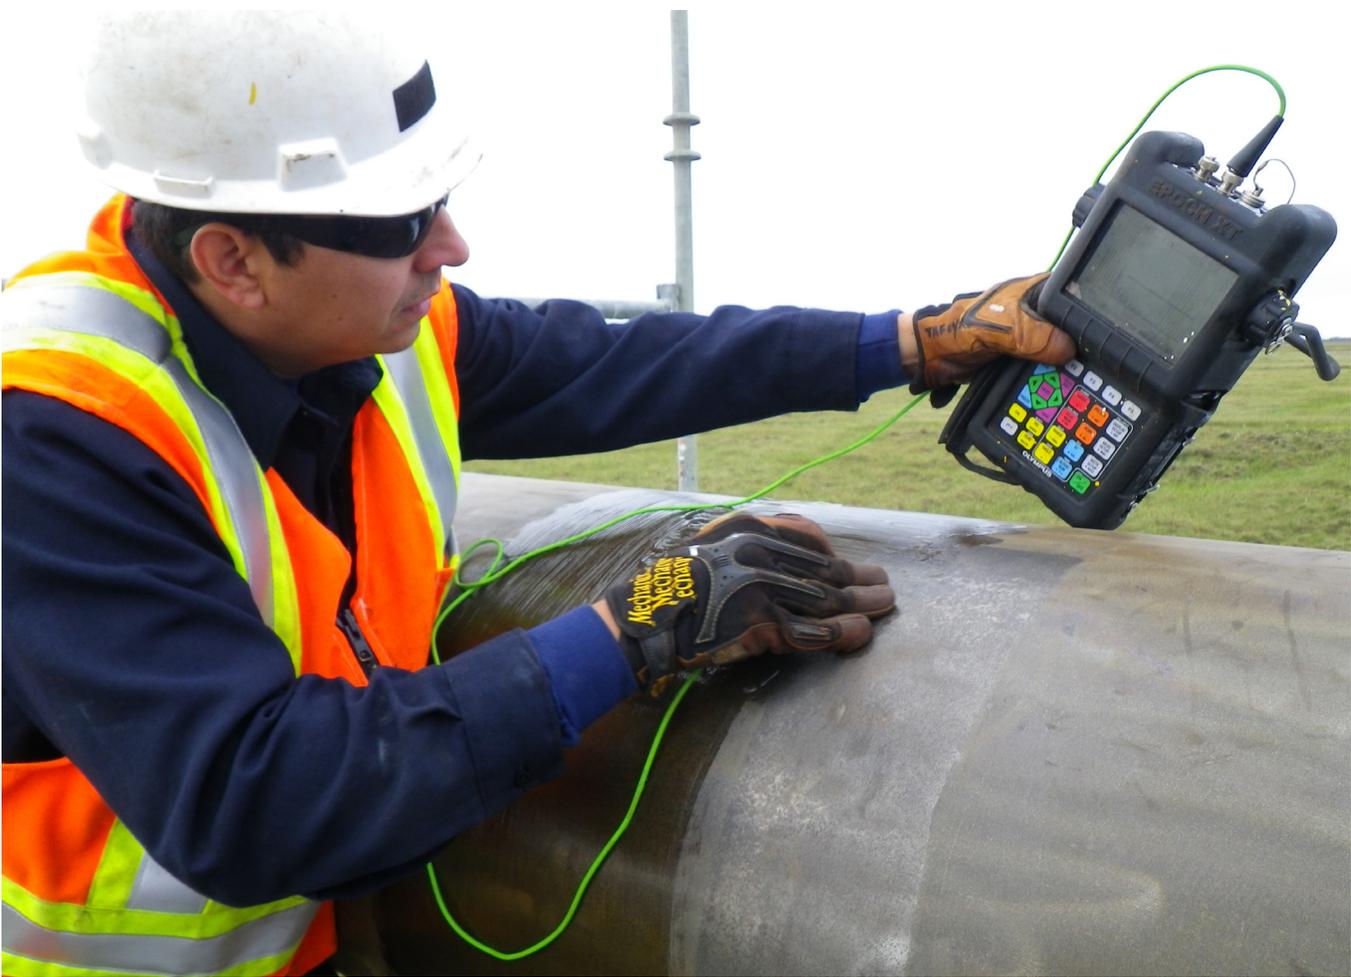
**A contractor inspects Kuparuk Pipeline for pipe wall metal loss using an ultrasonic test unit.**

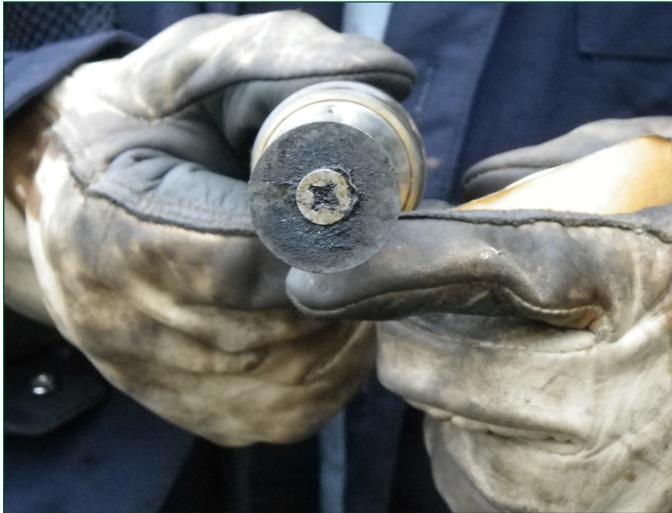
**Pipeline operators can use data from a corrosion coupon (pictured above) to identify pipeline locations that are susceptible to corrosion.**

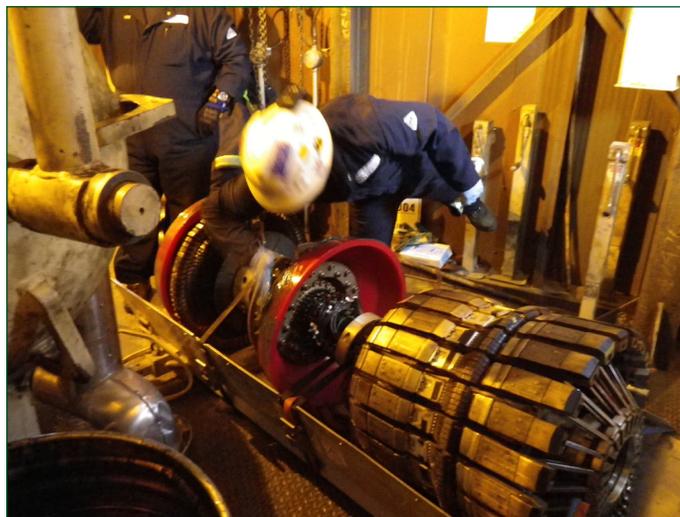
**A contractor inspects the magnetic flux leakage tool used to internally inspect Kuparuk Pipeline.**

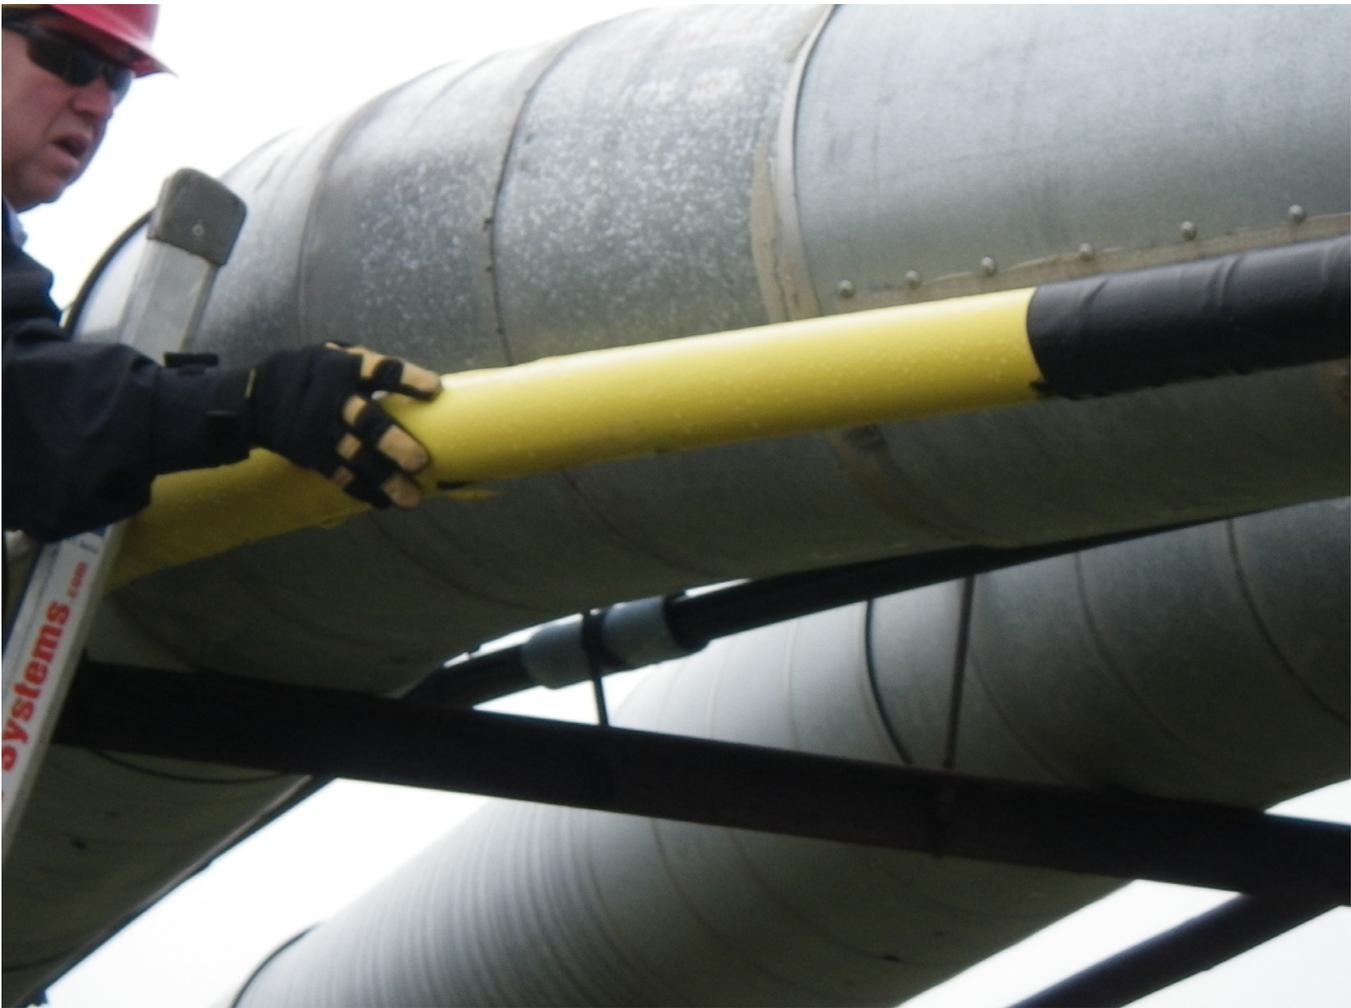
**The above-ground section of Nuiqsut Natural Gas Pipeline shares vertical support members with the Alpine pipelines. In this photo, a USDOT/PHMSA specialist inspects the pipeline coating.**

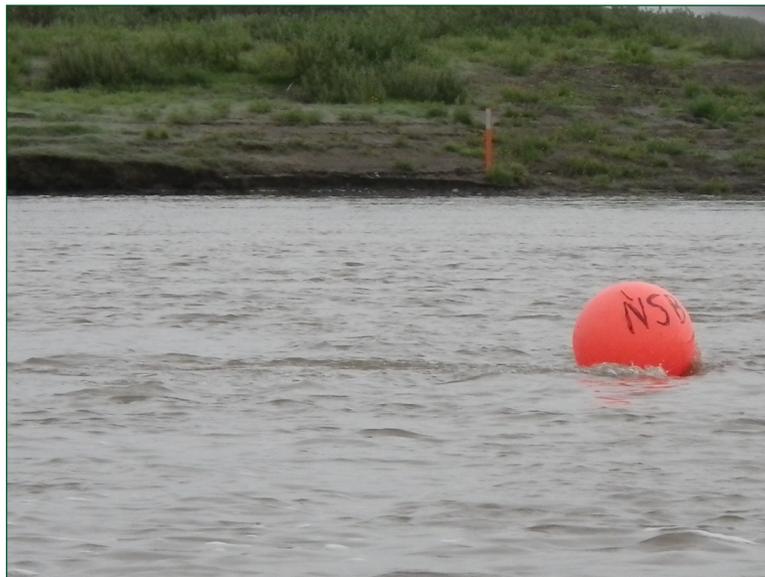
During the August surveillance and monitoring inspections, the NNGP operator visually inspected the shoreline of the Nigliq Channel for erosion and determined the need for an erosion mitigation survey. NSB contacted the SPCO the following month to report that an erosion mitigation survey had been completed in September

**The NNGP operator marked the surface location of a piece of abandoned pipe with a brightly-colored float to warn boaters.**

of 2010 and the operator planned to implement erosion mitigation measures in the summer of 2011. The NNGP operator is developing inspection criteria that will be used for routine inspections of the Nigliq Channel.

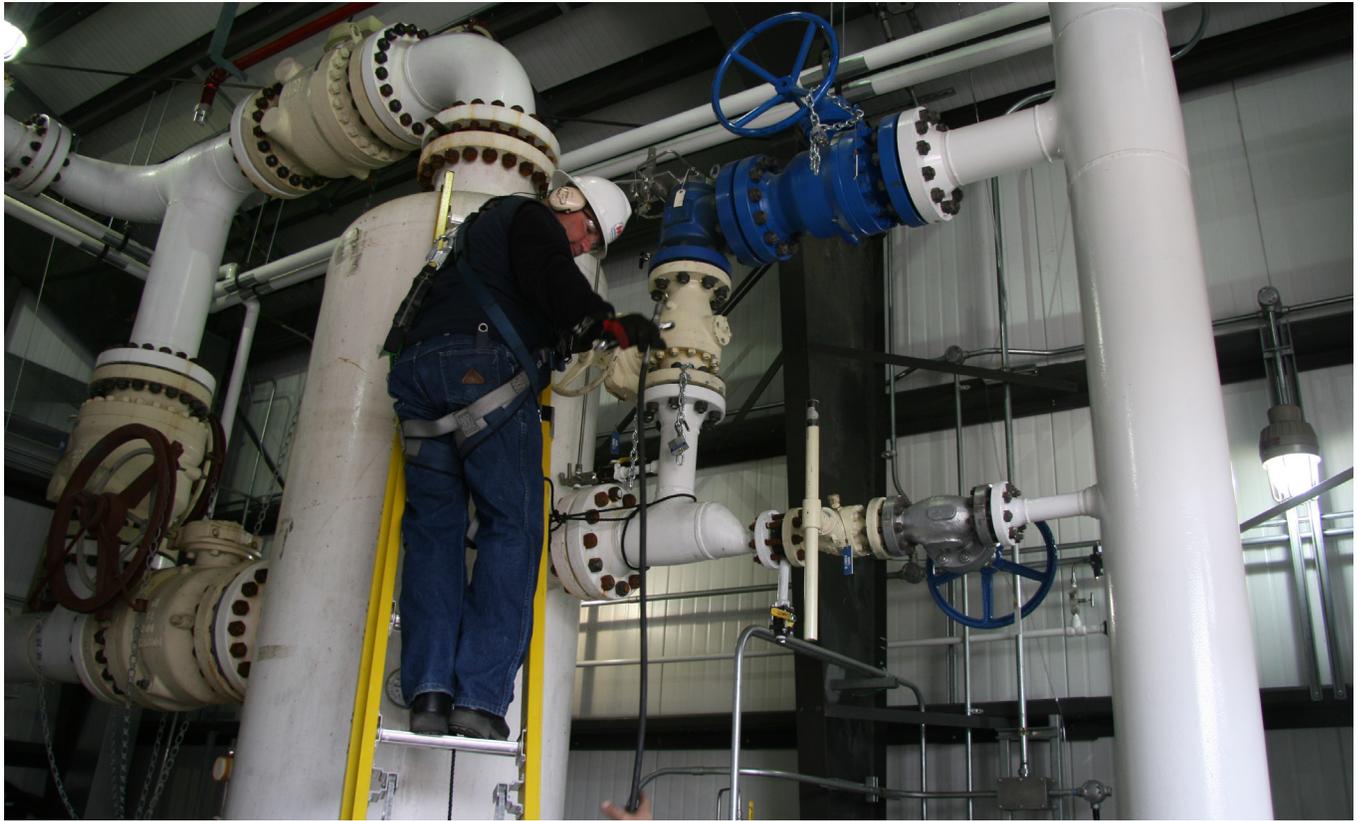
**A Marathon worker conducts valve tests on Kenai-Kachemak Pipeline.**

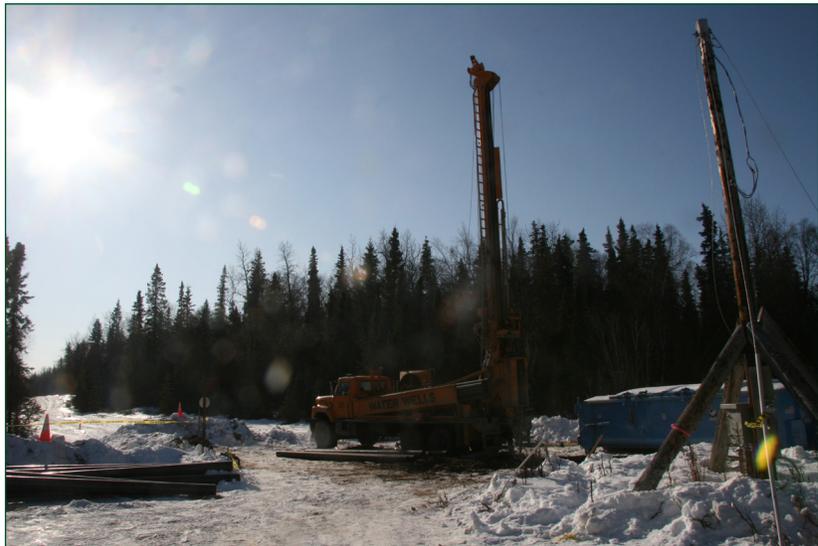
**View of the Nikiski Alaska Pipeline cathodic protection anode bed installation site**

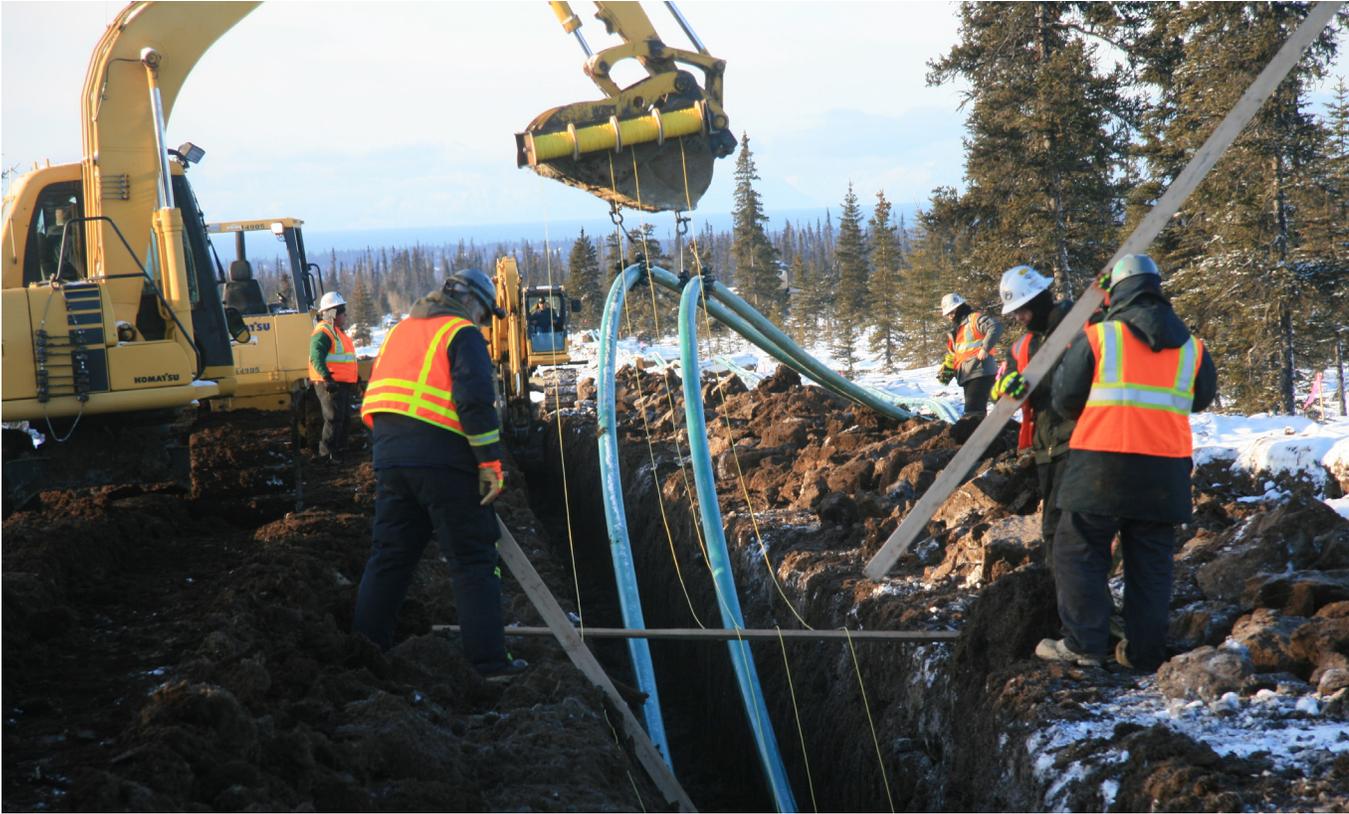
**North Fork Pipeline is the first common-carrier pipeline in Alaska to be constructed using composite pipe material. In the above photograph, the construction crew lowers the Fiberspar LinePipe into the excavated trench.**

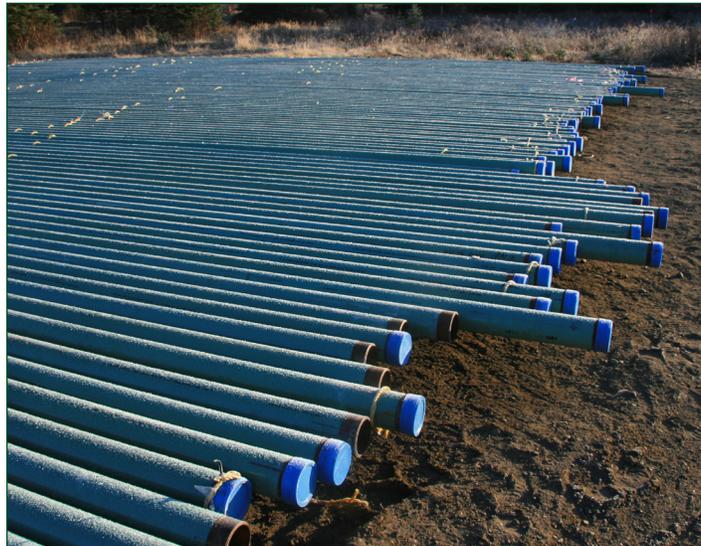
**Steel pipe staged at the construction site - segments with damaged coating were recoated before being used to construct North Fork Pipeline.**

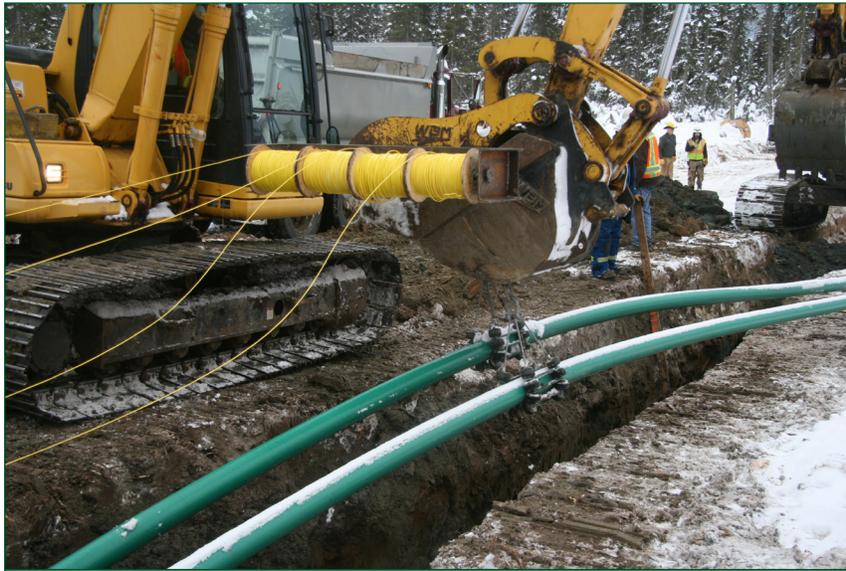
**Construction crews use an excavator and a special assembly to guide the Fiberspar LinePipe into the trench.**

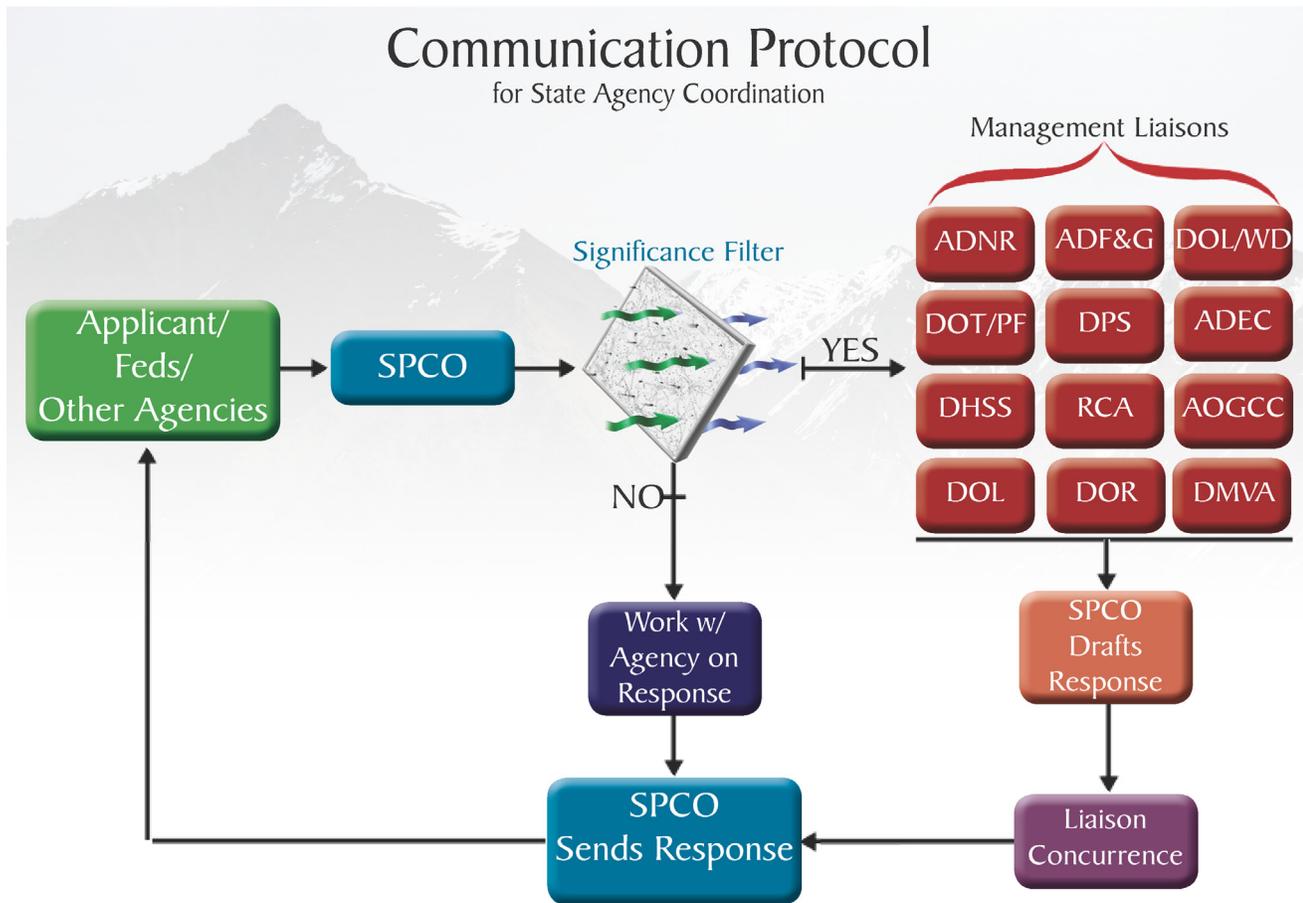
The above diagram represents the SPCO-managed flow of information between pipeline right-of-way applicants and State of Alaska agencies.
