2013

Annual ADNR Surveillance and Monitoring Report

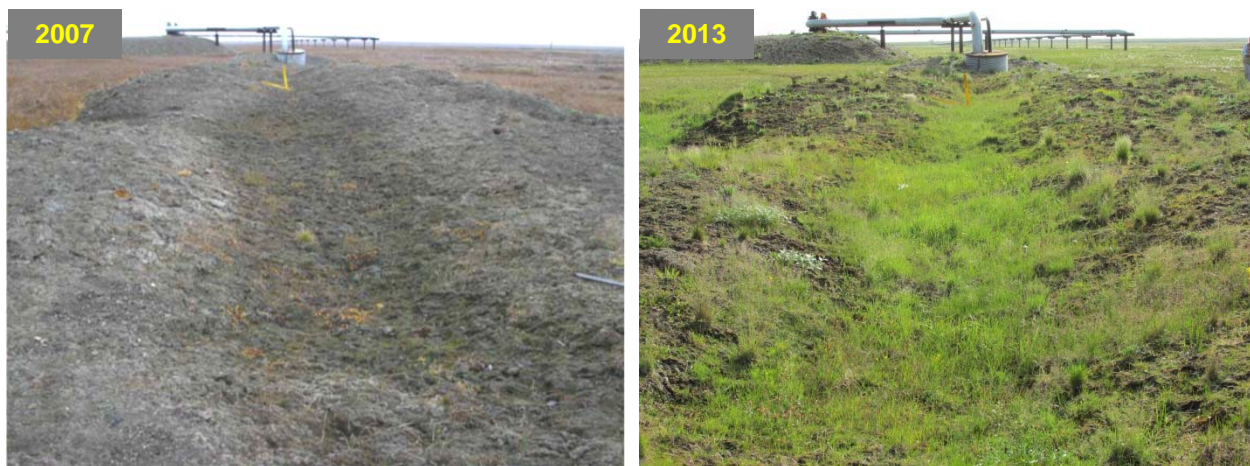
Figure 2. Views (facing east) of backfilled trench, Badami Pipeline East Shaviovik Crossing, 13 September 2007 and 3 August 2013.

ELEVATION MONITORING: The backfilled trench appeared mostly stable in 2013; the topography appeared similar to conditions in 2007 (Figures 2 and 3). Although wetland plant species such as *Carex aquatilis* (water sedge), *Eriophorum angustifolium* (tall cottongrass), and *E. scheuchzeri* (white cottongrass) were colonizing the central portion of the trench, no standing water or evidence of seasonal channels were observed. Similarly, no signs of erosion were noted on the face of the backfilled trench, where it meets the river bank (Figure 4).

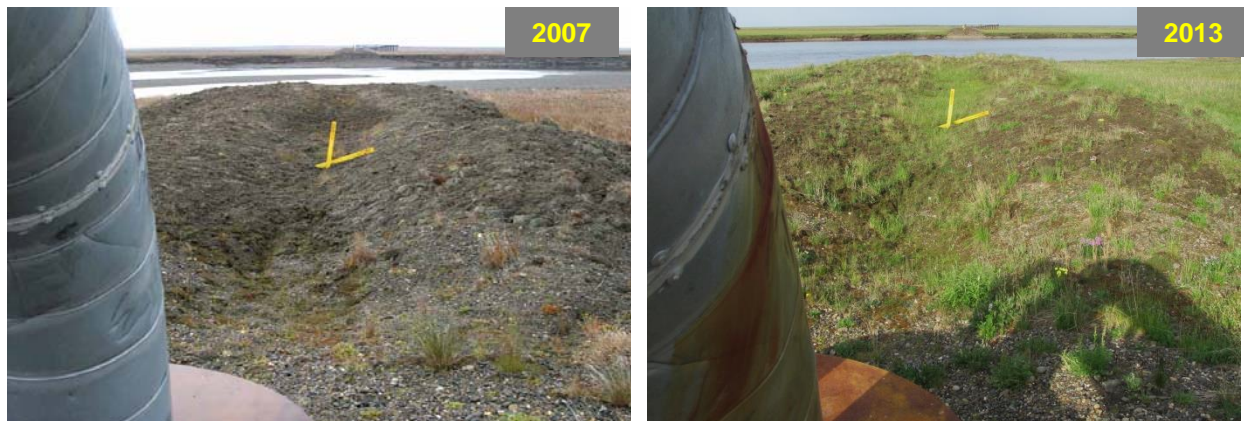
Figure 3. Views (facing west) of backfilled trench, Badami Pipeline East Shaviovik Crossing, 13 September 2007 and 3 August 2013.

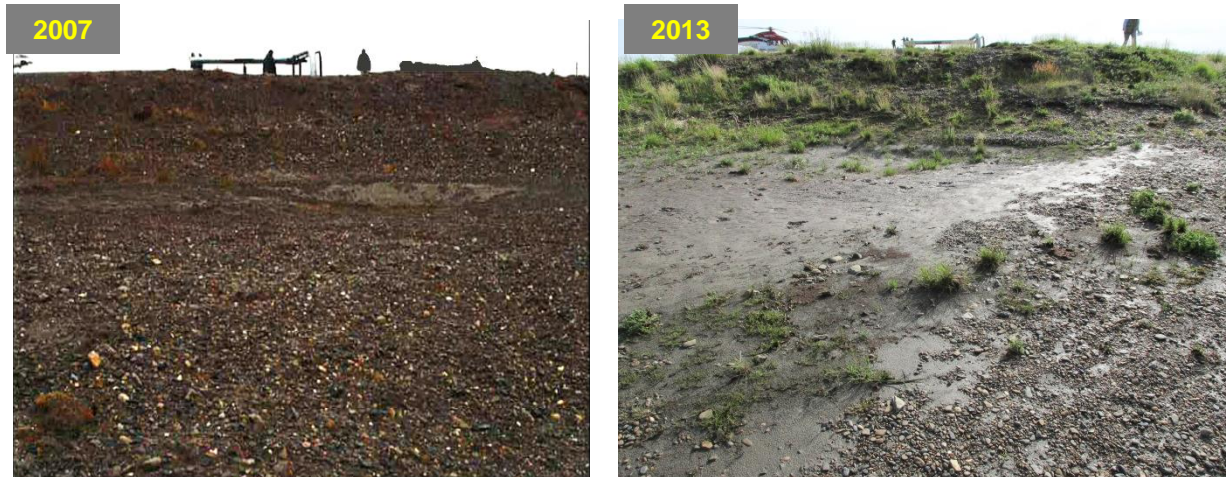
Figure 4. Views (facing east) of the face of the backfilled trench where it meets the river bank, Badami Pipeline East Shaviovik Crossing, 13 September 2007 and 3 August 2013.

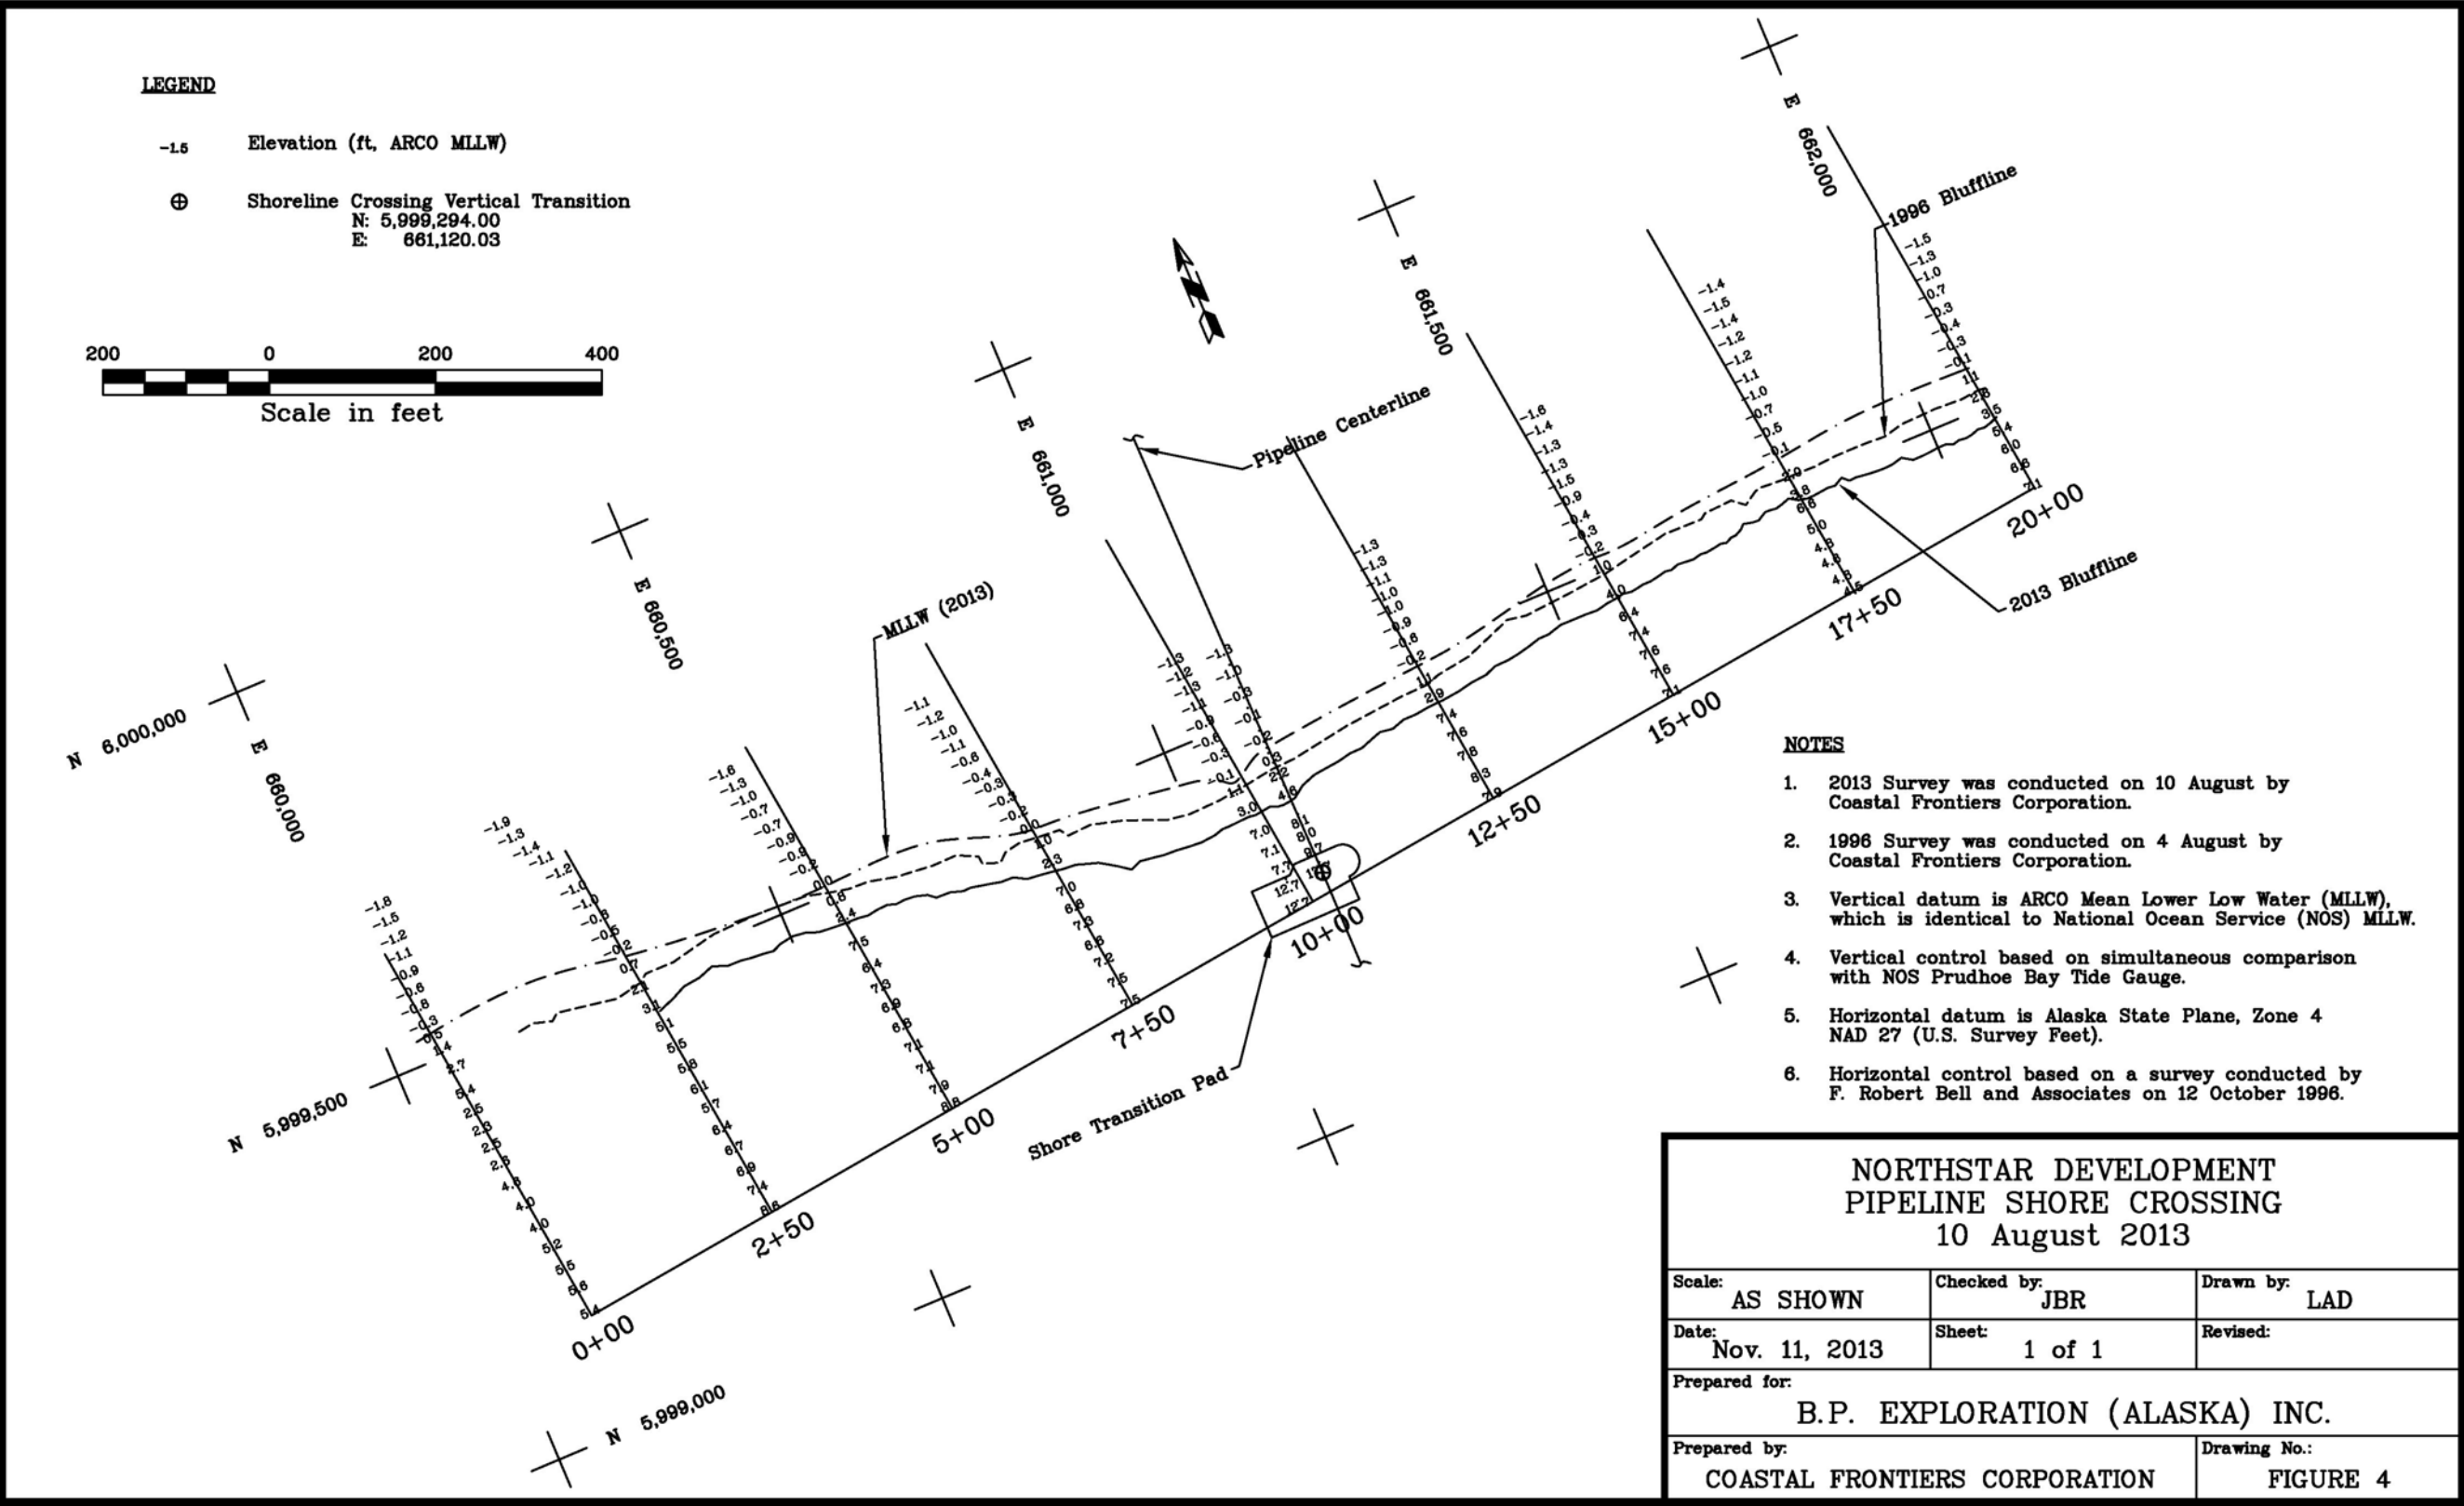
Figure 4. Northstar Shore Crossing Ground Survey Results, 10 August 2013

As shown in Figure 4, ten shore-perpendicular profiles are surveyed annually from the backshore to wading depth at alongshore intervals of 250 feet and atop the pipeline crossing. The positions of the 1996 and 2013 blufflines are plotted to note the coastal recession that has occurred since the initial survey. The Mean Lower Low Water (MLLW) shoreline at the time of the 2013 survey is also included in the figure. The 2,000 ft long monumented baseline can be re-surveyed at any time to determine changes in bluff position. Appendix A presents cross-sectional profiles of each of these ten transects as surveyed in August of 1996 and 2000 through 2013. These profiles display the low-lying coastal plain (El. +7 to +8 ft, MLLW), the 3 to 4 foot high eroding bluff, the narrow sand beach, and the gently sloping seabed to a water depth of 1 to 2 feet below MLLW. Due to physical interference with facilities on the shore pad, Station 10+00 was replaced after construction was completed in August 2000 with two others: Station 9+85 (15 feet west of Station 10+00) and the pipeline centerline (Station 10+25, approx.).

For each survey, the bluff positions can be directly compared, as is clearly noted on the plotted profiles in Appendix A. No bluff erosion rates are available at the westernmost survey transects (Stations 0+00 and 2+50) due to the lack of a discernable bluff edge. In addition to the surveyed profiles, the field survey efforts of 1996 through 2013 precisely located the continuous bluff edge along the 2,000-ft wide study reach.

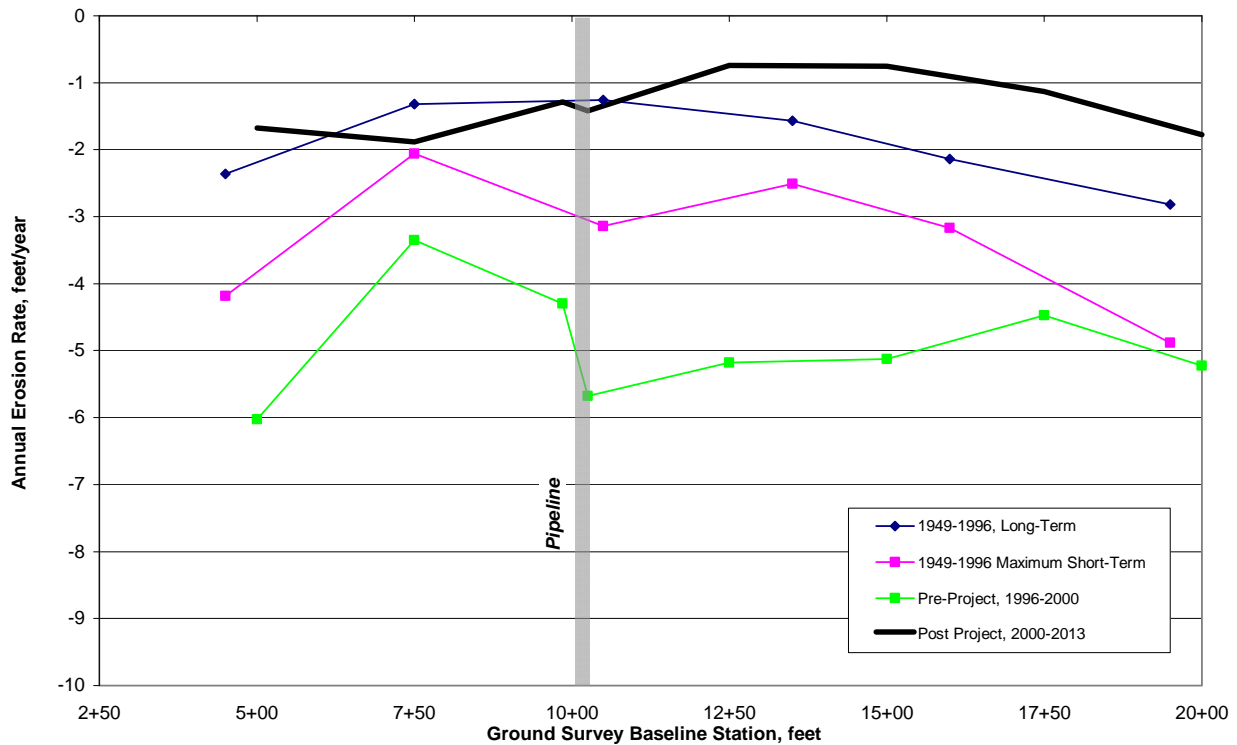
Figure 6. Short- and Long-Term Bluff Erosion Rate Comparison

Figure 6 compares the long-term and maximum short-term erosion rates determined during the 1949-1996 period generated from aerial photo analysis with the results of the more recent ground survey tasks. Average annual bluff erosion rates based on the ground survey results are shown for the Pre-Project (1996-2000) and the Post-Project (2000-2013) periods. Surveyed bluff erosion rates for the 1996 - 2000 period were greater than the long-term averages determined by air photo comparisons that date back to 1949. As the bluff change data is extended to show the conditions of the 2000 - 2013 period ("Post-Project"), the area-wide erosion rate decreased to 1.3 ft/year; 50% less than the long-term average bluff recession rate of 2.6 ft/year determined from the 1949 - 1996 air photo analysis.

The average annual bluff erosion rate at the pipeline shore crossing (Station 10+25) for the 2000-2013 period is 1.4 ft/year, or 25% of the average rate of 5.7 ft/year for the 1996-2000 ("Pre-Project") period.

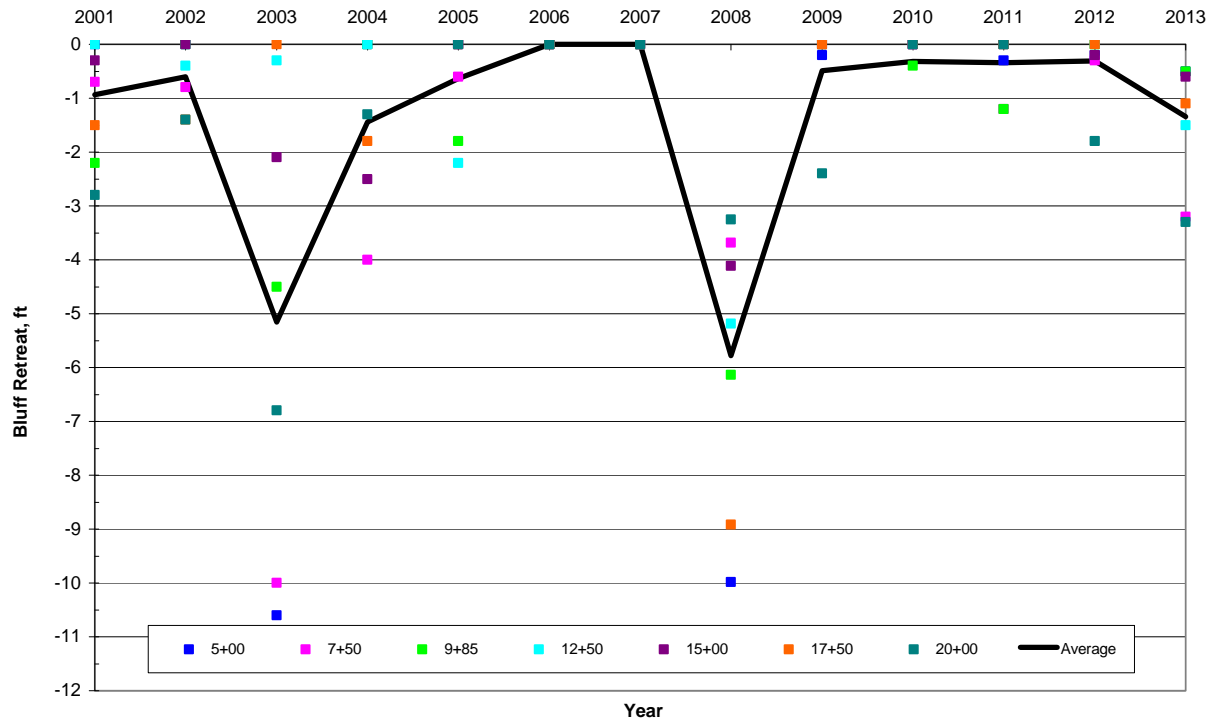
Figure 7. Annual Variability of Bluff Recession Rates

Figure 7 shows the variability of bluff recession rates at each surveyed transect based on the annual survey results. For 11 of the 13 years since the pipelines were installed, bluff changes were modest (less than 3 ft/year). However, in 2003 and 2008, the average rates of erosion over the study region were 5.2 and 5.8 ft/year, respectively. The erosion rates vary significantly for these transect locations during both of these years, suggesting a non-uniform retreat rate along the coast. Maximum rates of retreat have been as high as 9 to 10 ft/year at certain locations (Stations 5+00, 7+50, 17+50). The results of the 2013 survey reveal a slight increase of the average erosion rate compared to the four most recent surveys (2009-2012); however this value is less than 25% of the highest rates of recession noted in 2003 and 2008.

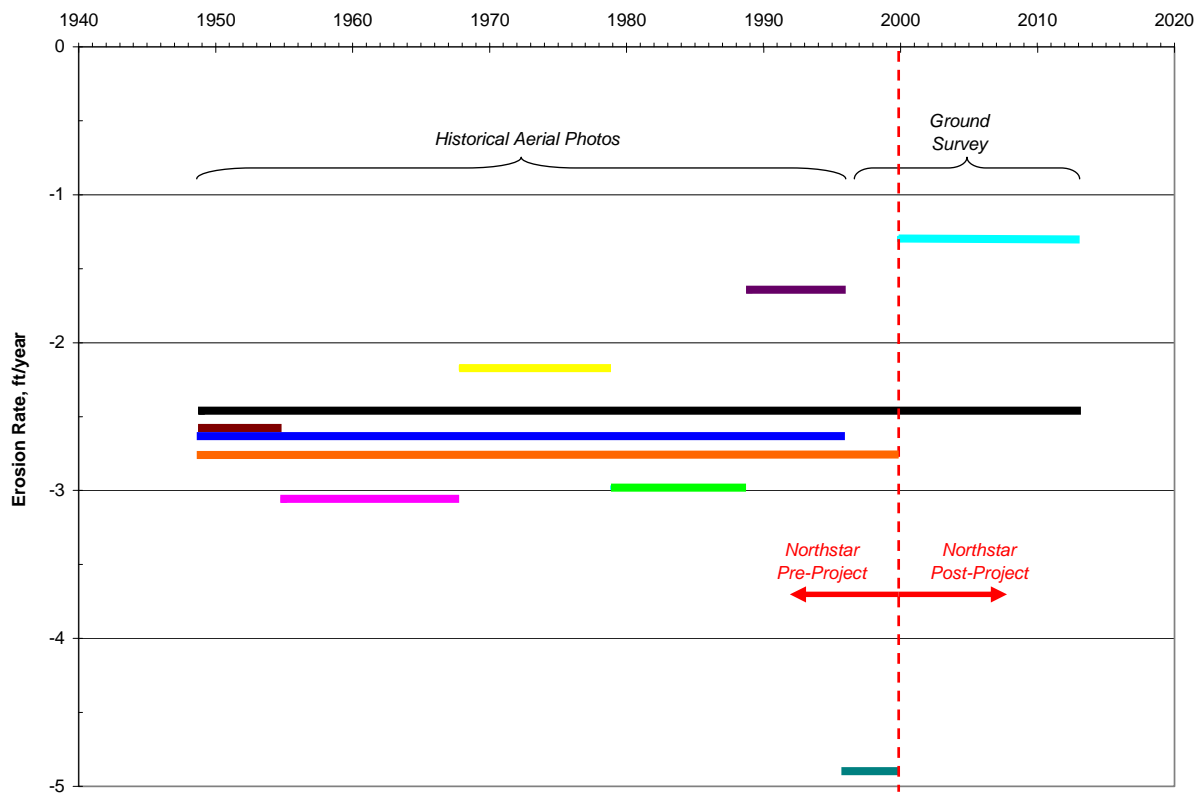
Figure 8. Bluff Erosion Timeline, 1949 – 2013

In Figure 8, a timeline of bluff erosion rates is shown for the various periods of comparison (both short- and long-term) for the periods of air photo comparison (1949 – 1996) and ground surveys (1996 – 2013). In addition, the pre- and post-project time frames are shown. The greatest erosion rate over the study area is 4.9 ft/year for the 1996-2000 period. The mildest period for bluff erosion occurred following the installation of the Northstar pipelines (2000-2013) when a rate of 1.3 ft/year was noted. For the pre-project period (1949-2000), the erosion rate was 2.8 ft/year. For the entire study period spanning 1949-2013, the erosion rate is 2.5 ft/year.

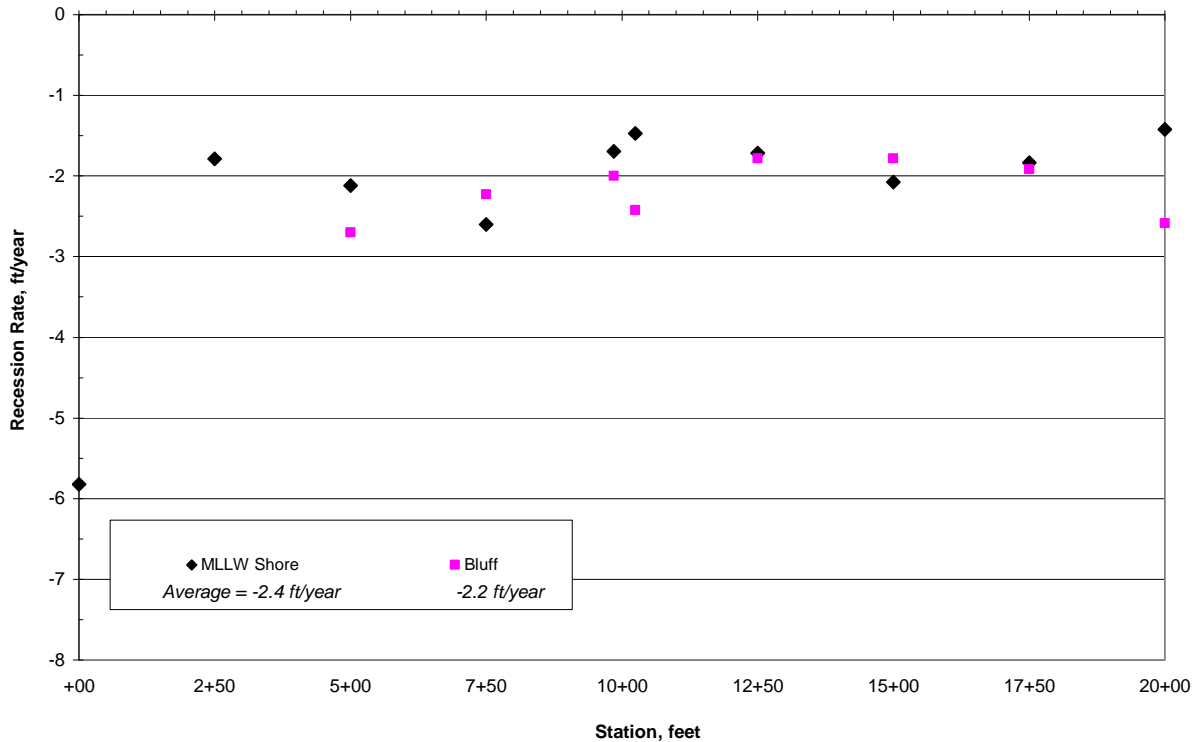
Figure 10. Comparison of Average Rates of Shore and Bluff Recession, 1996 - 2013

Figure 10 presents this information graphically, and shows the range of recession rates of both the shoreline and the bluff to vary between 1 and 3 ft/year over most of the study range. The only transect that has shown substantially greater erosion than the average range is at the far west end of the study area (Station 0+00) where no bluff exists and long-term shore erosion of 5.8 ft/year has occurred.

Along many of the surveyed transects, the erosion rates of the shore and the bluff are comparable. However, the bluff erosion rate is about 61% greater than the shore erosion rate at the shore crossing (Station 10+25) due to the greater susceptibility of the pipeline backfill to erode relative to the adjacent native tundra.

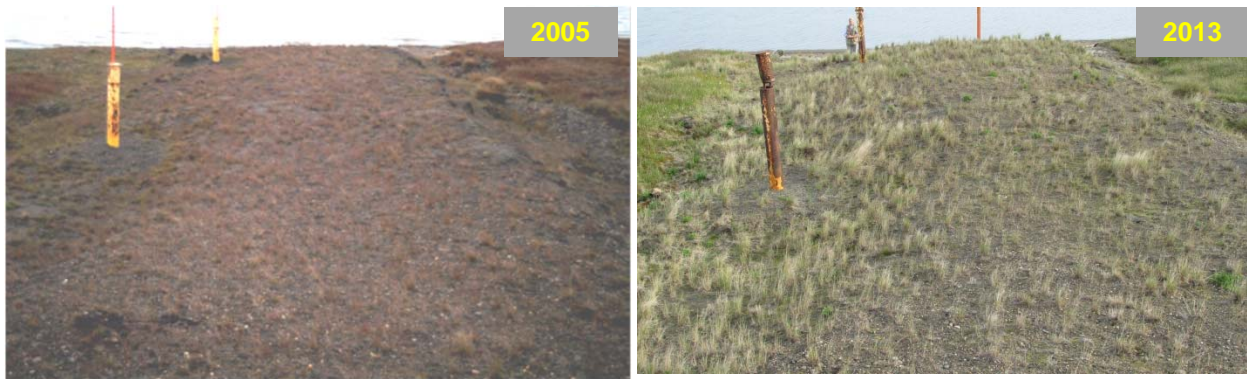
SITE DESCRIPTION: Vegetation on the surface of the backfilled trench was moderate and dominated by the seeded *P. borealis* (Figure 2), although several forbs and other grasses also have established. On the remnant gravel area, vegetation has developed sufficiently that it appears similar to the surrounding tundra (Figure 3). The seaward side slope of the backfilled trench only has sparse cover of *P. borealis*. The surrounding vegetation is dominated by Moist Sedge Meadow Tundra.

Figure 2. Views (north) of the backfilled trench in 15 September 2005 and 3 August 2013, Northstar Pipeline Landfall Shore Crossing.

PLANT MONITORING: The success of the rehabilitation treatments applied at the Northstar Pipeline Landfall Shore Crossing was qualitatively assessed on 3 August 2013. A moderate cover of vascular plants has established on the backfilled trench (Figure 2). The dominant species was the seeded grass *P. borealis*, although we identified 12 additional indigenous vascular species, including grasses, forbs, and shrubs (Table 2). Only trace cover of vegetation, consisting exclusively of *P. borealis*, was found growing through the mesh fabric on the seaward side slope of the backfilled trench (Figure 4). Vegetation recovery on the remnant gravel area has progressed to the point where the plant community appears similar to the surrounding tundra (Figure 3); 11 indigenous species were recorded in this area (Table 2).

ELEVATION MONITORING: The backfilled trench and the remnant gravel area appeared mostly stable in 2013 (Figures 2 and 3). The seaward side slope of the backfilled trench where erosion control fabric was installed appeared stable and similar to conditions in 2012 (Figure 4). An erosion gully has formed beneath the fabric at the west end (Figure 5), probably due to snow melt running off the backfilled trench or summer rainfall. The backfilled trench behind it, however, appears to be unaffected. It is possible this gully will enlarge over time, in which case the side slope will require further treatment.

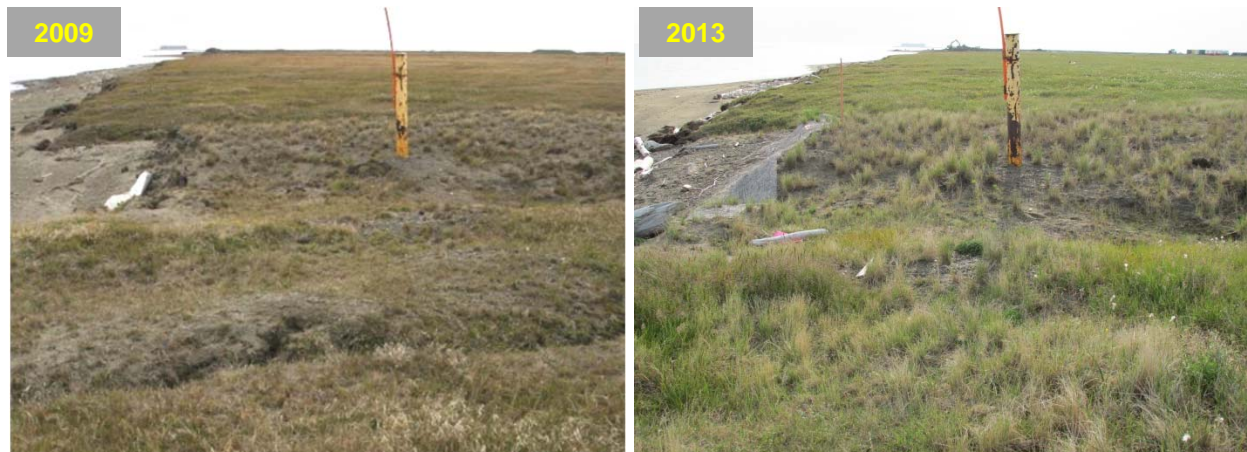
Figure 3. Views (east) of the remnant gravel area (foreground) and the backfilled trench (background) 10 July 2009 and 3 August 2013, Northstar Pipeline Landfall Shore Crossing.

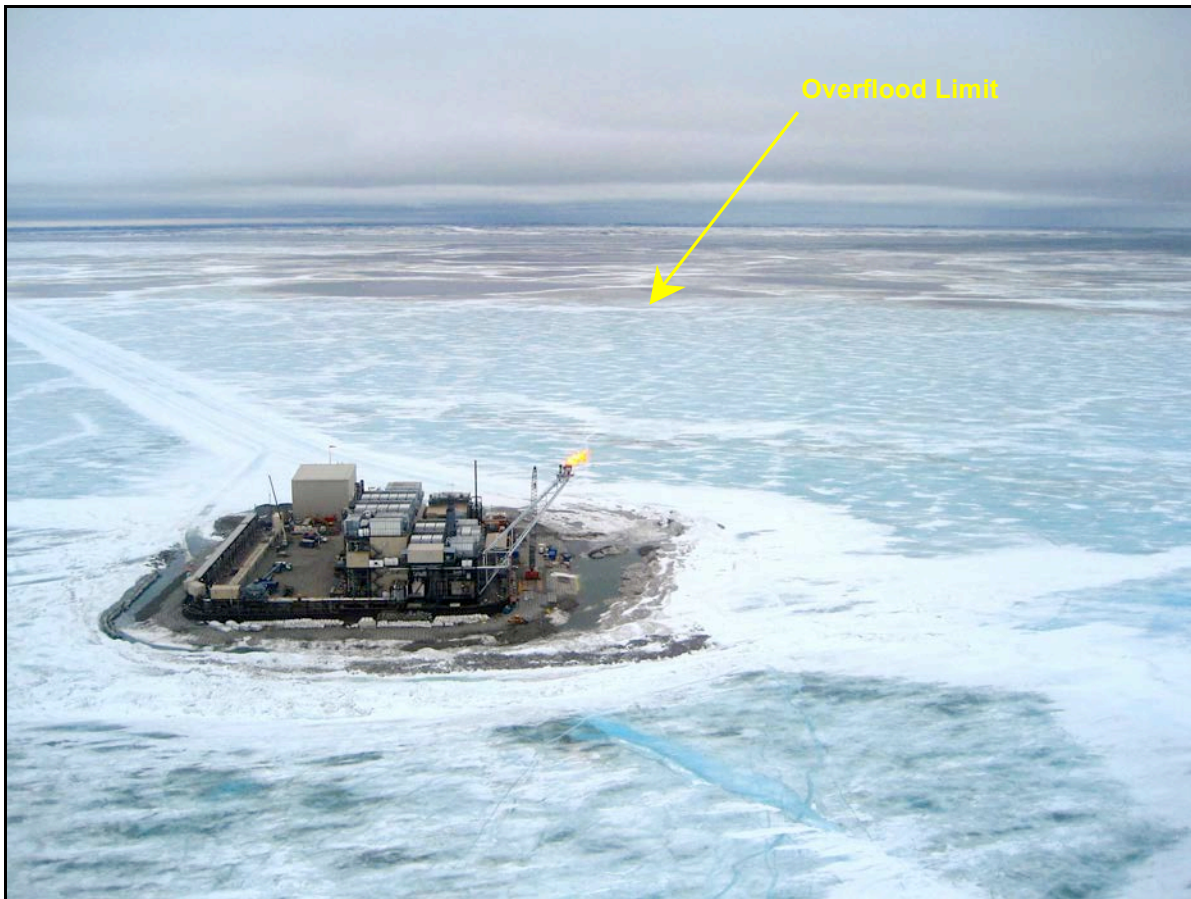
Plate 1. Kuparuk River Overflood (June 5, 2013)

The 2013 Kuparuk River overflow, although vigorous by historical standards, nevertheless remained within the footprint established by previous flood boundaries (Figure 10). As shown in Drawing CFC-815-03-002, the flood water was partially contained by Stump and Long Islands, but extended well offshore on the Northstar pipeline route. The seaward edge was located approximately 16,100 ft north of Stump Island and only 5,600 ft south of Northstar Production Island (Plate 1).

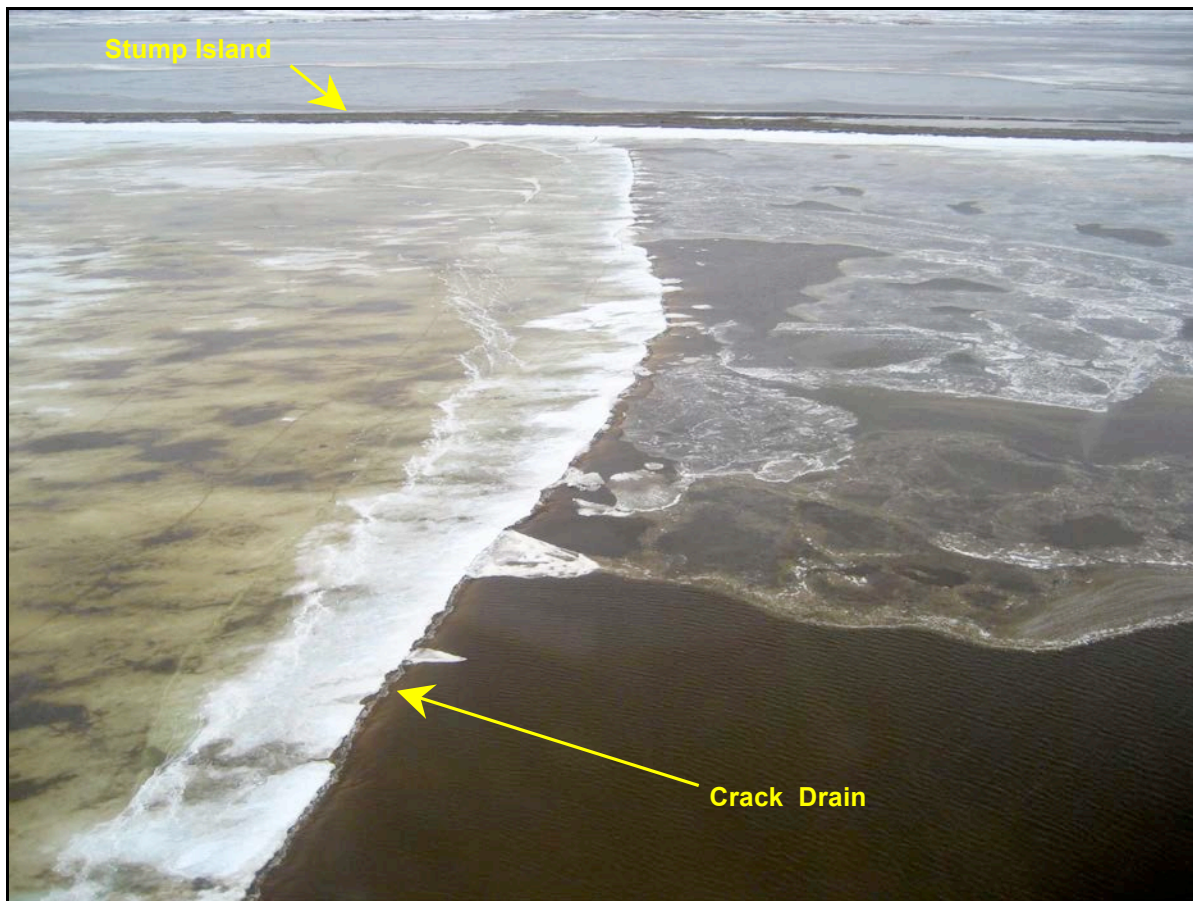
Plate 2. Linear Crack Drain off Stump Island (June 5, 2013)

Fifty two of the 67 drainage features were circular or oblong in plan form. The remaining 15 features were linear crack drains with lengths exceeding 50 ft (Plate 2). Fifteen drains were located within 300 ft of the pipeline alignment, while 25 were farther to the west and 27 farther to the east (Drawing CFC-815-03-002).

sites (primarily along the crack drains), and six at locations where drainage features were not evident during the June reconnaissance flight. It is likely that the drains at these sites were obscured by meltwater at the time of the flight (Plate 2).

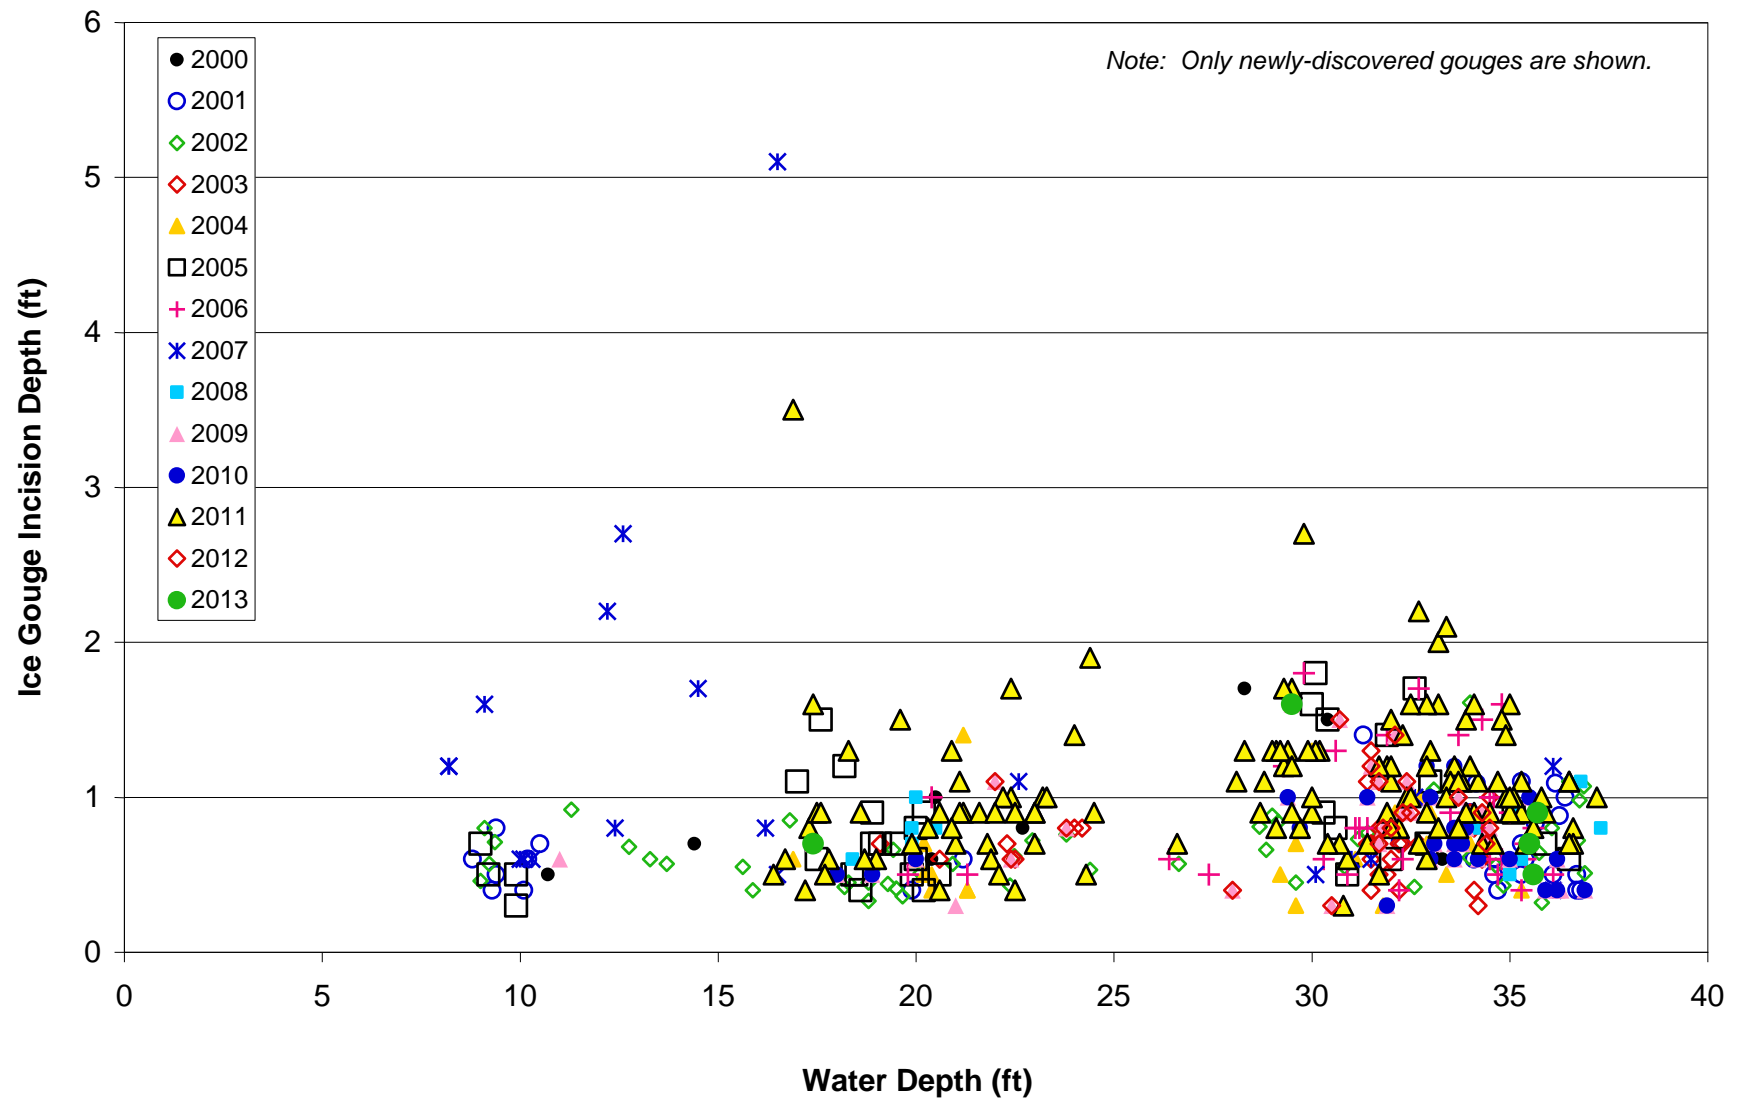
Figure 6. Ice Gouge Incision Depth vs. Water Depth

The incision depths and incision widths of the newly-discovered gouges are plotted against water depth in Figures 6 and 7, respectively. The figures also include comparable data for all of the new gouges discovered during each of the thirteen prior annual survey programs (2000-2012). The following conclusions are suggested by a comparison of the gouge data from 2013 with those from the prior surveys:

1. The number of gouges was extremely low by historical standards, with five newly-discovered gouges in 2013 versus an annual average of 30.3 during the fourteen-year period of record. The historical maximum, 130 gouges, occurred in 2011 while the minimum, 4 gouges, occurred in 2009.
2. The severity of the gouging was consistent with historical precedent. Specifically, the mean incision depth of 0.9 ft and mean ridge height of 0.3 ft were identical to the long-term average values recorded on the Northstar pipeline route from 2000 through 2013. The mean incision width of 16 ft and mean water depth of 30.7 ft were somewhat larger than the long-term averages, but the minimum and maximum values of all four parameters were contained within the envelopes established in prior years (Figures 6 and 7).

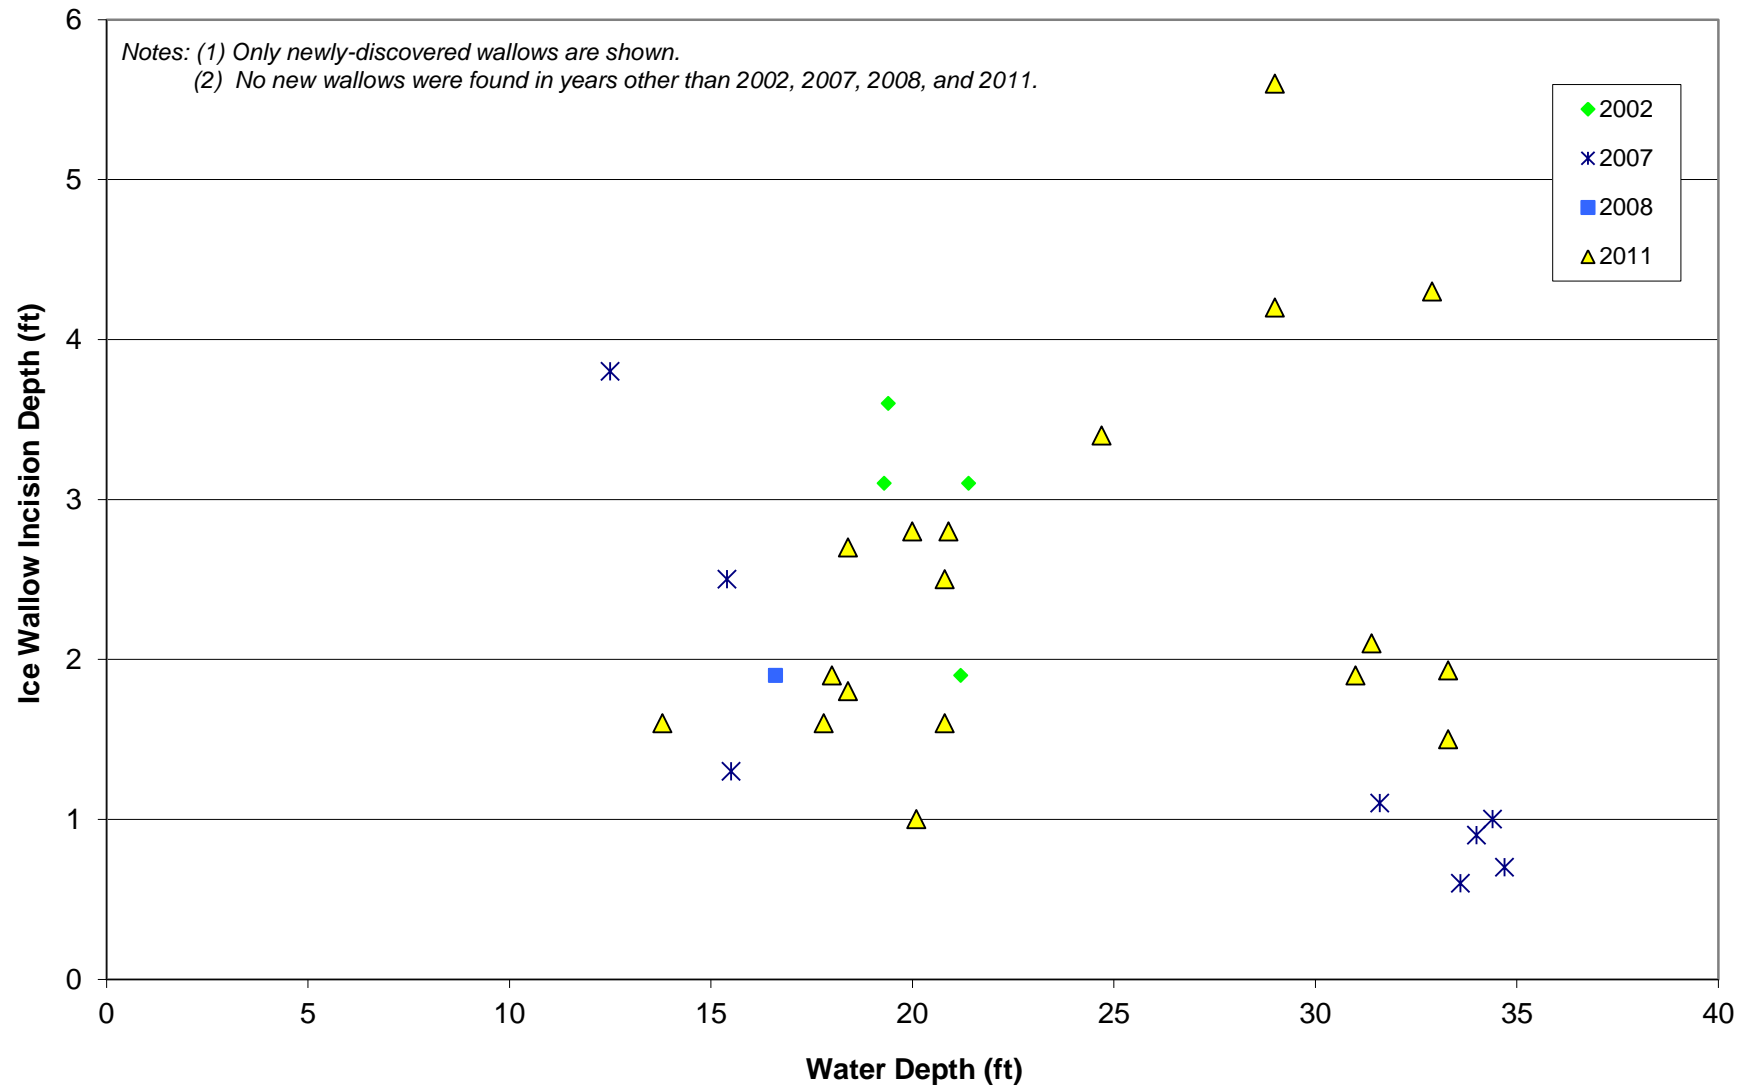
Figure 8. Ice Wallow Incision Depth vs. Water Depth

No new wallows were identified during the 2013 survey, but two of the 18 wallows first discovered in 2011 were found again. Table 7 summarizes the characteristics of all newly-discovered wallows for each of the fourteen years in which monitoring of the pipeline route has been conducted (2000-13). The incision depths and incision widths of these features are plotted against water depth in Figures 8 and 9, respectively.

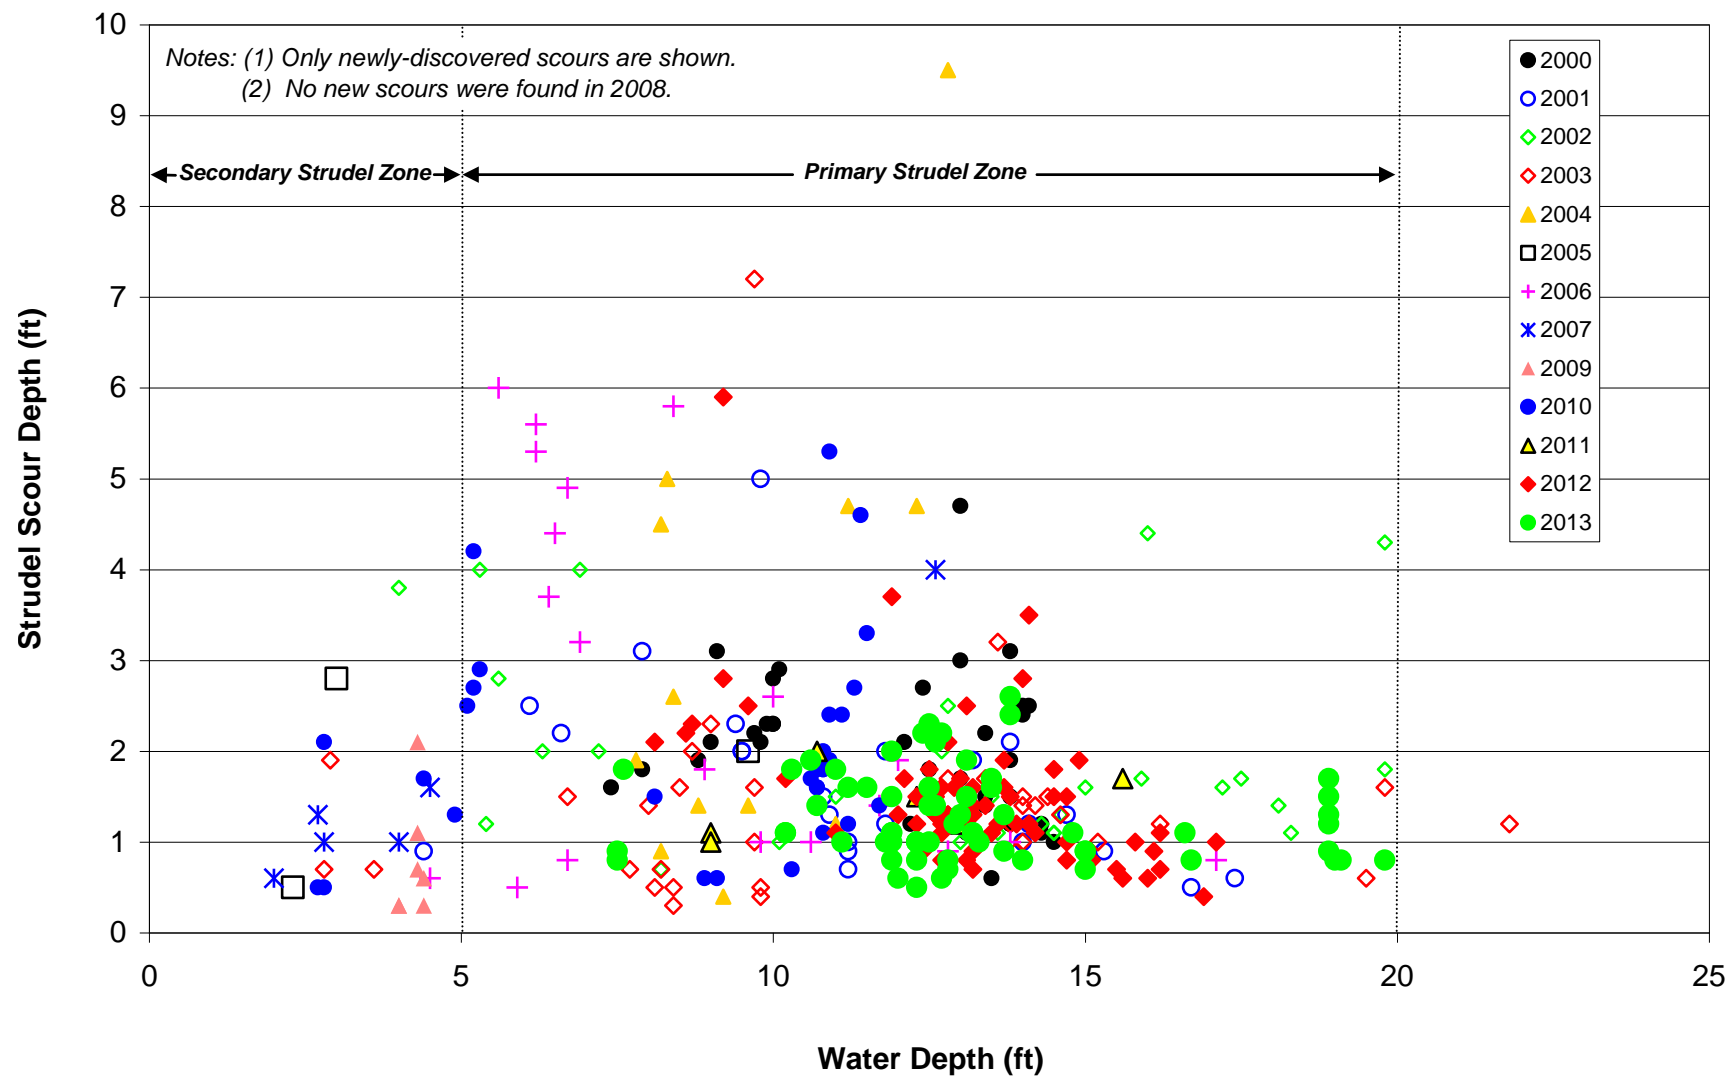
Figure 11. Strudel Scour Depth vs. Water Depth for Circular Scours

Scatter plots of scour depth versus water depth, scour maximum horizontal dimension versus water depth, and scour maximum horizontal dimension versus scour depth are presented for the 63 newly-discovered scours in Figures 11, 12, and 13. The figures also display the data acquired for all newly-discovered circular scours in the 5,000-ft monitoring corridor from 2000 through 2012. Because of their distinctly different nature, linear scours have been excluded.
