2013

Annual ADNR Surveillance and Monitoring Report

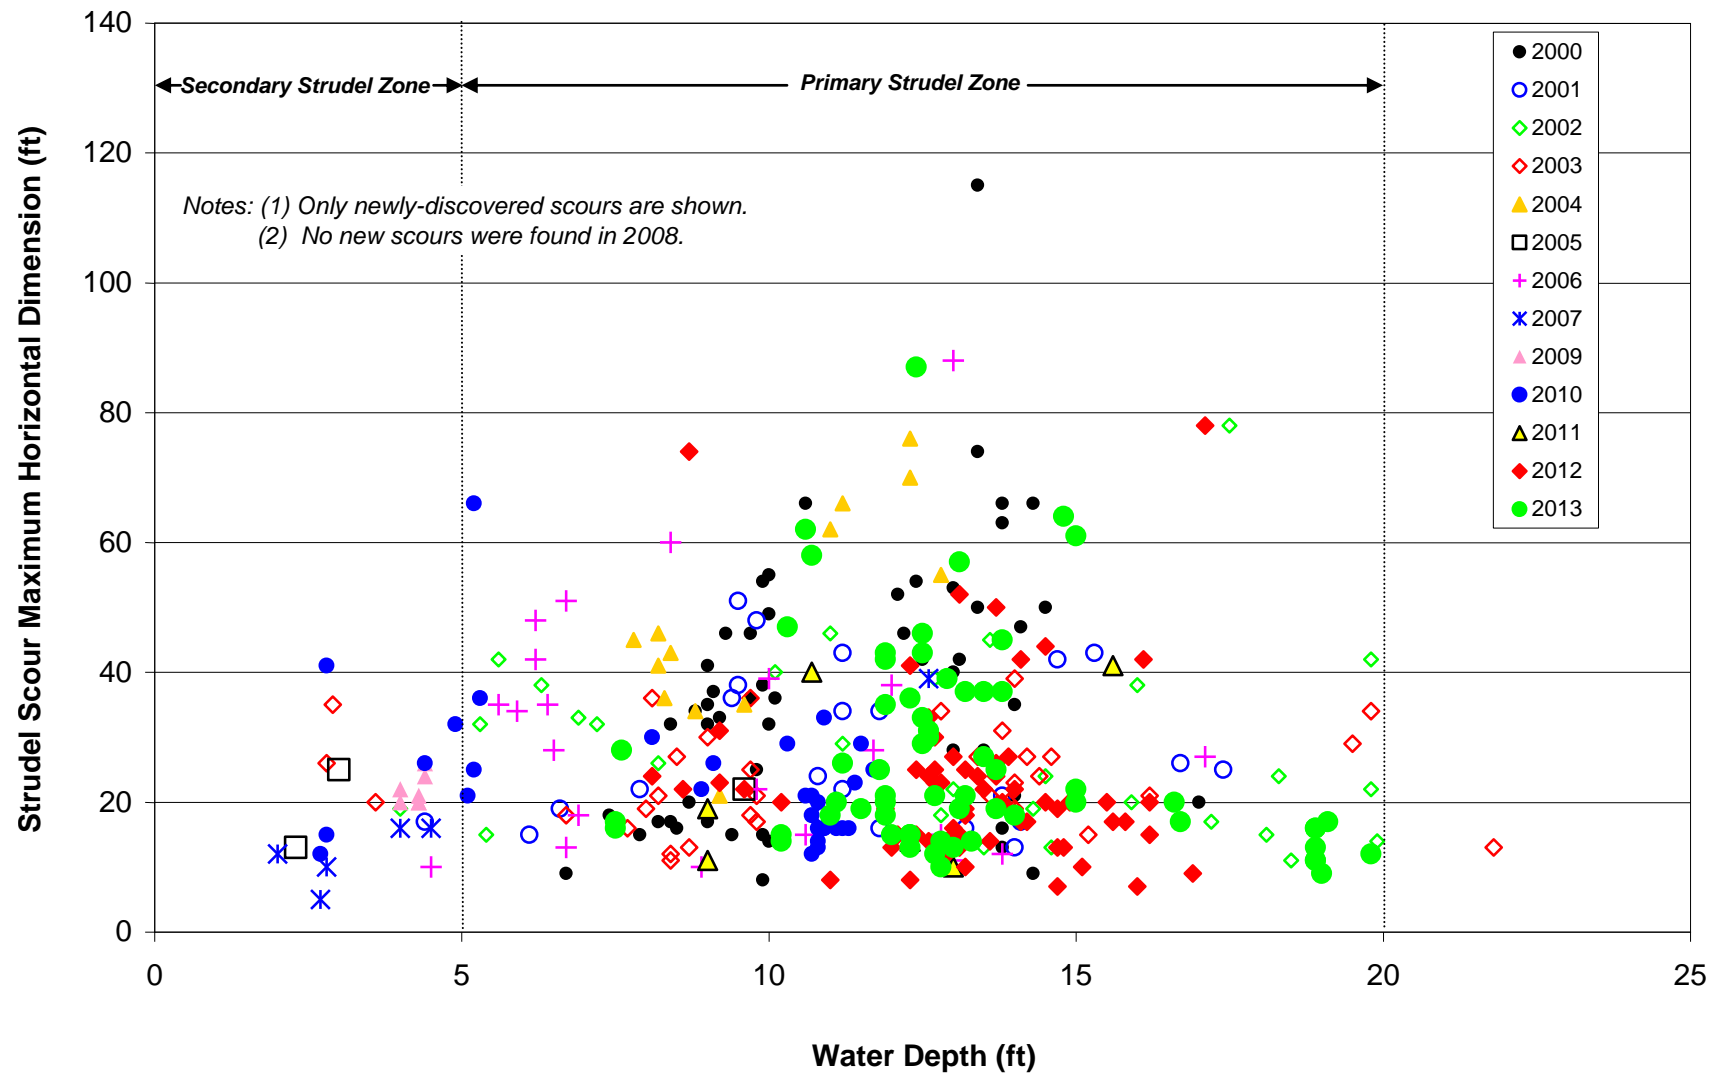
Figure 12. Strudel Scour Maximum Horizontal Dimension vs. Water Depth for Circular Scours

Scatter plots of scour depth versus water depth, scour maximum horizontal dimension versus water depth, and scour maximum horizontal dimension versus scour depth are presented for the 63 newly-discovered scours in Figures 11, 12, and 13. The figures also display the data acquired for all newly-discovered circular scours in the 5,000-ft monitoring corridor from 2000 through 2012. Because of their distinctly different nature, linear scours have been excluded.

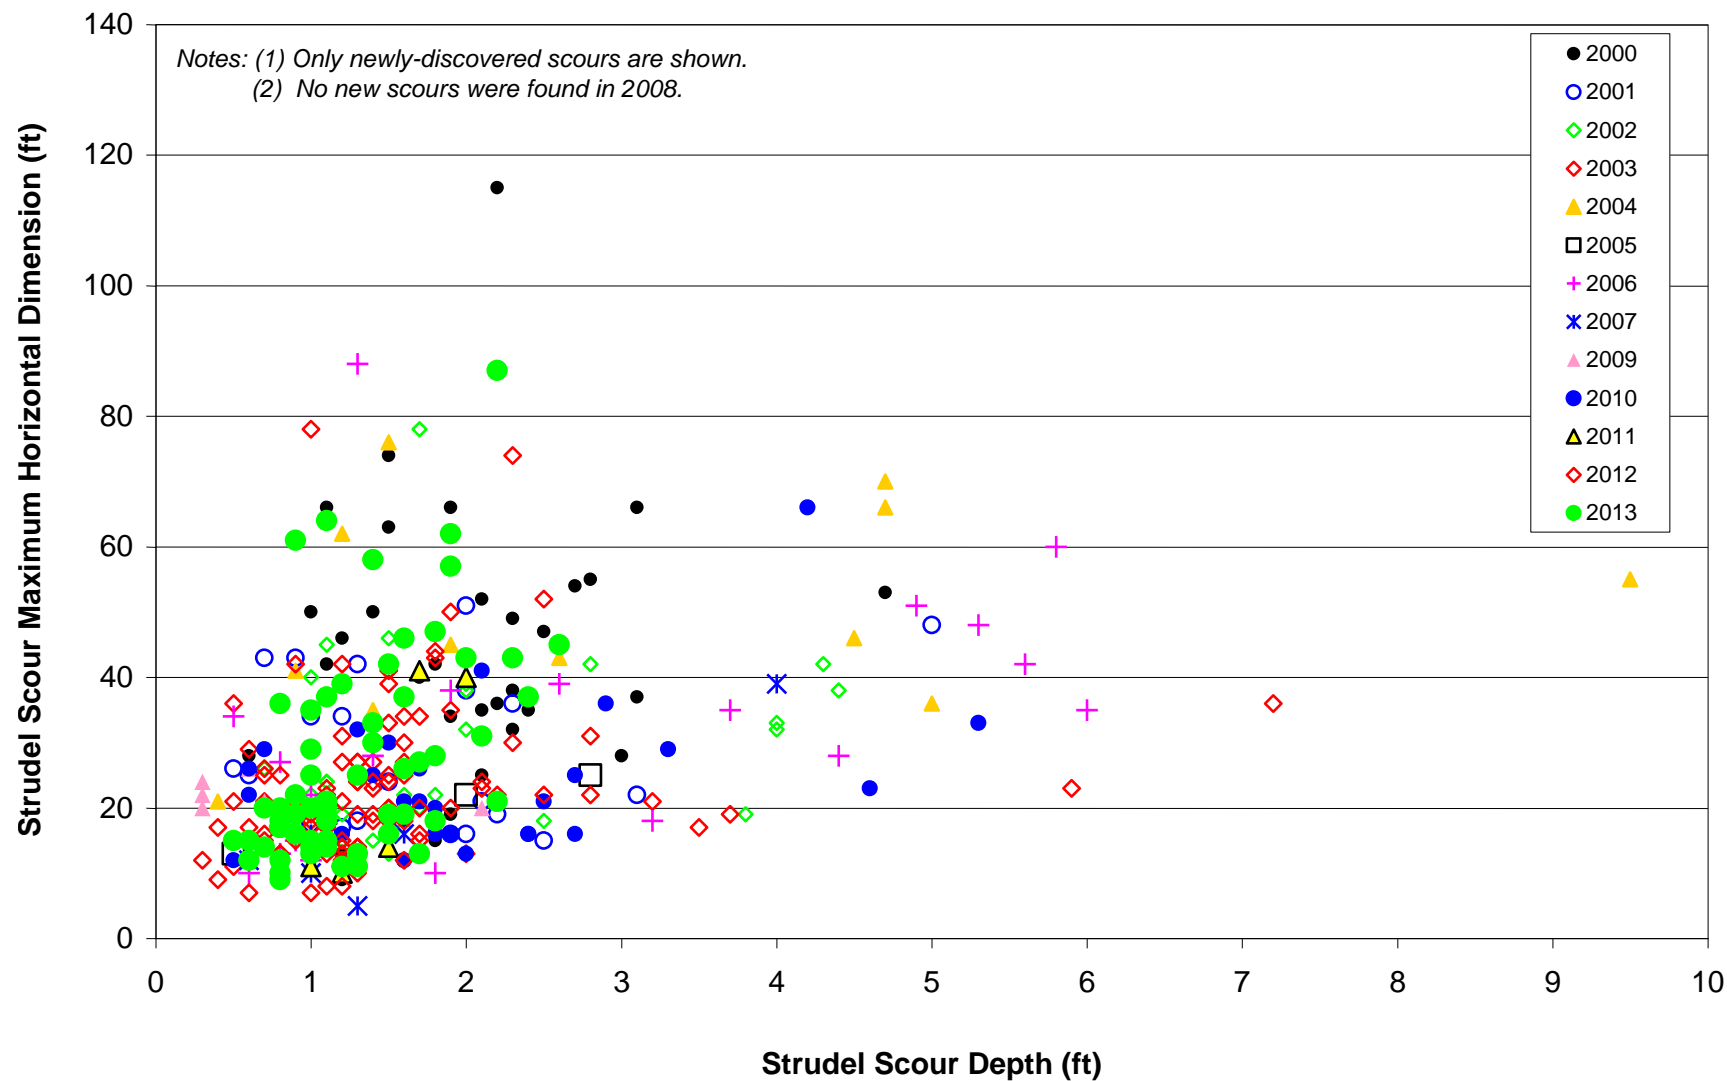
Figure 13. Strudel Scour Maximum Horizontal Dimension vs. Strudel Scour Depth for Circular Scours

Figure 13 suggests that strudel scour maximum horizontal dimensions tend to increase with scour depth. The data exhibit substantial scatter, however, with a correlation coefficient (R^2) of only 0.13 (essentially unchanged since 2011).

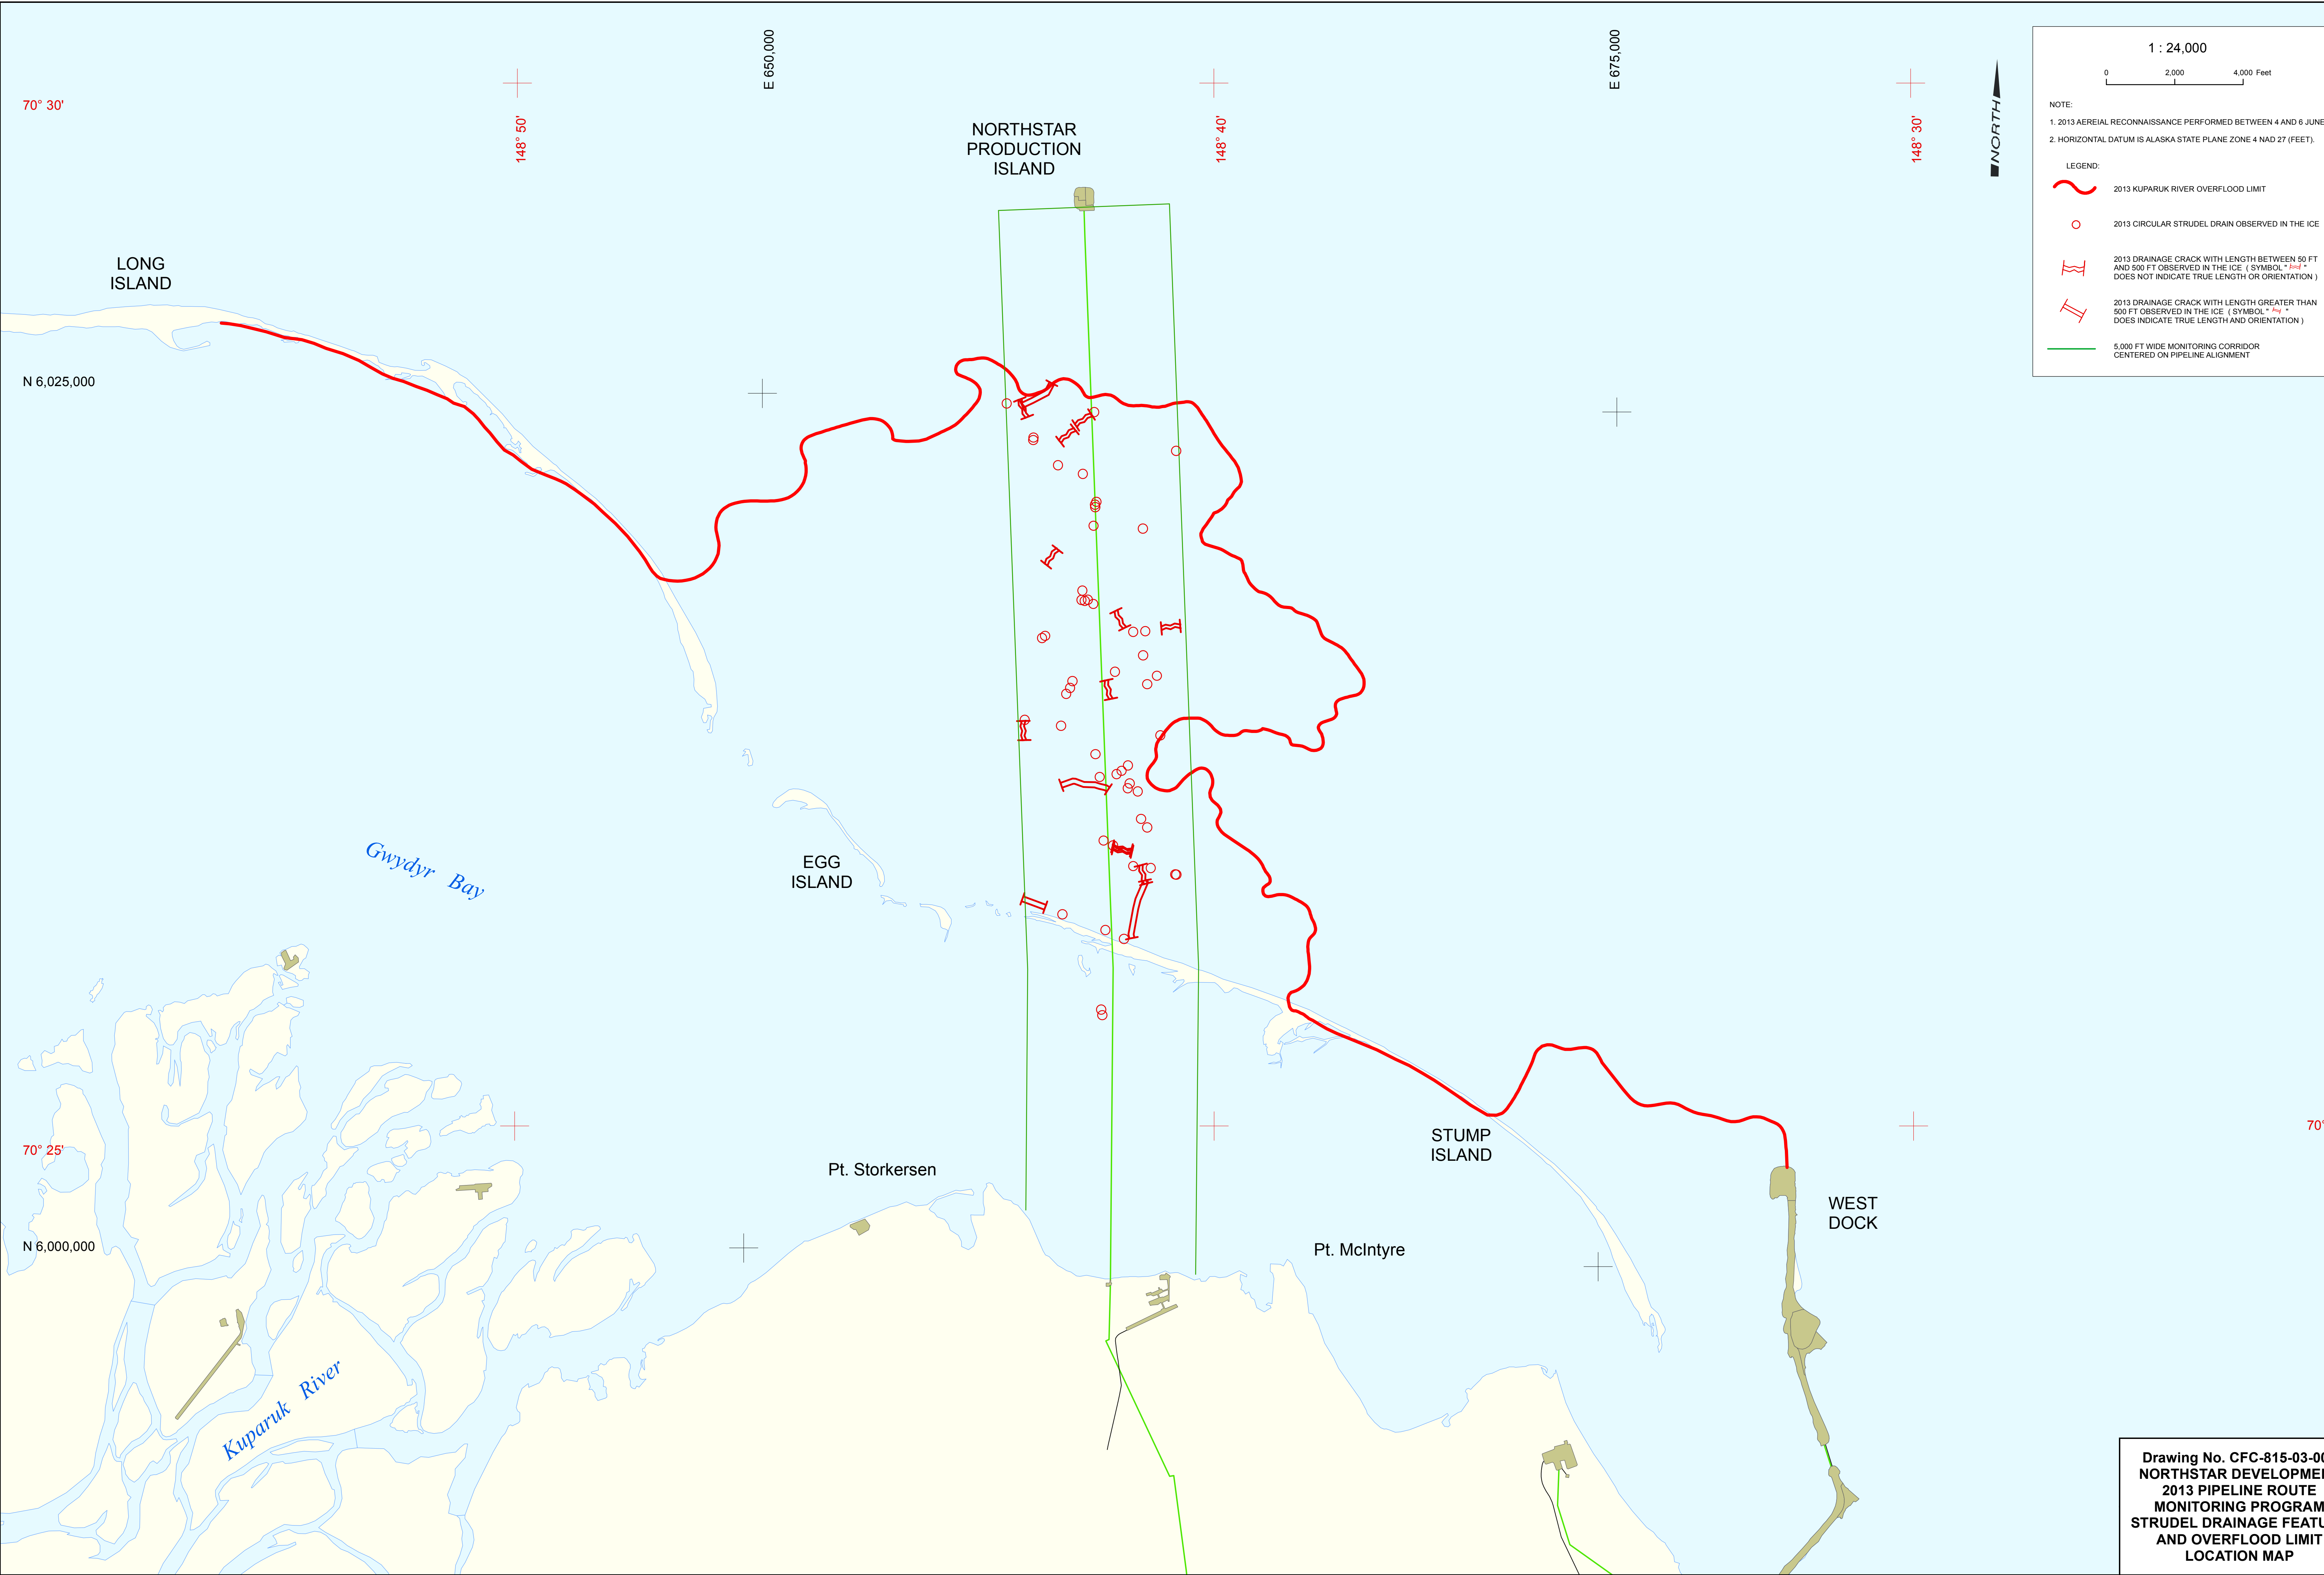
Drawing No. CFC-815-03-002
NORTHSTAR DEVELOPMENT
2013 PIPELINE ROUTE
MONITORING PROGRAM
STRUDEL DRAINAGE FEATURE
AND OVERFLOOD LIMIT
LOCATION MAP

The 2013 Kuparuk River overflow, although vigorous by historical standards, nevertheless remained within the footprint established by previous flood boundaries (Figure 10). As shown in Drawing CFC-815-03-002, the flood water was partially contained by Stump and Long Islands, but extended well offshore on the Northstar pipeline route. The seaward edge was located approximately 16,100 ft north of Stump Island and only 5,600 ft south of Northstar Production Island (Plate 1).

Fifty two of the 67 drainage features were circular or oblong in plan form. The remaining 15 features were linear crack drains with lengths exceeding 50 ft (Plate 2). Fifteen drains were located within 300 ft of the pipeline alignment, while 25 were farther to the west and 27 farther to the east (Drawing CFC-815-03-002).
