**RE: Annual Report for Right-of-Way Lease - ADL 69354**

Tesoro Alaska Pipeline Company  
2013 Annual Comprehensive Report of Pipeline Activities  
and  
State of the Pipeline System  
Nikiski ROW Lease ADL #69354

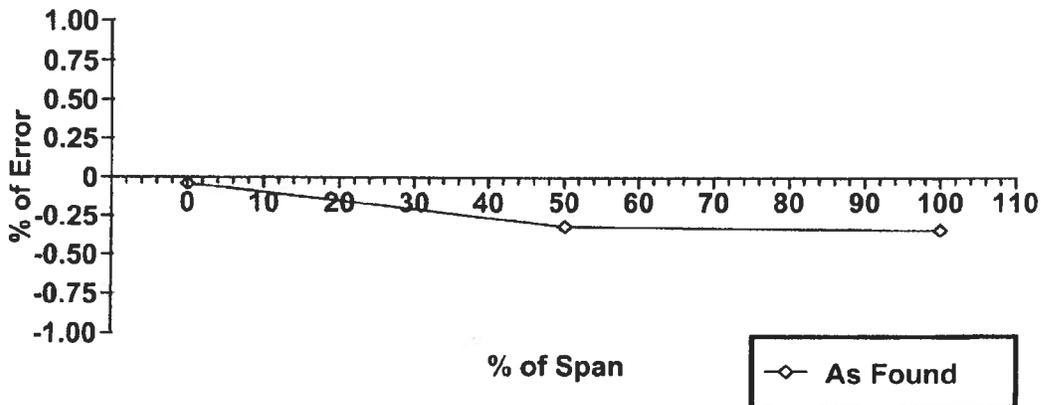
Device Identification	
AMS Tag:	PT-20033
Device Tag:	PT-20033
Manufacturer:	Rosemount
Model Name:	3051
Device Identifier:	1973423

Device Calibration Data			
Date/Time Calibrated:	7/22/2013 2:12:52 PM	Max Error Limit:	0.50 % of Span
Technician:	pokryfge	Notification Limit:	0.60 % of Span
User:	pokryfge	Adjustment Limit:	0.40 % of Span
Ambient Temperature:	(N/A)	Calibration Interval:	1 Years
Temperature Standard:	IPTS-68	Critical Service:	No
Work Order Number:		Input Range:	0.00 - 2000.00 psi
Service Reason:	Routine	Output Range:	4.00 - 20.00 mA
Service Notes:			
Relationship:	Linear

Errors (%)			
Error	Limit	Actual: As Found	Actual: As Left
Maximum	0.5000	-0.3388 (Pass)	(N/A)
Zero	(N/A)	(N/A)	(N/A)

Calibration Results: As Found				
Test Point	Input	Output	Output Error	Output Error (%)
1	1.2000	4.0030	-0.0066	-0.0413
2	1003.1000	11.9740	-0.0508	-0.3175
3	1999.9000	19.9450	-0.0542	-0.3388

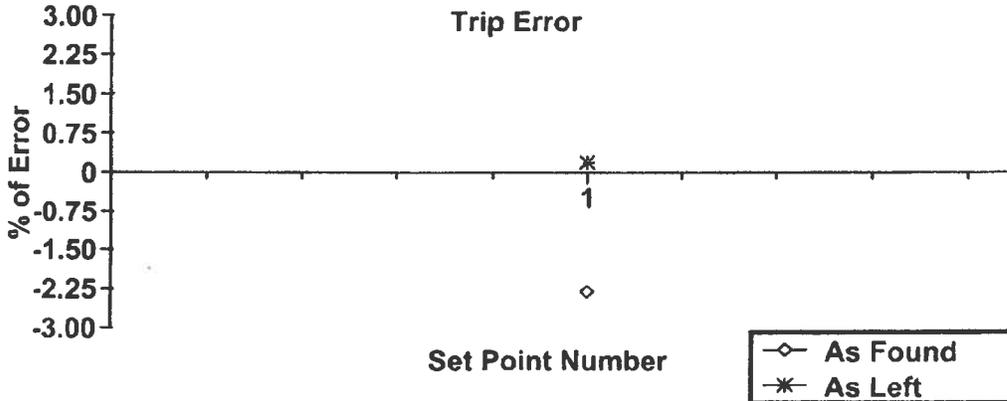
Device Identification	
AMS Tag:	PSHH-20060
Device Tag:	
Manufacturer:	CCS
Model Name:	646GZEM7
Device Identifier:	PSHH-20060

Device Calibration Data			
Date/Time Calibrated:	7/22/2013 1:39:28 PM	Max Error Limit:	3.00 % of Span
Technician:	pokryfge	Notification Limit:	3.00 % of Span
User:	pokryfge	Adjustment Limit:	3.00 % of Span
Ambient Temperature:	(N/A)	Calibration Interval:	3 Years
Temperature Standard:	IPTS-68	Critical Service:	Yes
Work Order Number:		Input Range:	1000.00 - 2000.00 psi
Service Reason:	Routine		
Service Notes:			
Relationship:	Switch		
Tolerance:	+/- 30.00 psi	Trip Direction:	Increasing
Ramp Time:	0 s	Test Reset Point:	No
Expected Deadband:	0.00 psi

Errors (%)			
Error	Limit	Actual: As Found	Actual: As Left
Trip Error	3.0000	-2.3100 (Pass)	0.1900 (Pass)
Deadband Error	(N/A)	(N/A)	(N/A)

Calibration Results: As Found									
Point	Set Point	Trip Point	Trip Error	Trip Error (%)	Reset Point	Reset Trip	Deadband	Deadband Error	Deadband Error (%)
1	1370.0000	1346.9000	-23.1000	-2.3100	(N/A)	(N/A)	(N/A)	(N/A)	(N/A)
