ANCHOR POINT ENERGY, LLC

Re: 2013 North Fork Pipeline Lessee Annual Report State of Alaska ROW Lease 230928

1.0 Project Overview

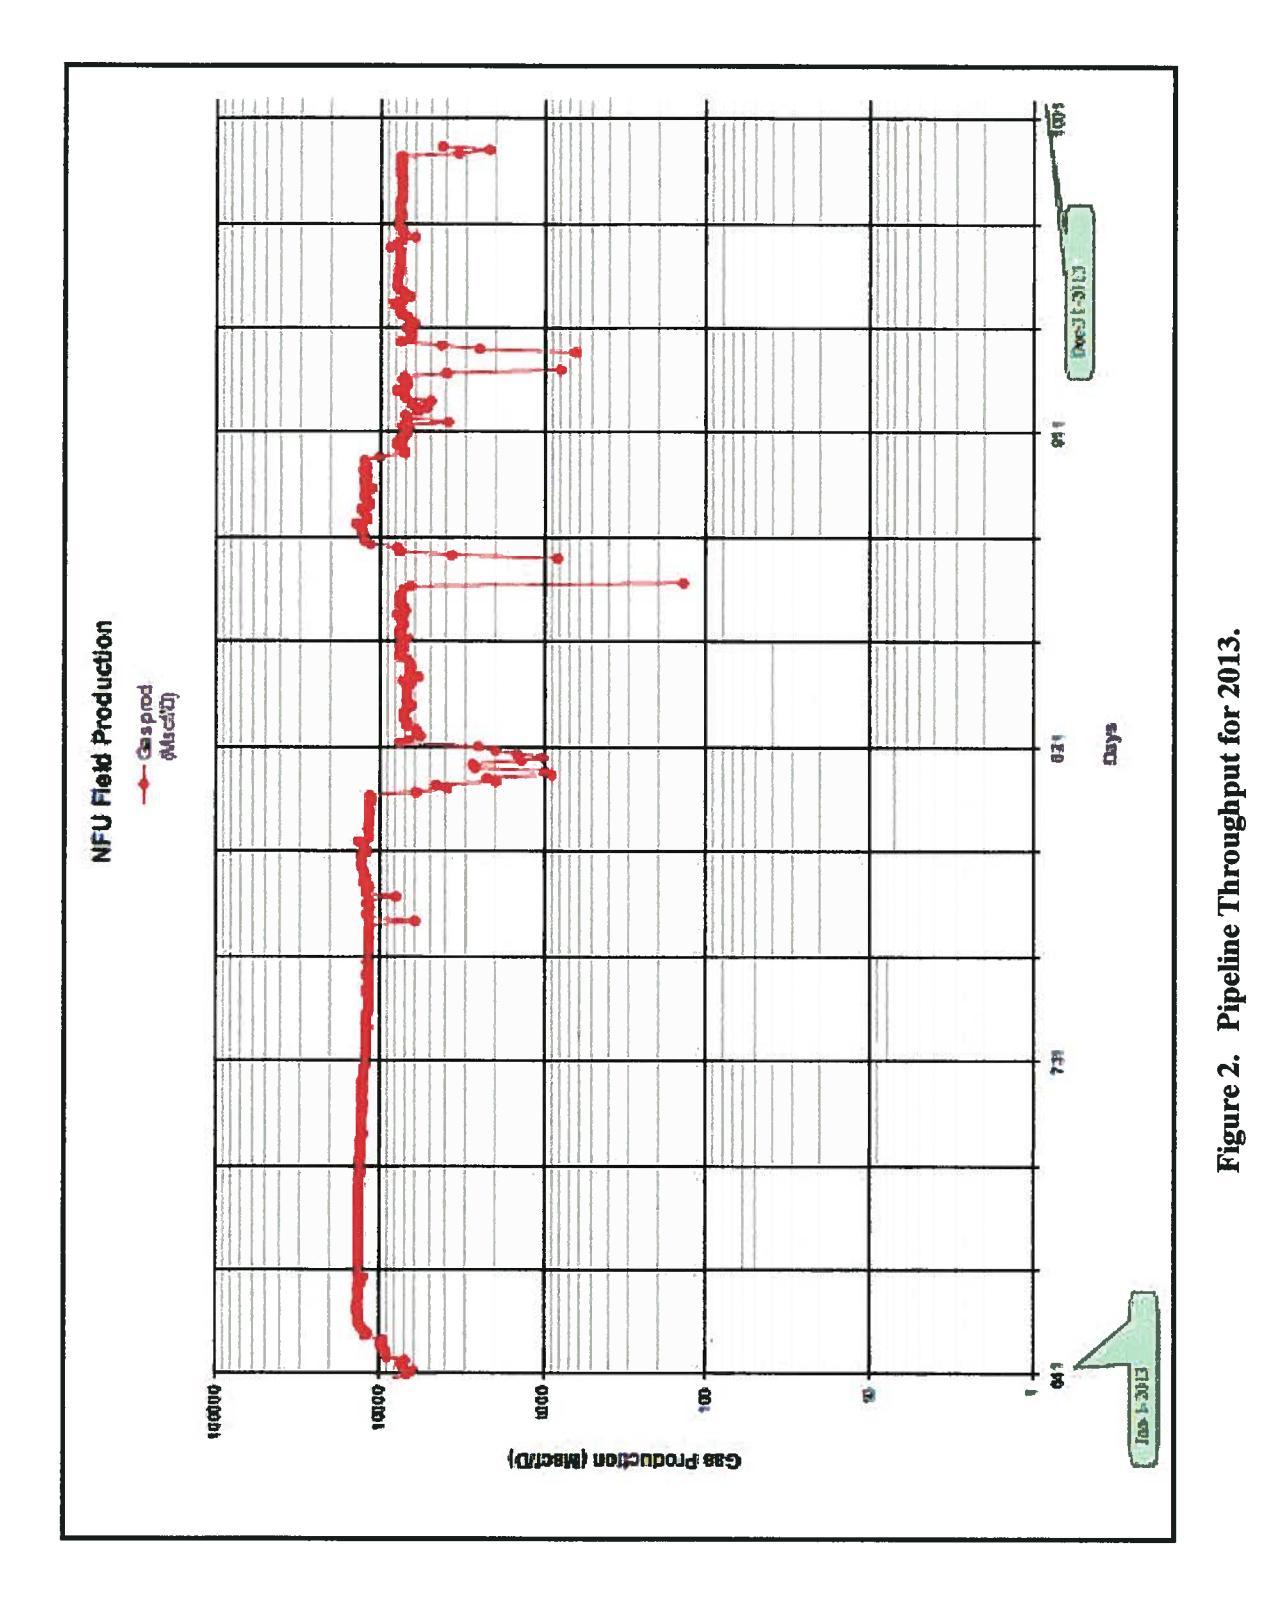
The pipeline was in operation during all of 2013 and has transported a total of 3,440 mmscf of natural gas through the end of 2013. Daily production varies typically from about 1.5 to just about 15 mmscf per day. The daily production was 9.4 mmscf. Figure 2 shows the production through the North Fork Gas Pipeline during 2013.

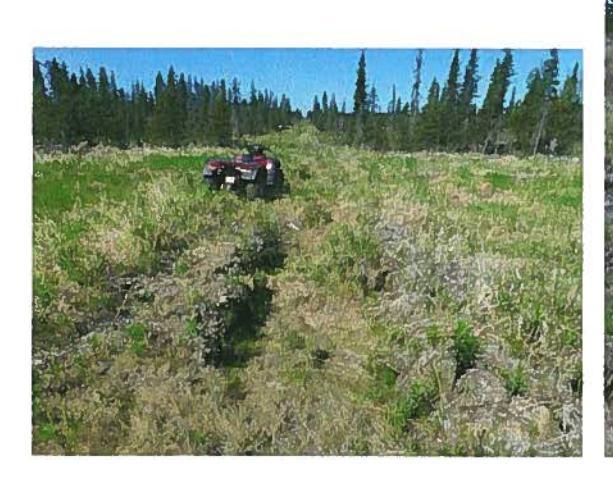
Photo 1. Area 1-Trench subsistence east of Coleman Lantern Road.

Area	Description	Comments
1	Trench subsidence at top of hill east of Coleman	Use existing materials adjacent to pipeline
	Lantern Road, approximately 250 lineal feet not in	trench to fill area.
	wettands. (Photo I)	
2	Trench subsidence from MP 2 easterly to trail,	Use existing materials adjacent to pipeline
	approximately 700 lineal feet not uplands. (Photo 2)	trench to fill area.
3	Water filled depression in wetland next to Wagon Road	Fill with about 3 dump truck loads of sand and
	approximately ¼ mile from the NFU Pad. (Photo 3)	place in depression with excavator.
4	Water eroded saw-cut trench in wetlands, on Wagon	Place sand bags in channel at 25 foot intervals.
	Road beginning near test station approximately 400	Fill with about 3 dump truck loads of peat and
	feet to 90 degree corner in road. (Photo 4)	place in depression either by hand or with a wide
		track skid steer loader.
5	Water filled depression in wetlands at end of Wagon	Fill with about 3 dump truck loads of sand and

Areas indicated above were all remediated during the summer of 2013.

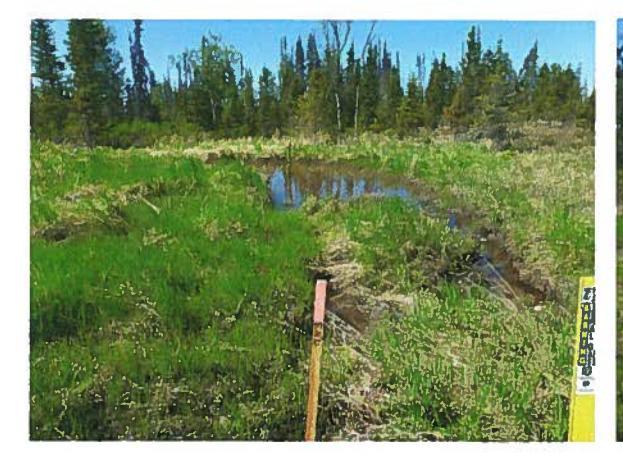
Photo 5. Area 5-Water filled depression at pipelone bend in wetland next to Wagon Road near the NFU Pad.

Road and approximately 1.3 miles from North Fork	place in depression with excavator.
	Road. (Photo 5)	
6	Drainage swale crossing 150 feet past end of Wagon	Use about 2 CY of 1-6 inch cobble.
	Road on Handcart Road. (Photo 6)	
7	Drainage swale crossing 150 feet past end of Wagon	Use about 2 CY of 1-6 inch cobble.
	Road on Handcart Road. (Photo 7)

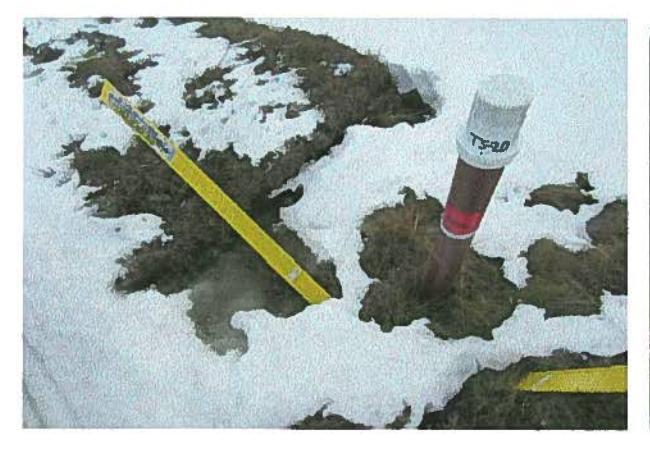
Photo 8. Damage of Pipeline Marker.

Damage on ROW: Minor damage was observed along the ROW. This included damage to several pipeline markers (Photos 8 and 10) and damage to a cathodic protection test station (Photo 9). The cause of damage is not entirely known, but all damage corrected soon after discovery.

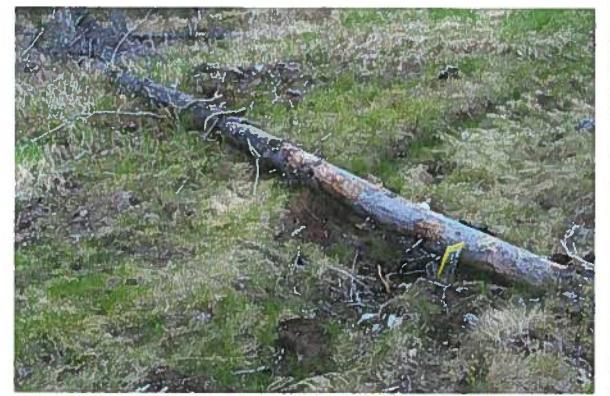
Photo 10. Damage of pipeline marker from fallen tree.

In addition, over the course of 2013, a total of 8 trees fell across the ROW, presumeably as a result of wind damage (see examples in Photo 10 and 11). All trees were cut up and placed alongside of the ROW during November 2013.
